**RAILWAY INVESTIGATION REPORT
R13D0054**

RUNAWAY AND MAIN-TRACK DERAILMENT

**MONTREAL, MAINE & ATLANTIC RAILWAY
FREIGHT TRAIN MMA-002
MILE 0.23, SHERBROOKE SUBDIVISION
LAC-MÉGANTIC, QUEBEC
06 JULY 2013**

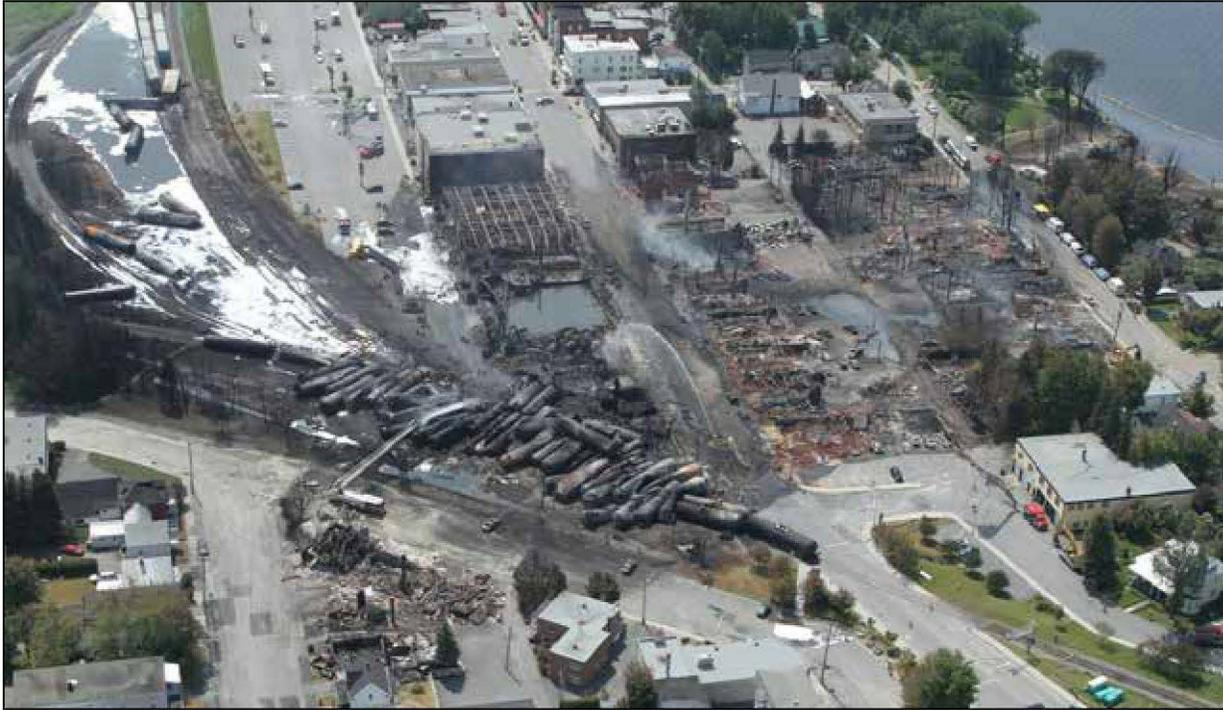
Photo 1. The Lac-Mégantic derailment site following the accident

As a result of the derailment and the ensuing fires and explosions, 47 people died, and about 2000 people were evacuated. Forty buildings and 53 vehicles were destroyed (Photo 1).

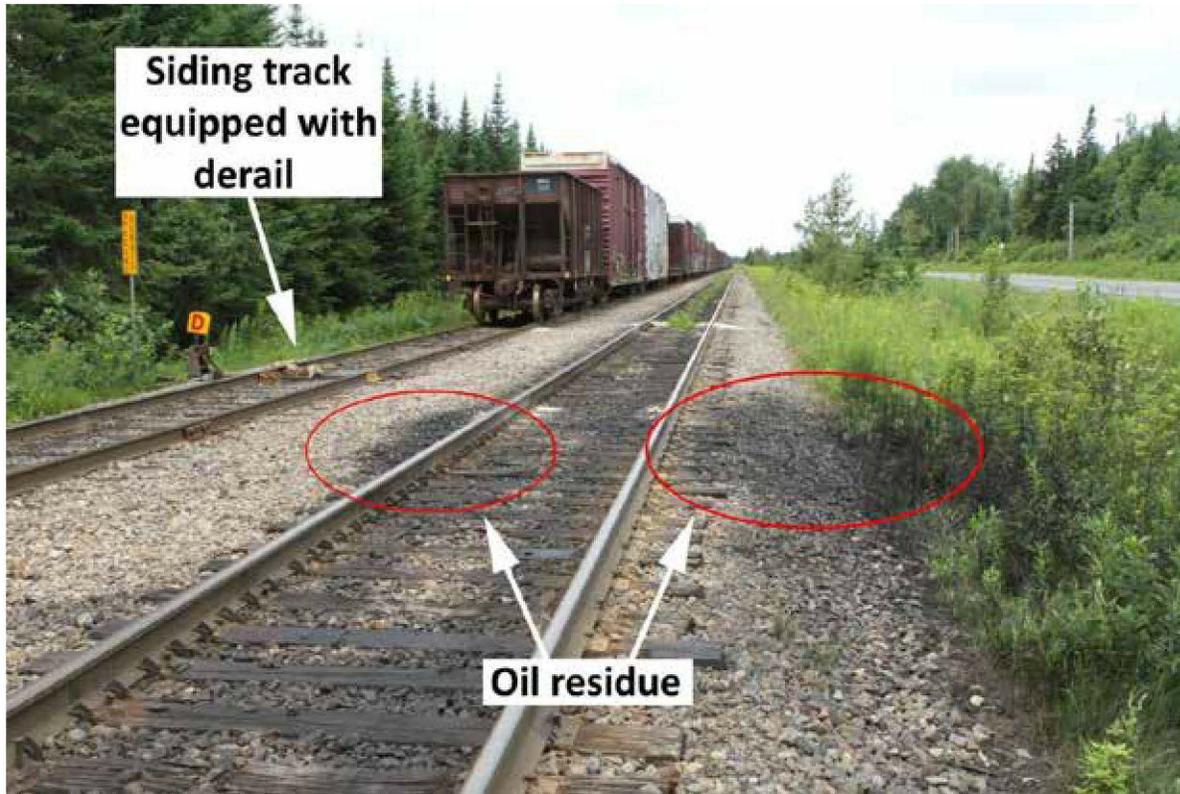
Photo 3. Oil residue on the ground and vegetation at Nantes. Note derail on adjacent siding track on left (view westward from the location where the lead locomotive was parked on the main track).

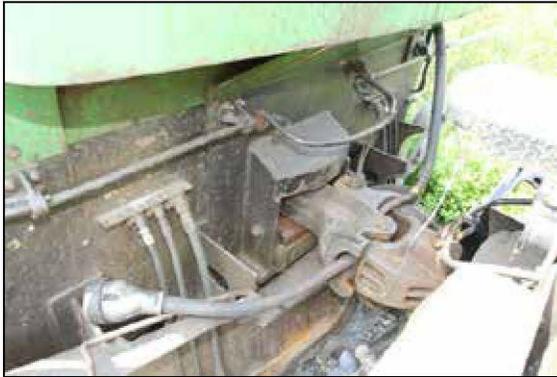
- One of the knuckles connecting the second locomotive (MMA 5026) and the third locomotive (CITX 3053) was broken, and a locomotive connector cable had been pinched between the knuckles (Photo 7), indicating that a separation had occurred and the consist had rejoined.

Photo 7. Pinched connector cable between couplers of second and third locomotives (occurring after the accident)

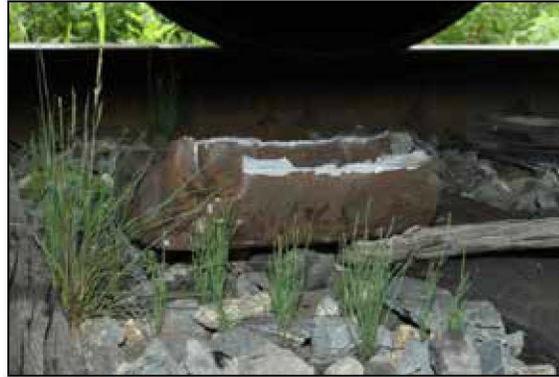
- A broken piece of the knuckle was found under the second locomotive, approximately 15 feet from the coupling (Photo 8). The locomotive knuckle and pin failed in tensile overstress mode, initiating at pre-existing fatigue cracks (Engineering Laboratory Report LP184/2013).

Photo 8. Broken locomotive knuckle segment found under the second locomotive

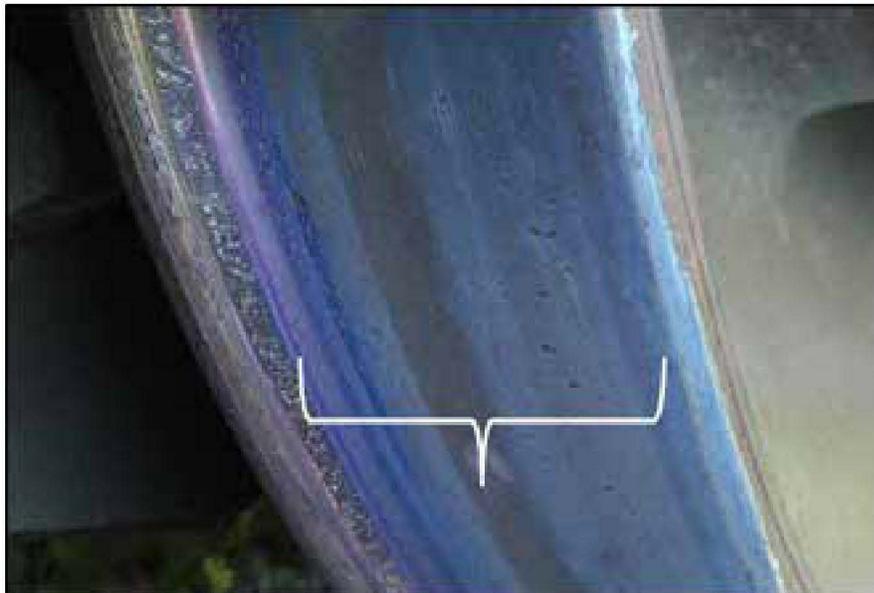
Photo 12. Blueing of locomotive wheel due to heat

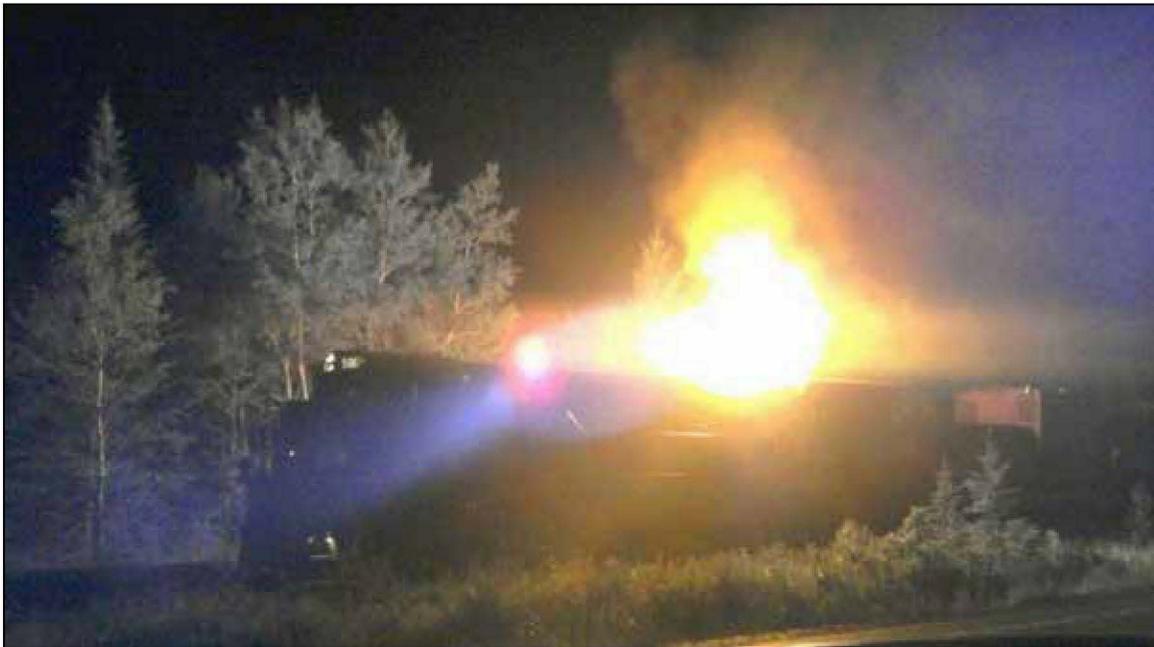
Photo 13. Locomotive fire at Nantes (photo: Nancy Cameron)

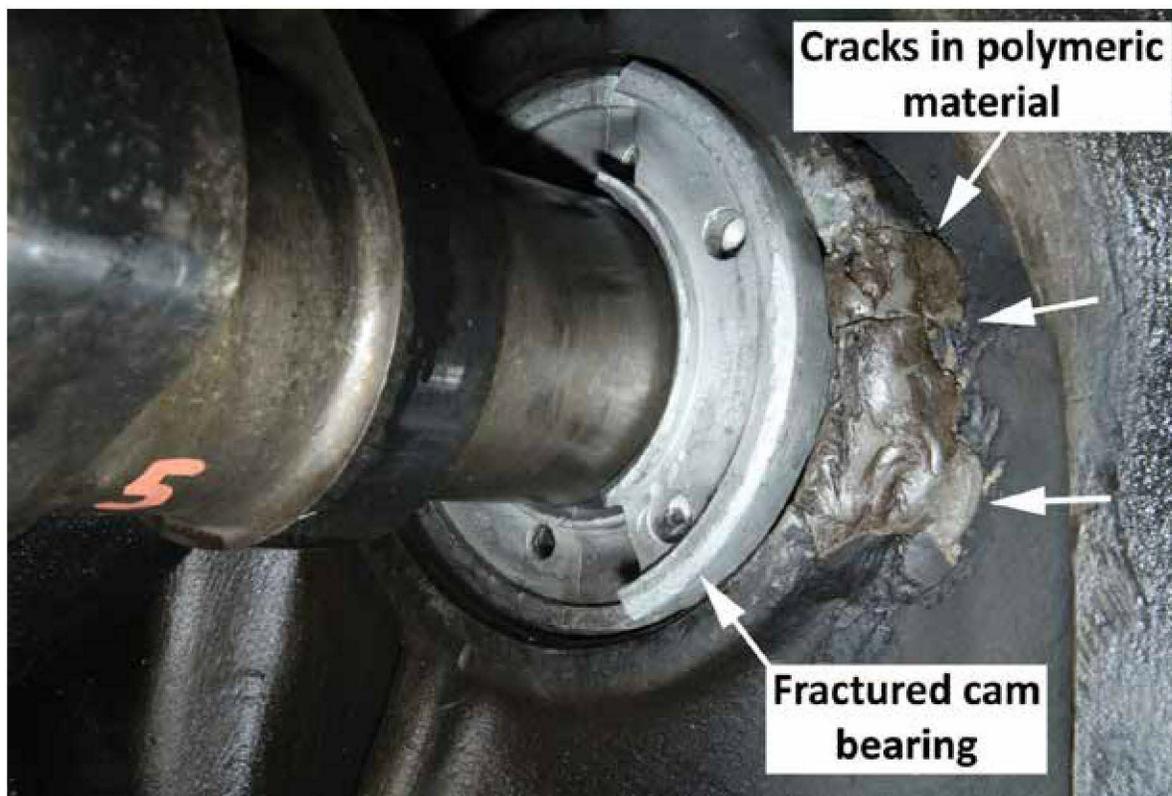
Following the accident, the locomotive consist was moved from Lac-Mégantic to a maintenance facility in Saint John for examination. A partial engine teardown of MMA 5017 was conducted (see Engineering Laboratory Report LP181/2013 for complete details). It was determined that the cam bearing had fractured when the mounting bolt was over-tightened after the cam bearing had been installed as part of a non-standard repair to the engine block. This temporary repair had been performed using a polymeric material, which did not have the strength and durability required for this use (Photo 14). Failure of the cam bearing reduced the engine oil supply to the valve train at the top of the associated power assembly. The decreased lubrication led to valve damage and eventually to a punctured piston crown. The damaged valves and piston crown allowed engine oil to flow into the cylinder and the intake and exhaust manifolds. Some of the engine oil collected in the body of the turbocharger. The engine fire later occurred in the exhaust stack due to the build-up and ignition of engine oil in the body of the turbocharger.

Photo 14. Polymeric material applied to cam bearing bore and fractured cam bearing

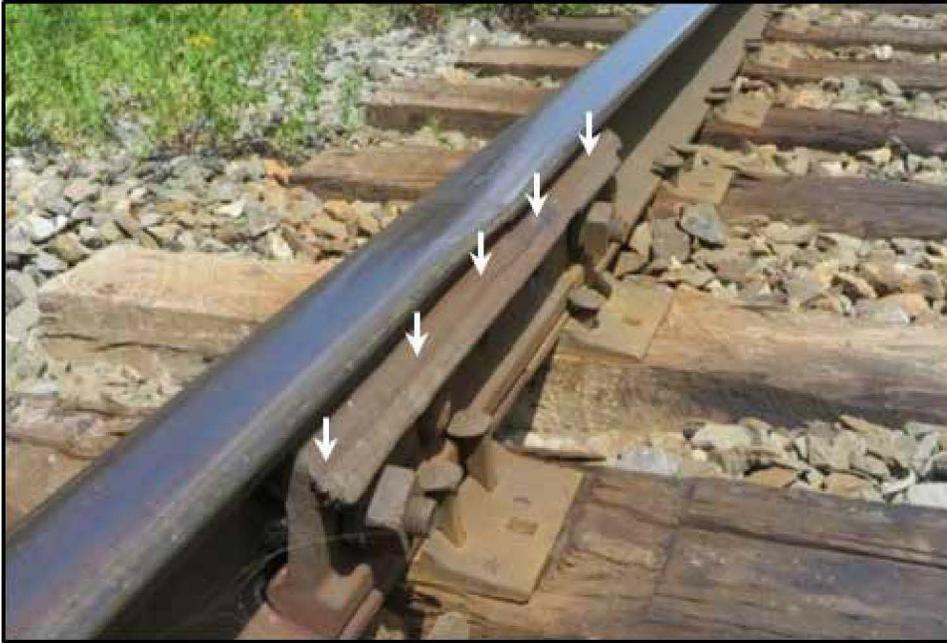
Photo 15. Damaged rail joint bar due to contact with wheel flanges

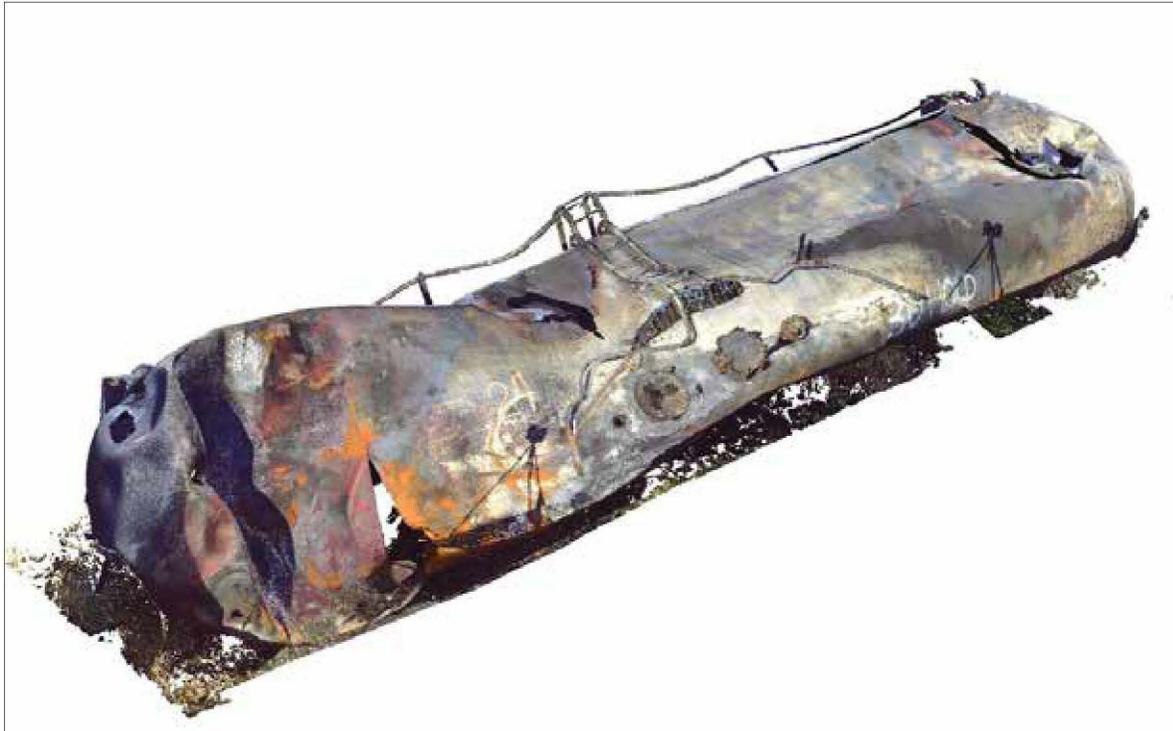
Photo 16. 3D laser scan of badly deformed tank

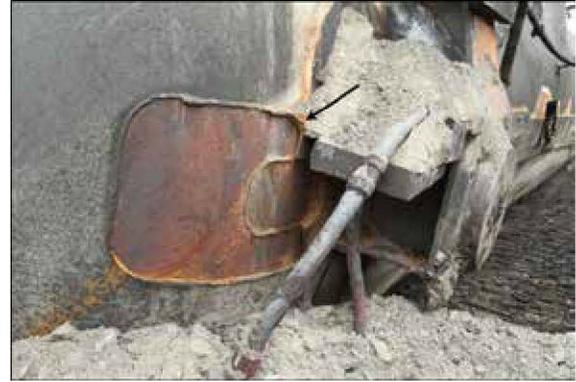
Photo 18. Damaged stub sill

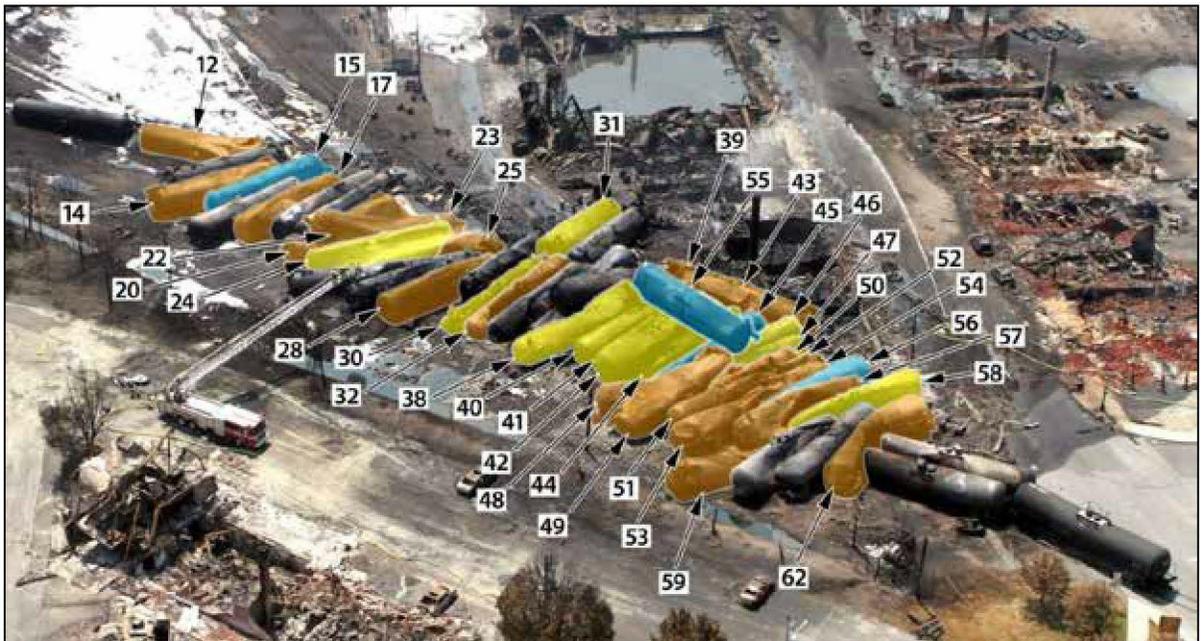
More than half of the tank cars (37 cars) released product due to impact damage to their shells (Photo 19). Other tank car shell damage included deformed/dented shells with no breach, as well as breaches due to thermal tears.

Photo 19. Tank cars with breaches to their shells (colour indicates relative size of breach: orange = large, yellow = medium, blue = small). The relative size of the breaches is also identified in Appendix B.

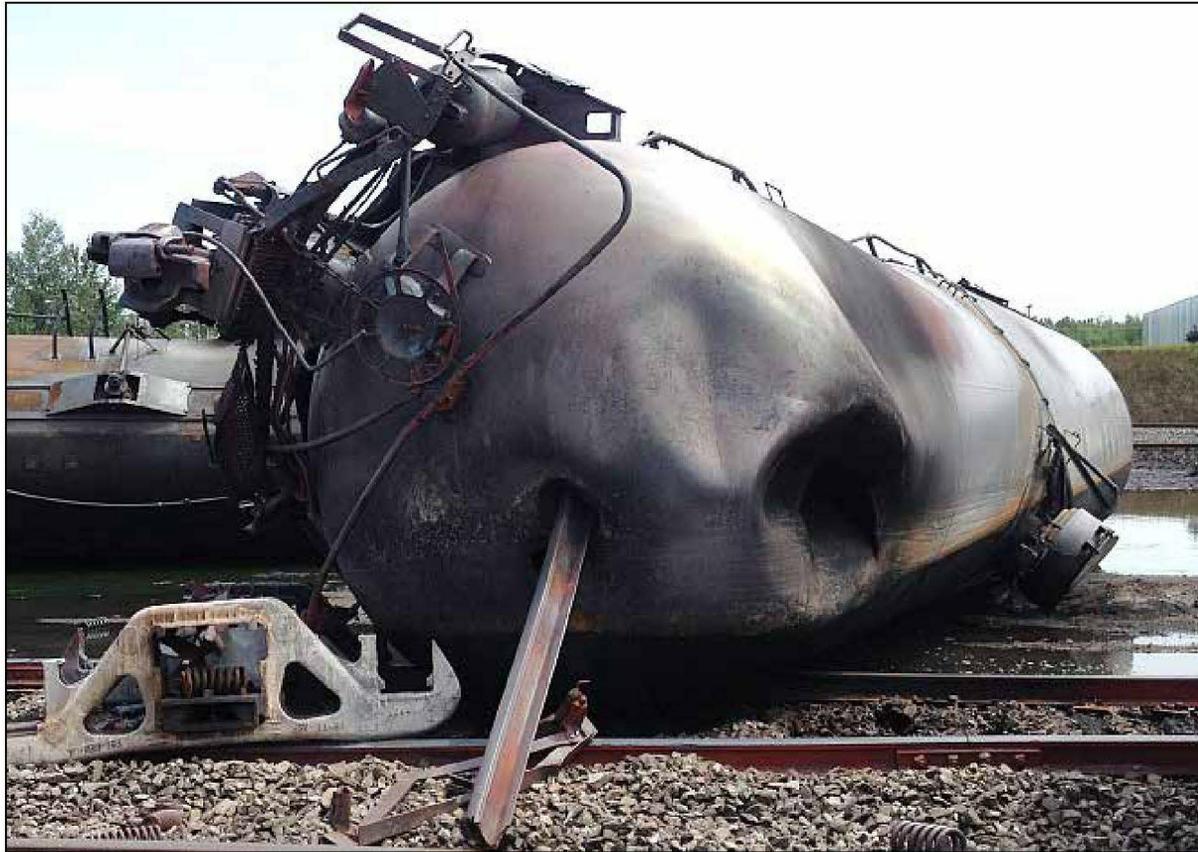
All but 4 of the 63 derailed cars exhibited some form of impact damage (for example, denting or breach) in the top portion of at least one head (Photo 20). About half of the tank cars (31) released product due to damage to the tank car head.

Photo 20. Head puncture due to rail impact

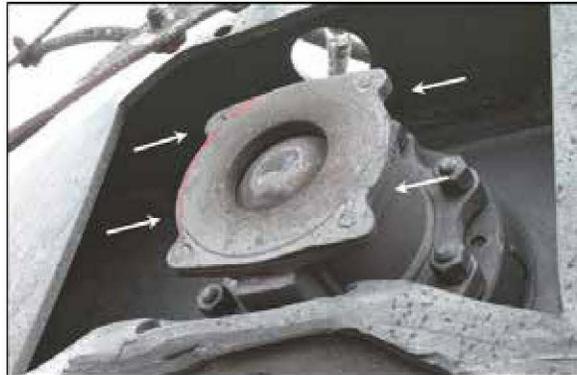
Photo 26. Bottom outlet valve with sheared-off nozzle

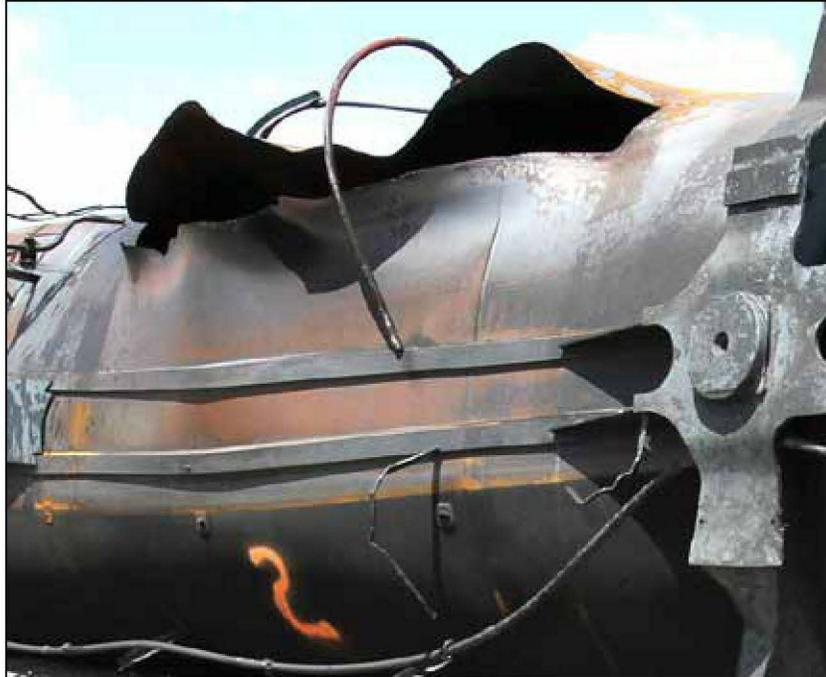
Photo 27. Thermal tear

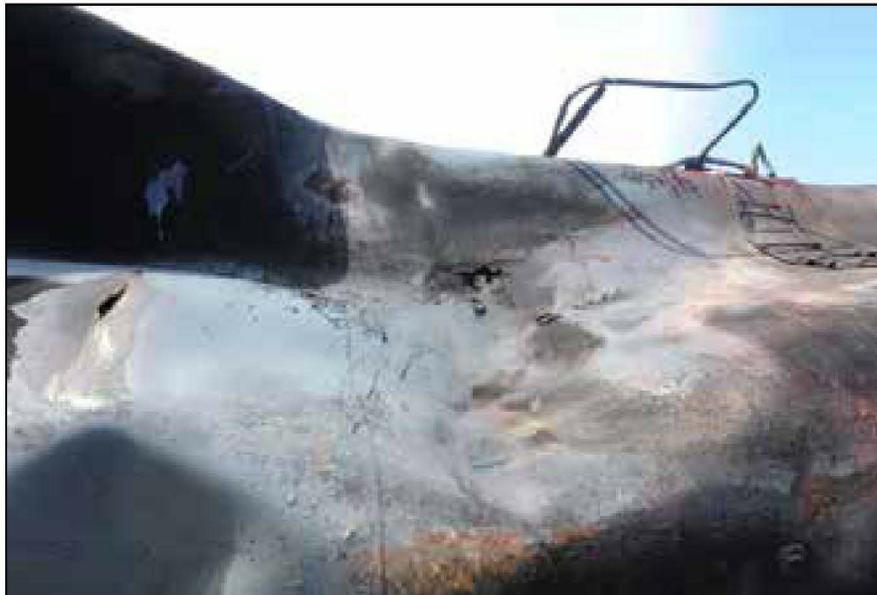
Photo 28. Burn-through

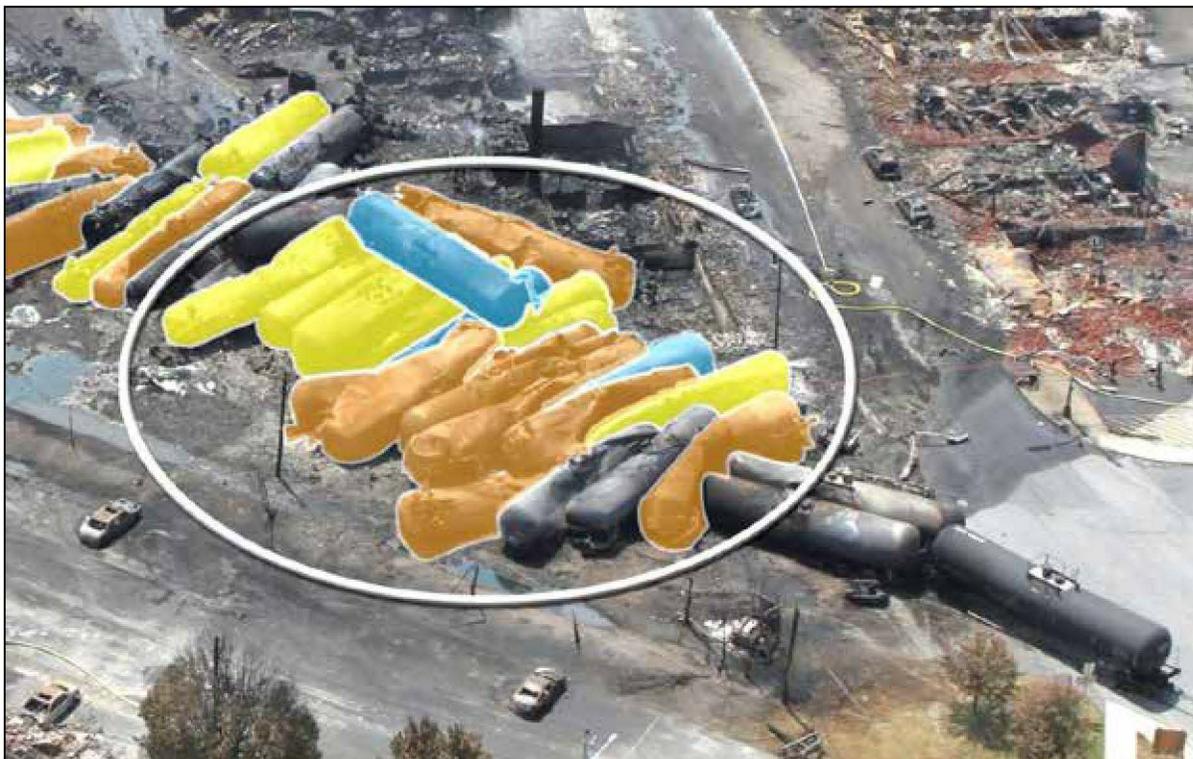
Photo 30. Concentration of large (orange) and medium (yellow) breaches toward the end of the derailment

About half of the cars with large breaches were clustered toward the end of the derailment. These cars would have encountered more severe derailment conditions than the conditions experienced by the cars located toward the front of the train, due to the large pileup ahead of them. This pileup likely acted as a wall for the cars derailing toward the end of the train. These highly constrained derailment conditions caused large-scale buckling and extreme tank deformations (that is, plastic collapse), which resulted in large shell ruptures. These cars derailed at a slower speed, and came to rest perpendicular to the track. Their thin wall construction (7/16 inch), as well as the absence of jackets, did not provide sufficient protection from the derailment forces. Consequently, large tank shell breaches occurred in a short period of time on about 1/3 of the derailed tank cars, which resulted in the rapid release of large quantities of petroleum crude oil.
