1 National Transportation Safety Board

4
5
6 Derailment of BNSF unit crude oil train U TIOEXP0 44T

7 Heimdal, ND

9 Mechanical Group Factual

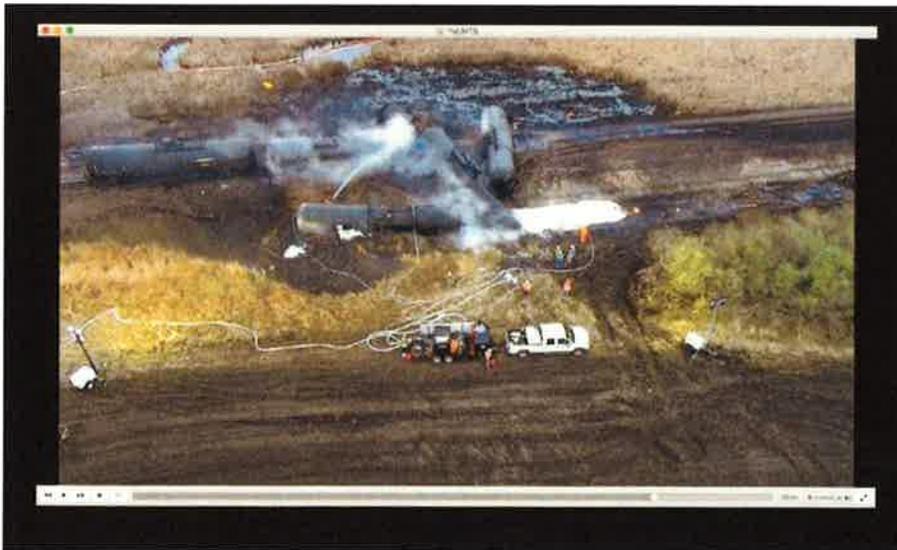
89 [Figure 1 Photo from drone of accident site after the fire was extinguished.](#)

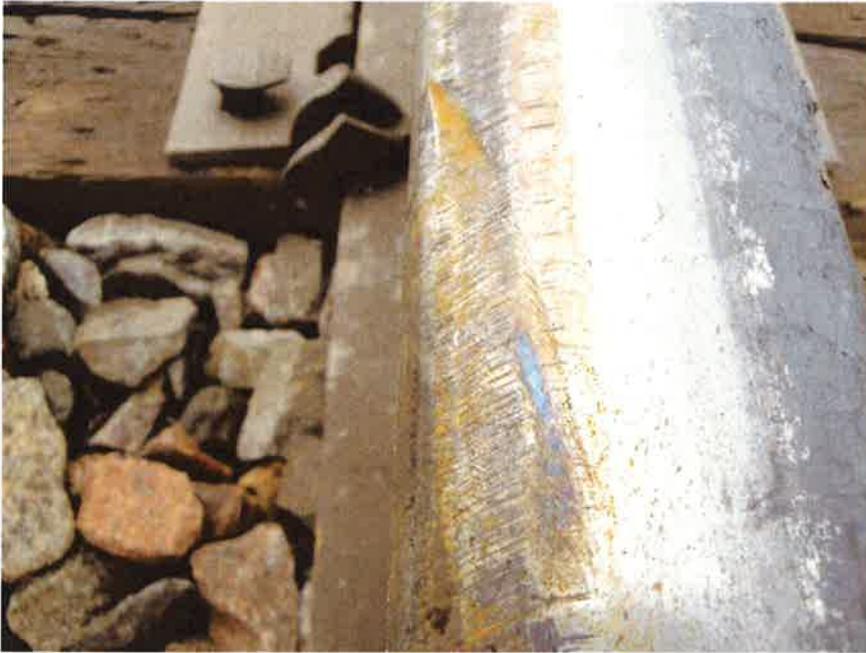
111 Preliminary review of event recorder data and physical data from the accident scene indicate the
112 eastbound train was approaching the POD at milepost 153.9 traveling at approximately 45 mph.

116 [Figure 2 POD at milepost 153.9](#)

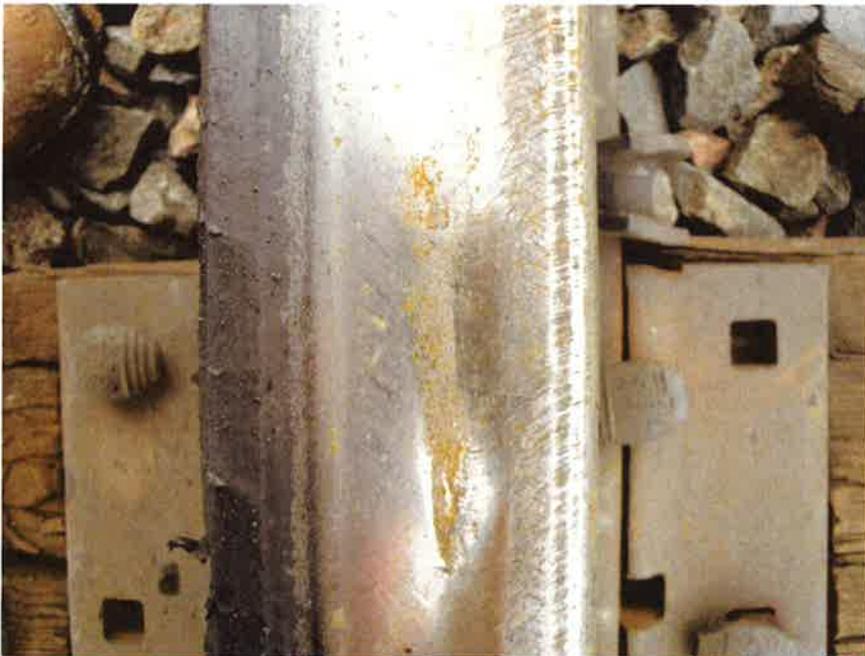
117 The throttle was in notch 2 with no brake pipe reduction and minimal tractive effort. There were
118 marks on the rail every 114 inches leading up to the POD.

120 [Figure 3 Rail marks every 114 inches.](#)

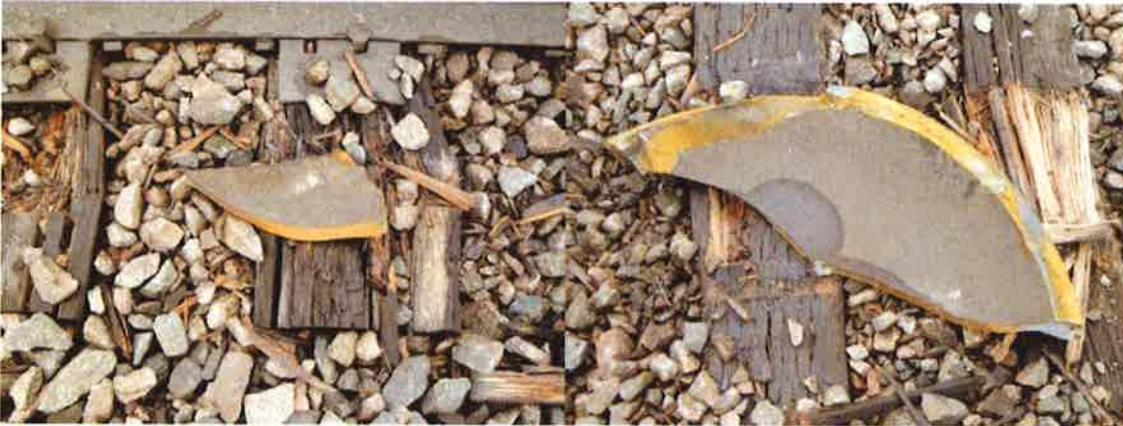
121 At milepost 150.7, 2 pieces of broken wheel were found. The 6 derailed cars came to rest at
122 milepost 149.1.

124 [Figure 4 Piece 1 at milepost 150.7](#)

[Figure 5 Piece 2 at milepost 150.7](#)

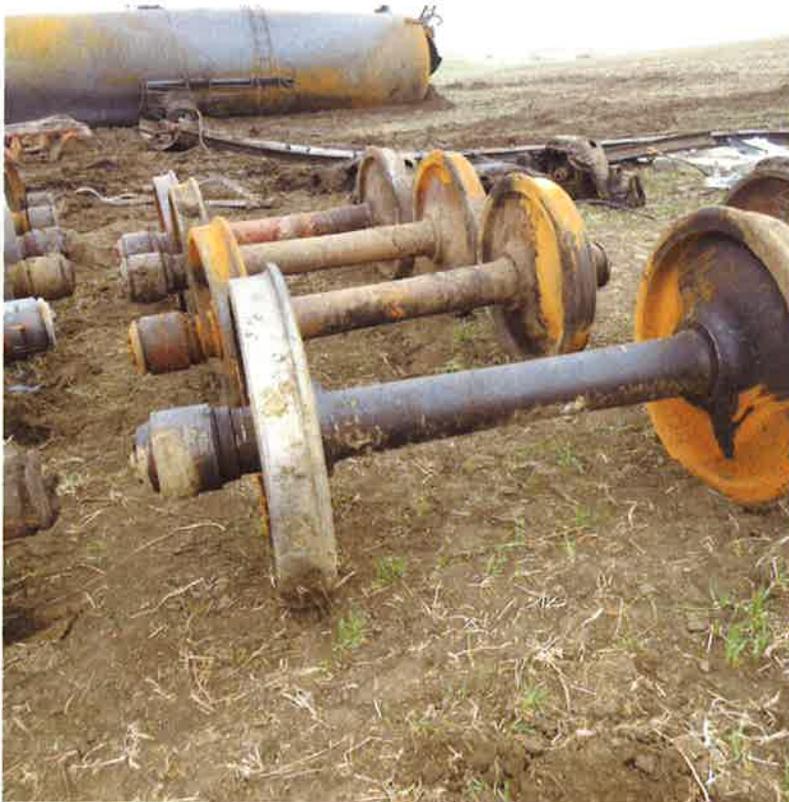
150 Figure 6 Running gear parts

151 The running gear parts were inspected for defects and regulatory compliance with no defects
152 noted. However, the “B” end truck of car TRFX 1224 had received the most damage from the
153 derailment. The left #2 wheel was broken and tagged with NTSB tag #1 as evidence.

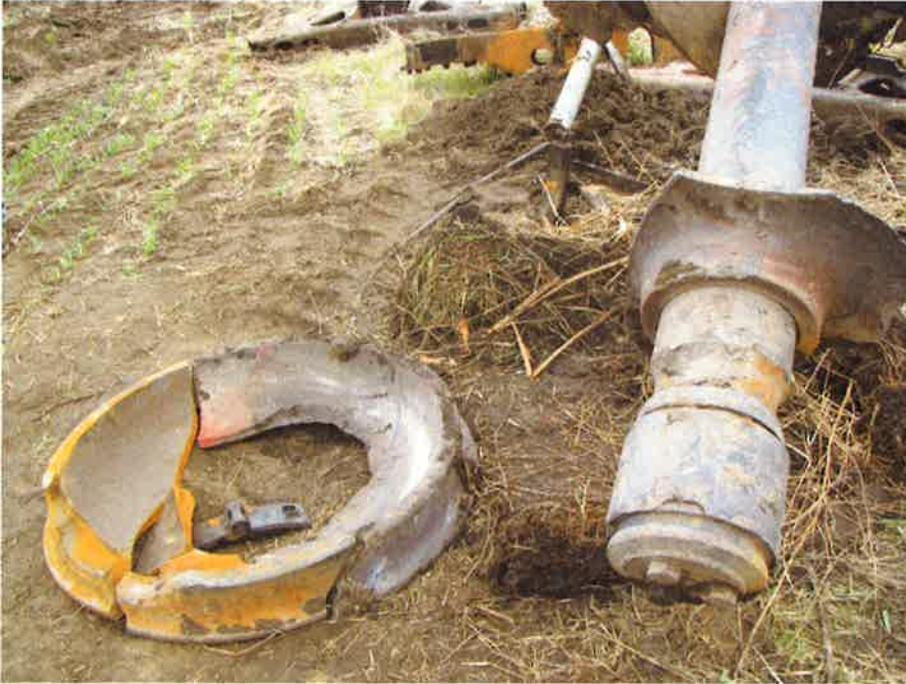
155 [Figure 7 Left #2 wheel.](#)
