APPENDIX G

Aesthetics

AESTHETICS

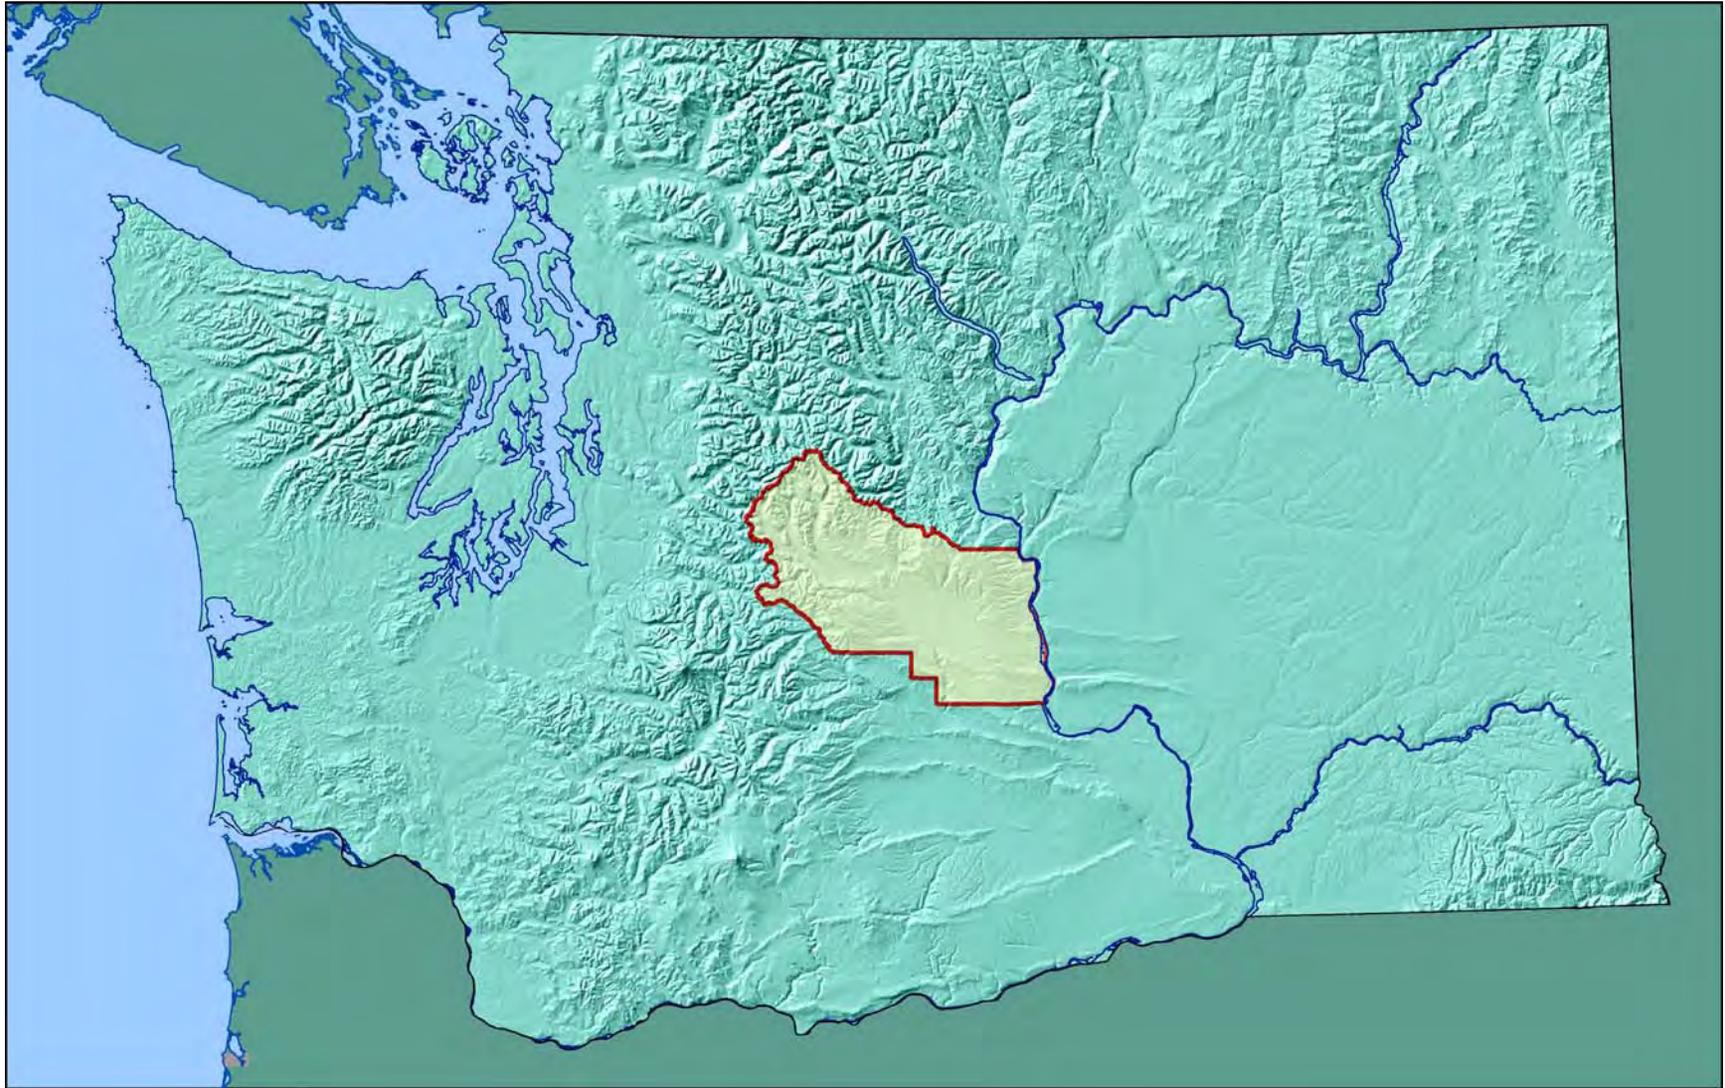
Figure G1
Kittitas County, roughly coterminous with the Kittitas Basin.

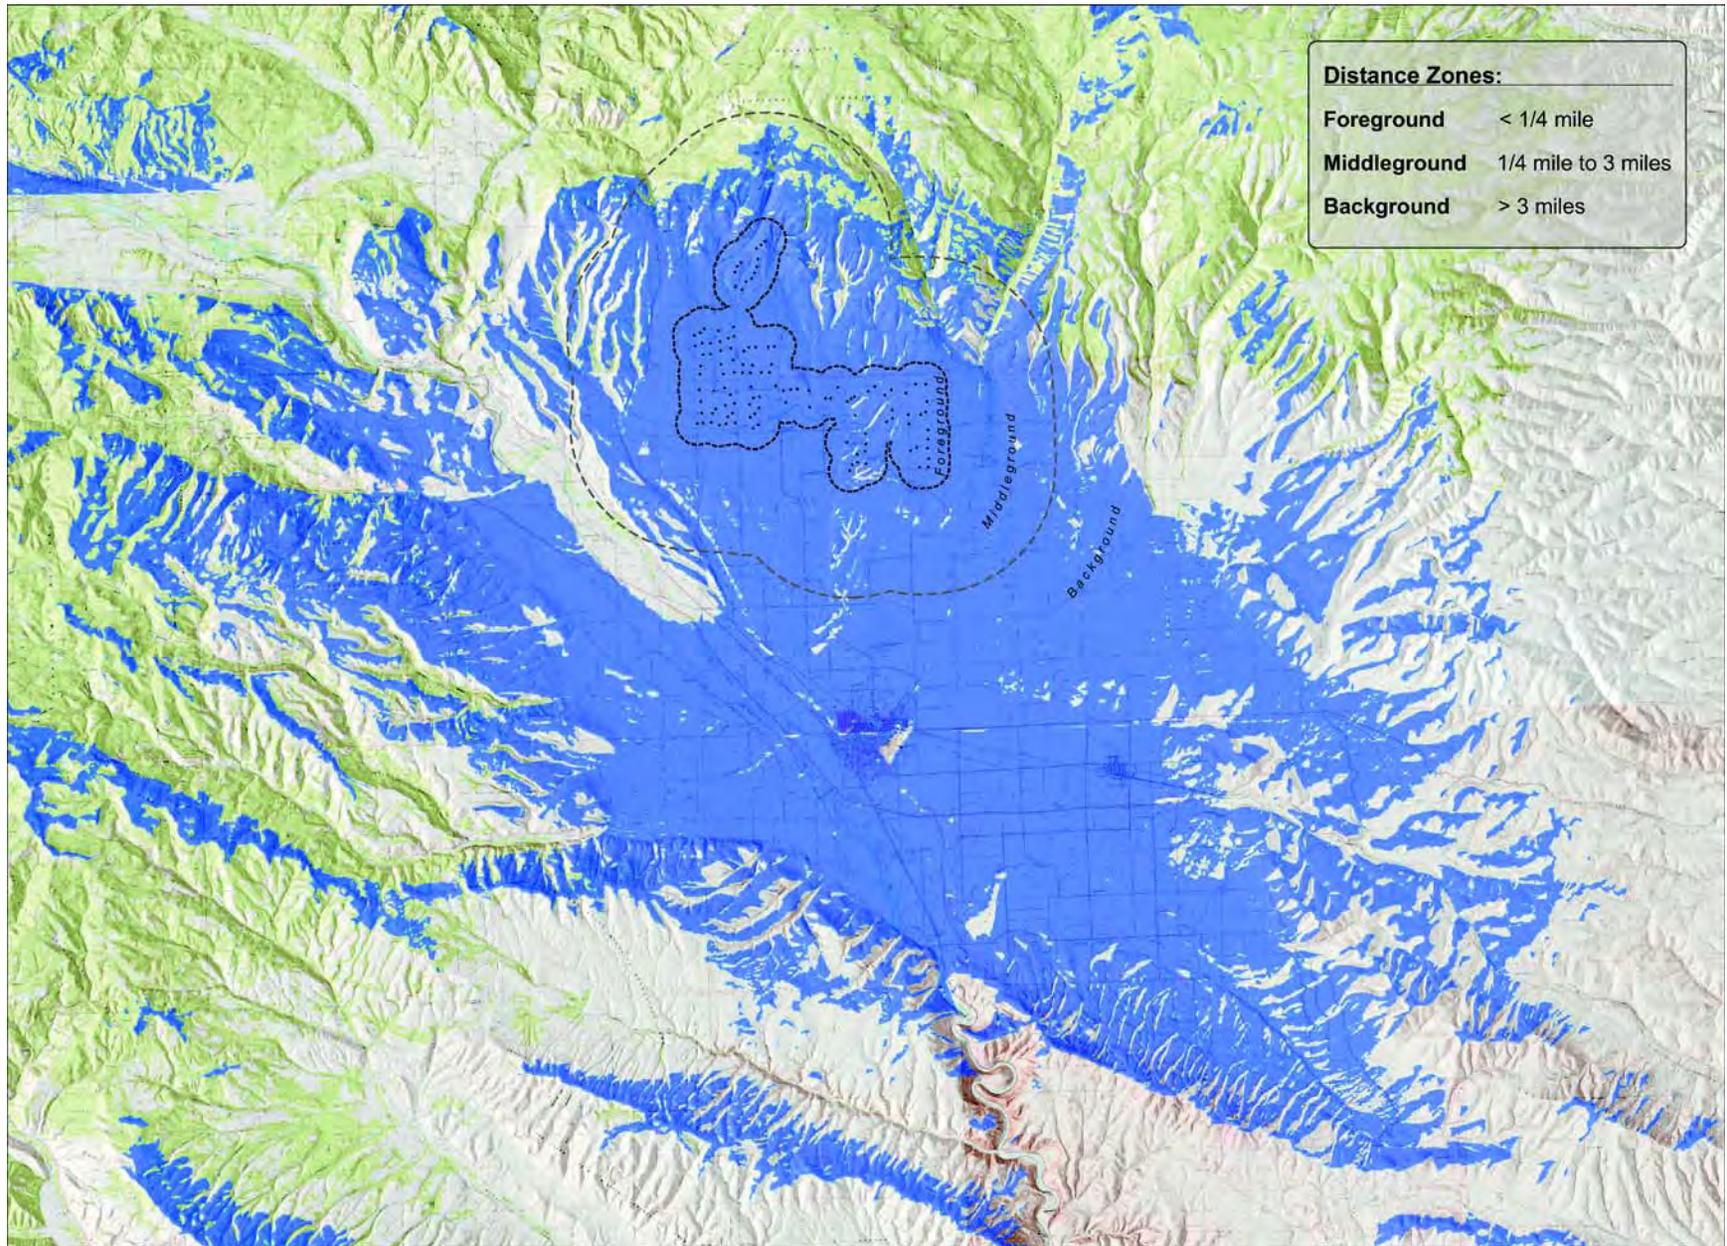
Figure G4
Viewshed of turbine blades indicated by shaded area.

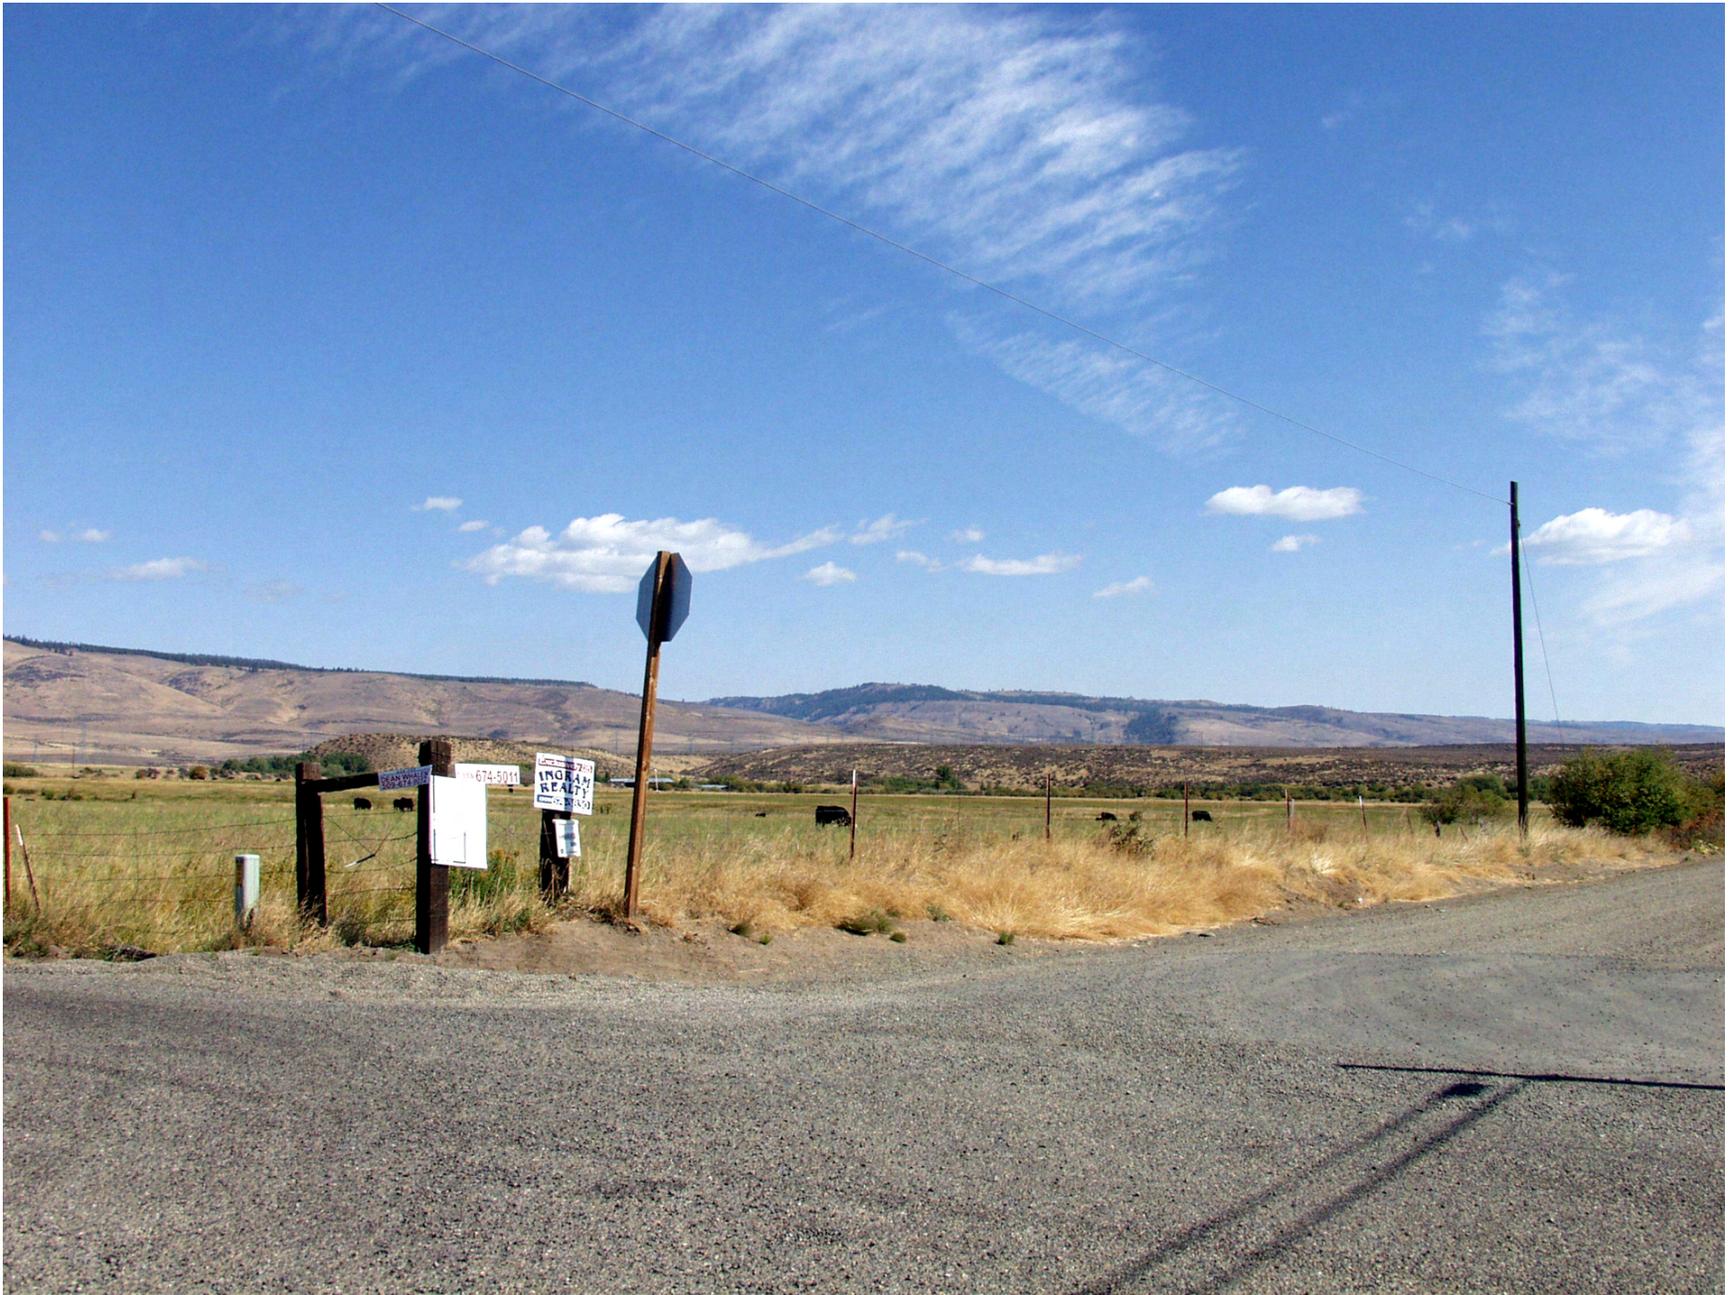
Figure G8
Key View 1A – Existing View looking northeast across the Northwest Valley Visual Assessment Unit
from the intersection of Smithson Road and Robbins Road.

Key View 1A: Figure G8 shows an existing view looking northeast across the Northwest Valley Visual Assessment Unit from the intersection of Smithson Road and Robbins Road.

Vividness: 3—View contains a memorable skyline: the Wenatchee Mountains, foothills, Naneum Canyon, and the north-south ridge running across the valley and the valley floor. View offers a range of vegetation characteristic of the region: Ponderosa Pine forest, shrub-steppe, and pasture.

Intactness: 3—No encroaching elements intrude into this view.

Unity: 3—Layered progression of visual elements from the valley floor, over the north-south ridge, and up the foothills to the horizon. Strong and harmonious vegetation patterns: fine texture of the pasture, coarse shrub-steppe, and smooth rangeland. Farm buildings nestled into the hills in the middleground evoke working rural landscape.

Overall Visual Quality: 3.0—High.

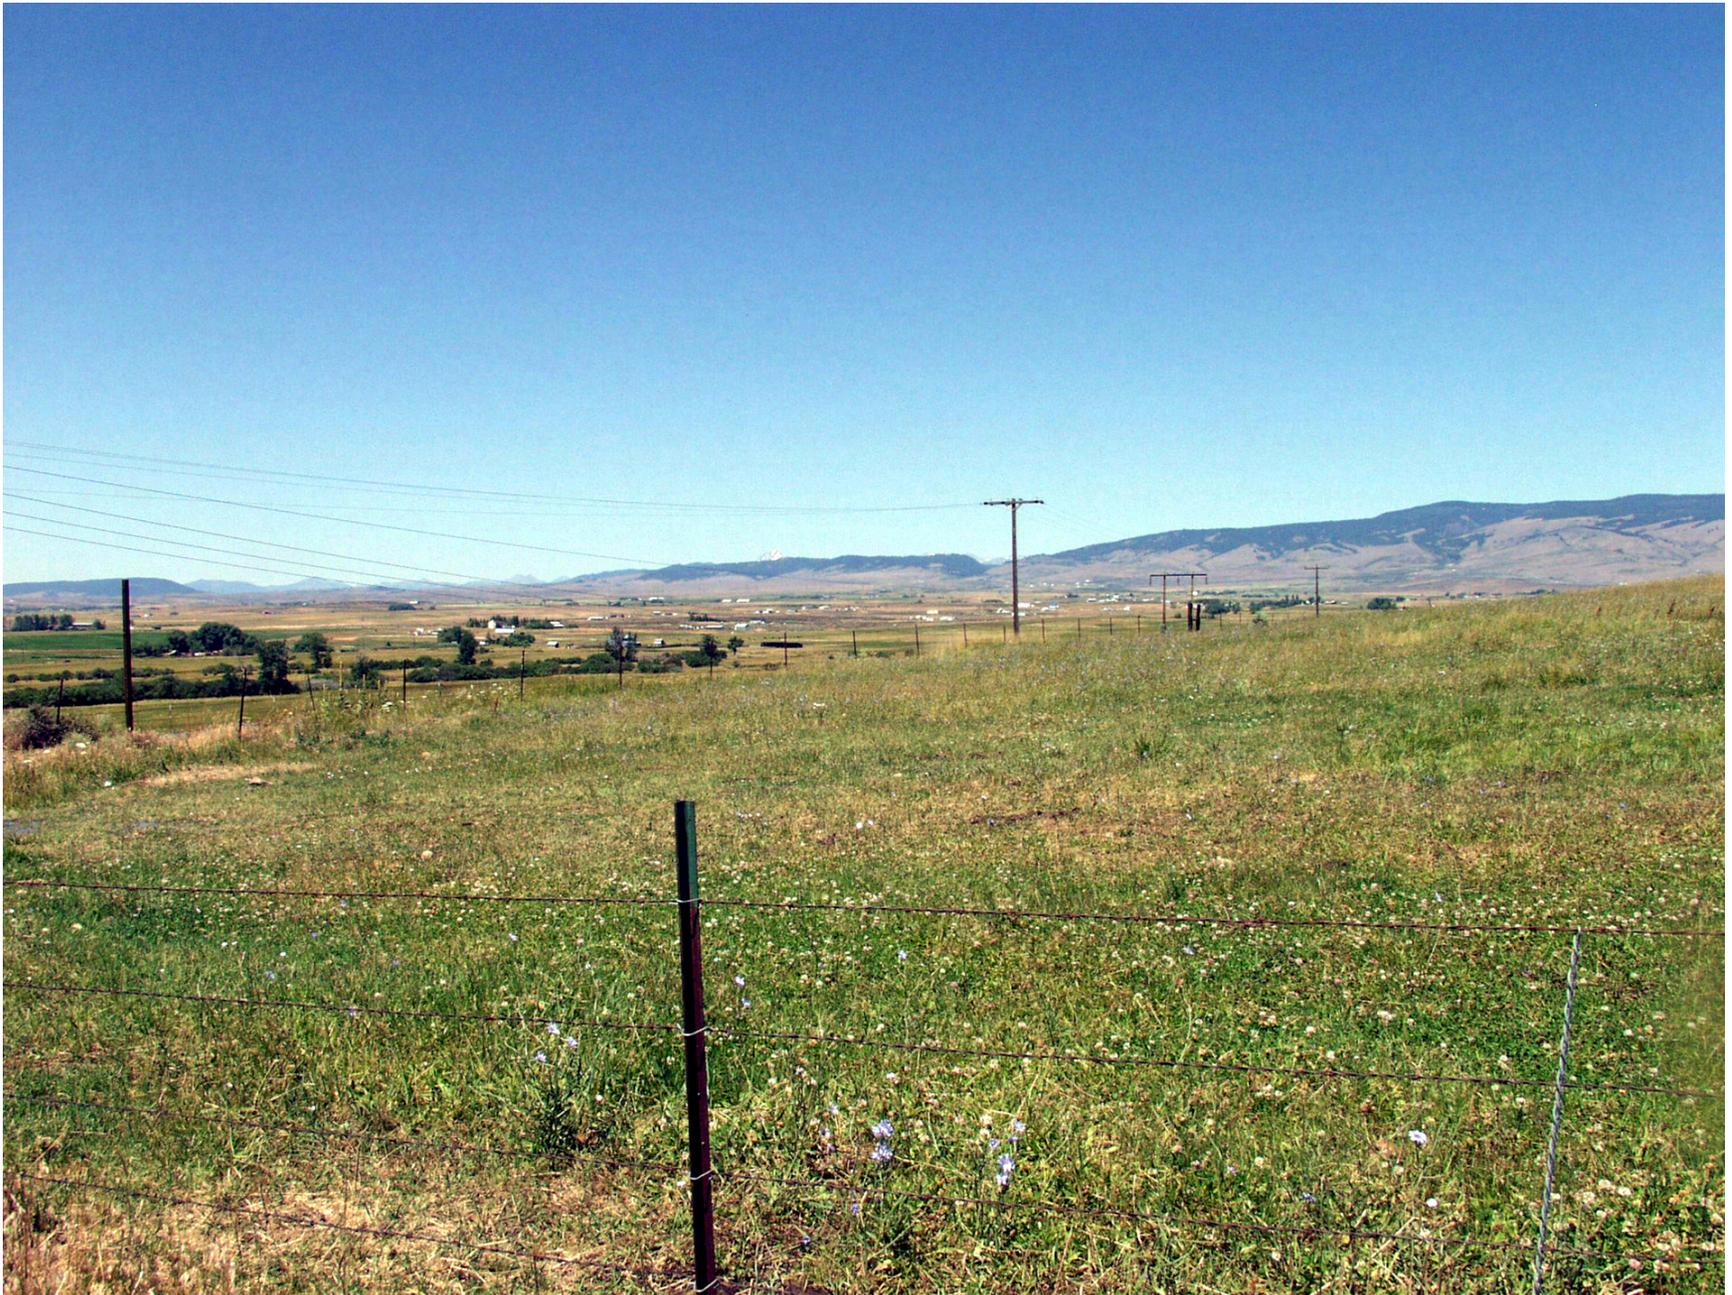
Figure G9
Key View 1B – Existing view looking northwest across the Northwest Valley Visual Assessment Unit from the intersection of Hungry Junction and Lookabout Lane.

Key View 1B: Figure G9 shows an existing view looking northwest across the Northwest Valley Visual Assessment Unit from the intersection of Hungry Junction and Lookabout Lane.

Vividness: 3— Memorable scene with the Wenatchee Mountains skyline including Mount Stuart, the foothills, and a broad section of the expansive valley floor. Full expression of characteristic regional vegetation: ponderosa pine forest, rangeland, and shrub-steppe in the middle ground, as well as riparian corridors and pasture.

Intactness: 3—High visual integrity, no encroaching elements in this landscape. Farm buildings and small power lines fit the working landscape.

Unity 3—Clear visual composition and progression from the rolling topography in the foreground to the horizon. Farm buildings dotting the middleground evoke the working landscape.

Overall Visual Quality: 3.0—High.

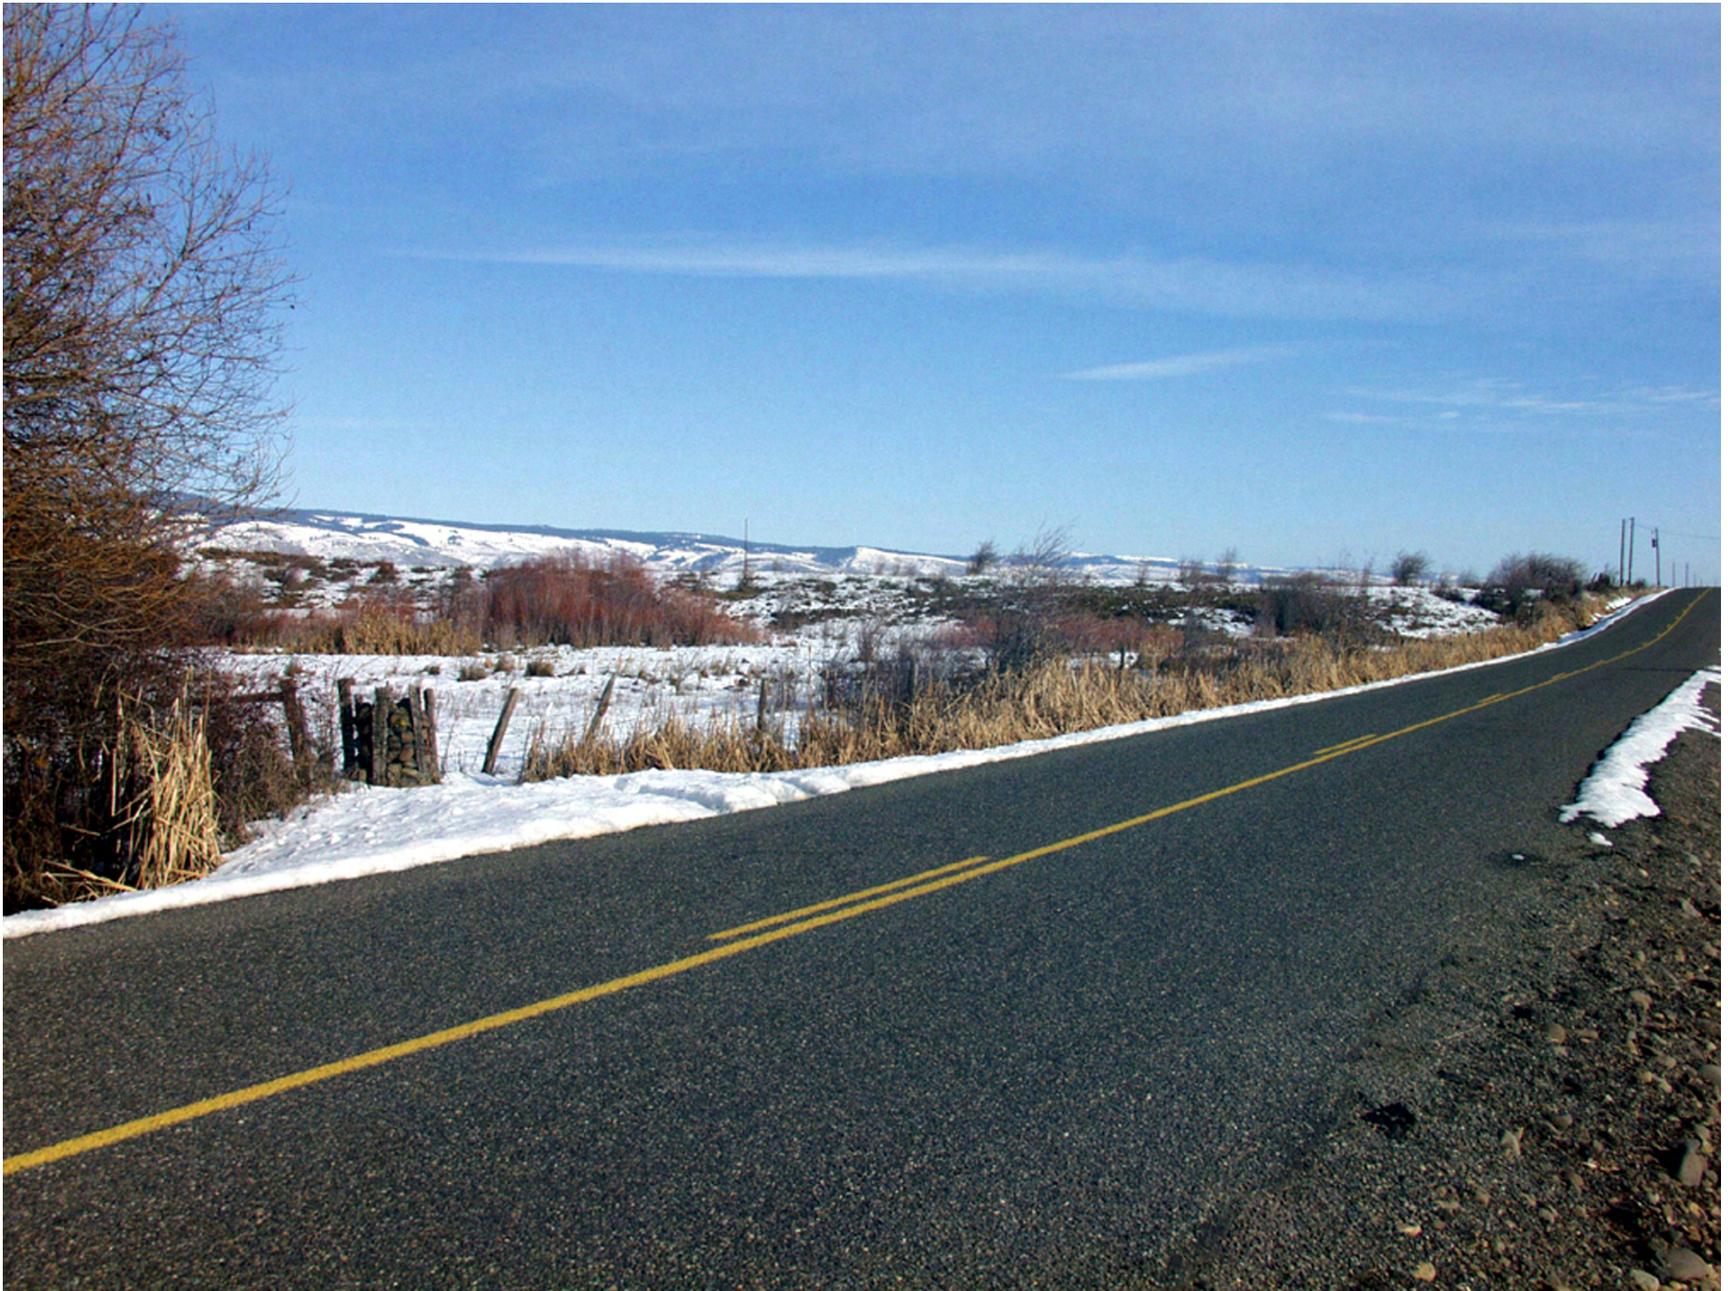
Figure G10
**Key View 1C – Existing view looking northeast across the Northwest Valley Visual Assessment Unit
along Smithson Road near U.S. Highway 97.**

Key View 1C: Figure G10 shows an existing view looking northeast across the Northwest Valley Visual Assessment Unit along Smithson Road near U.S. Highway 97.

Vividness: 2—Diverse visual patterns of wetlands and pasture, however, the baseline of the mountains against the valley floor is unclear. High vegetation species diversity: pasture, windrows, riparian, shrub-steppe, and forest.

Intactness: 2—Dendritic pattern of small creeks interrupted by Smithson Road.

Unity: 2—Traditional fencing and fields fit with topography and riparian vegetation. Progression from foreground to middleground and background is unclear.

Overall Visual Quality: 2.0— Moderate.

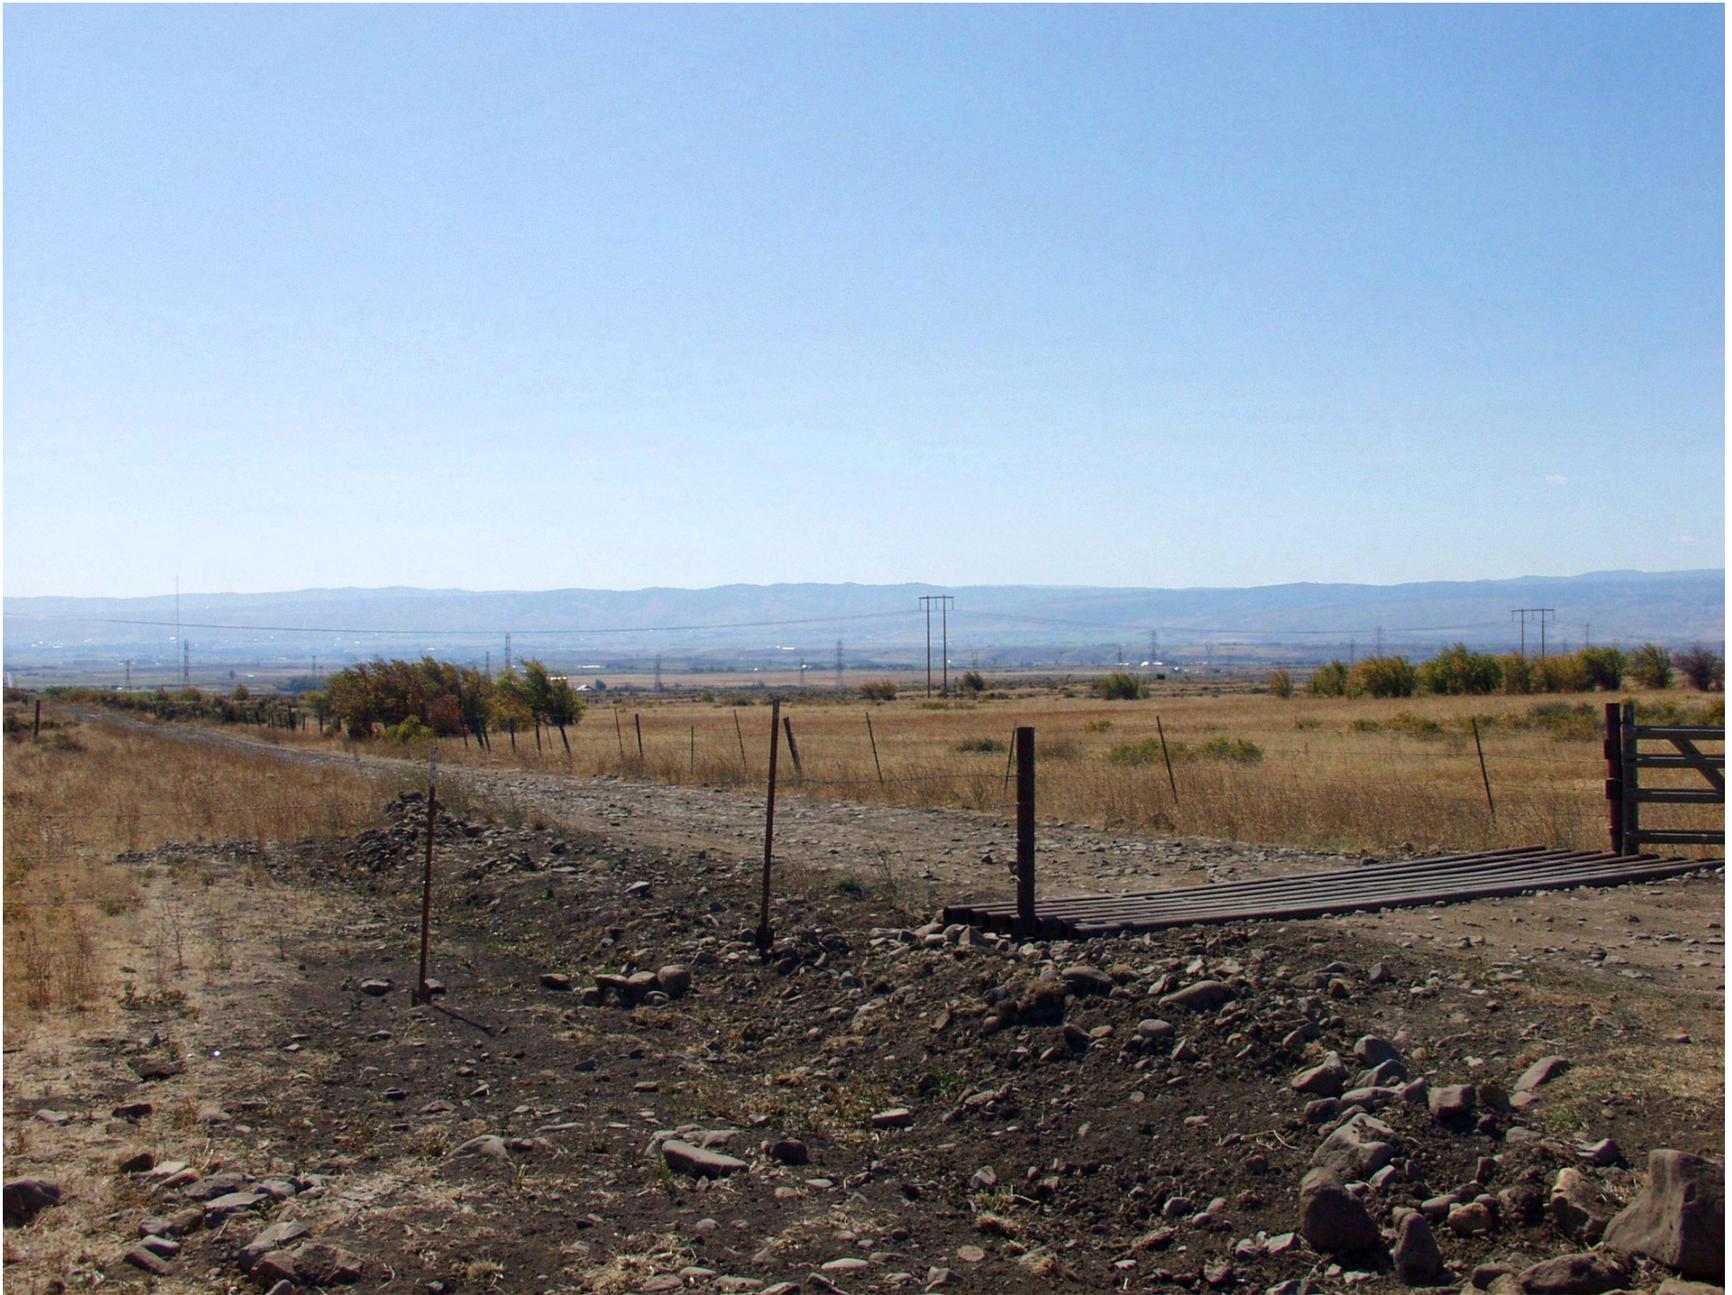
Figure G11
Key View 1D – Existing view looking southwest across the Northwest Valley Visual Assessment Unit
from immediately north of the project area.

Key View 1D: Figure G11 shows an existing view looking southwest across the Northwest Valley Visual Assessment Unit from immediately north of the project area.

Vividness: 2—Typical view across the valley to the Manastash Ridge allows an appreciation of the larger form of the valley. Visual patterns of non-irrigated rangeland and wind rows are simple but unremarkable.

Intactness: 2—Power lines encroaching in close and distant middleground. Disturbed and uncultivated lands in middleground.

Unity: 2— Progression from foreground to middleground and background is blurred, but enclosure of valley floor by ridge is clear.

Overall Visual Quality: 2.0—Moderate.

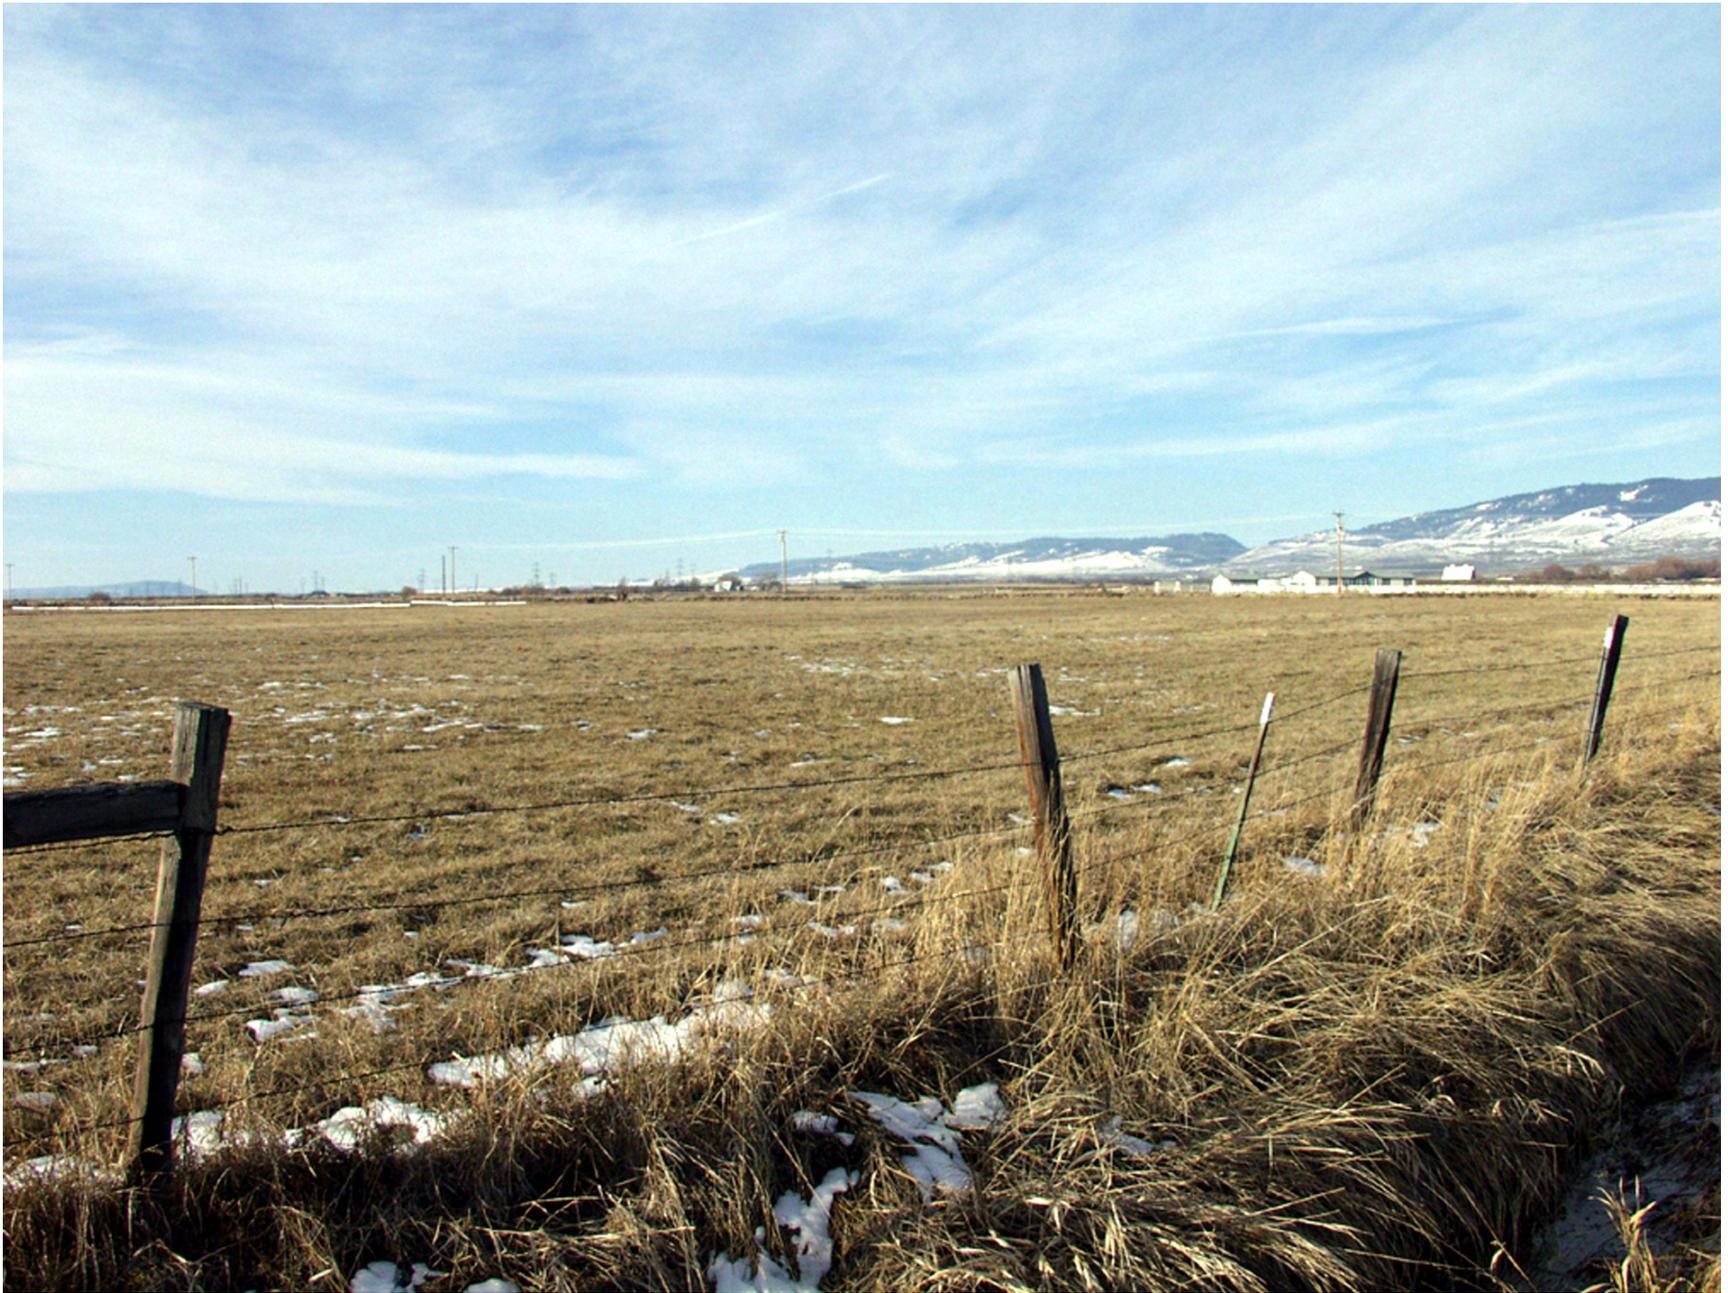
Figure G12
Key View 1E – Existing view looking northwest across the Northwest Valley Visual Assessment Unit from Reecer Creek Road.

Key View 1E: **Figure G12** shows an existing view looking northwest across the Northwest Valley Visual Assessment Unit from Reecer Creek Road.

Vividness: 2—Wenatchee Mountains skyline present, but low vegetation diversity in foreground and middleground. Distinct visual patterns of field, farmstead, and mountains, but extent of field is monotonous.

Intactness: 2—Wide open, but interrupted somewhat by ranch home at farm that blurs boundary between valley floor and foothills. Power lines compromise the horizon line.

Unity: 2—Field, farms, and mountains clear, but not visually integrated.

Overall Visual Quality: 2.0—Moderate.

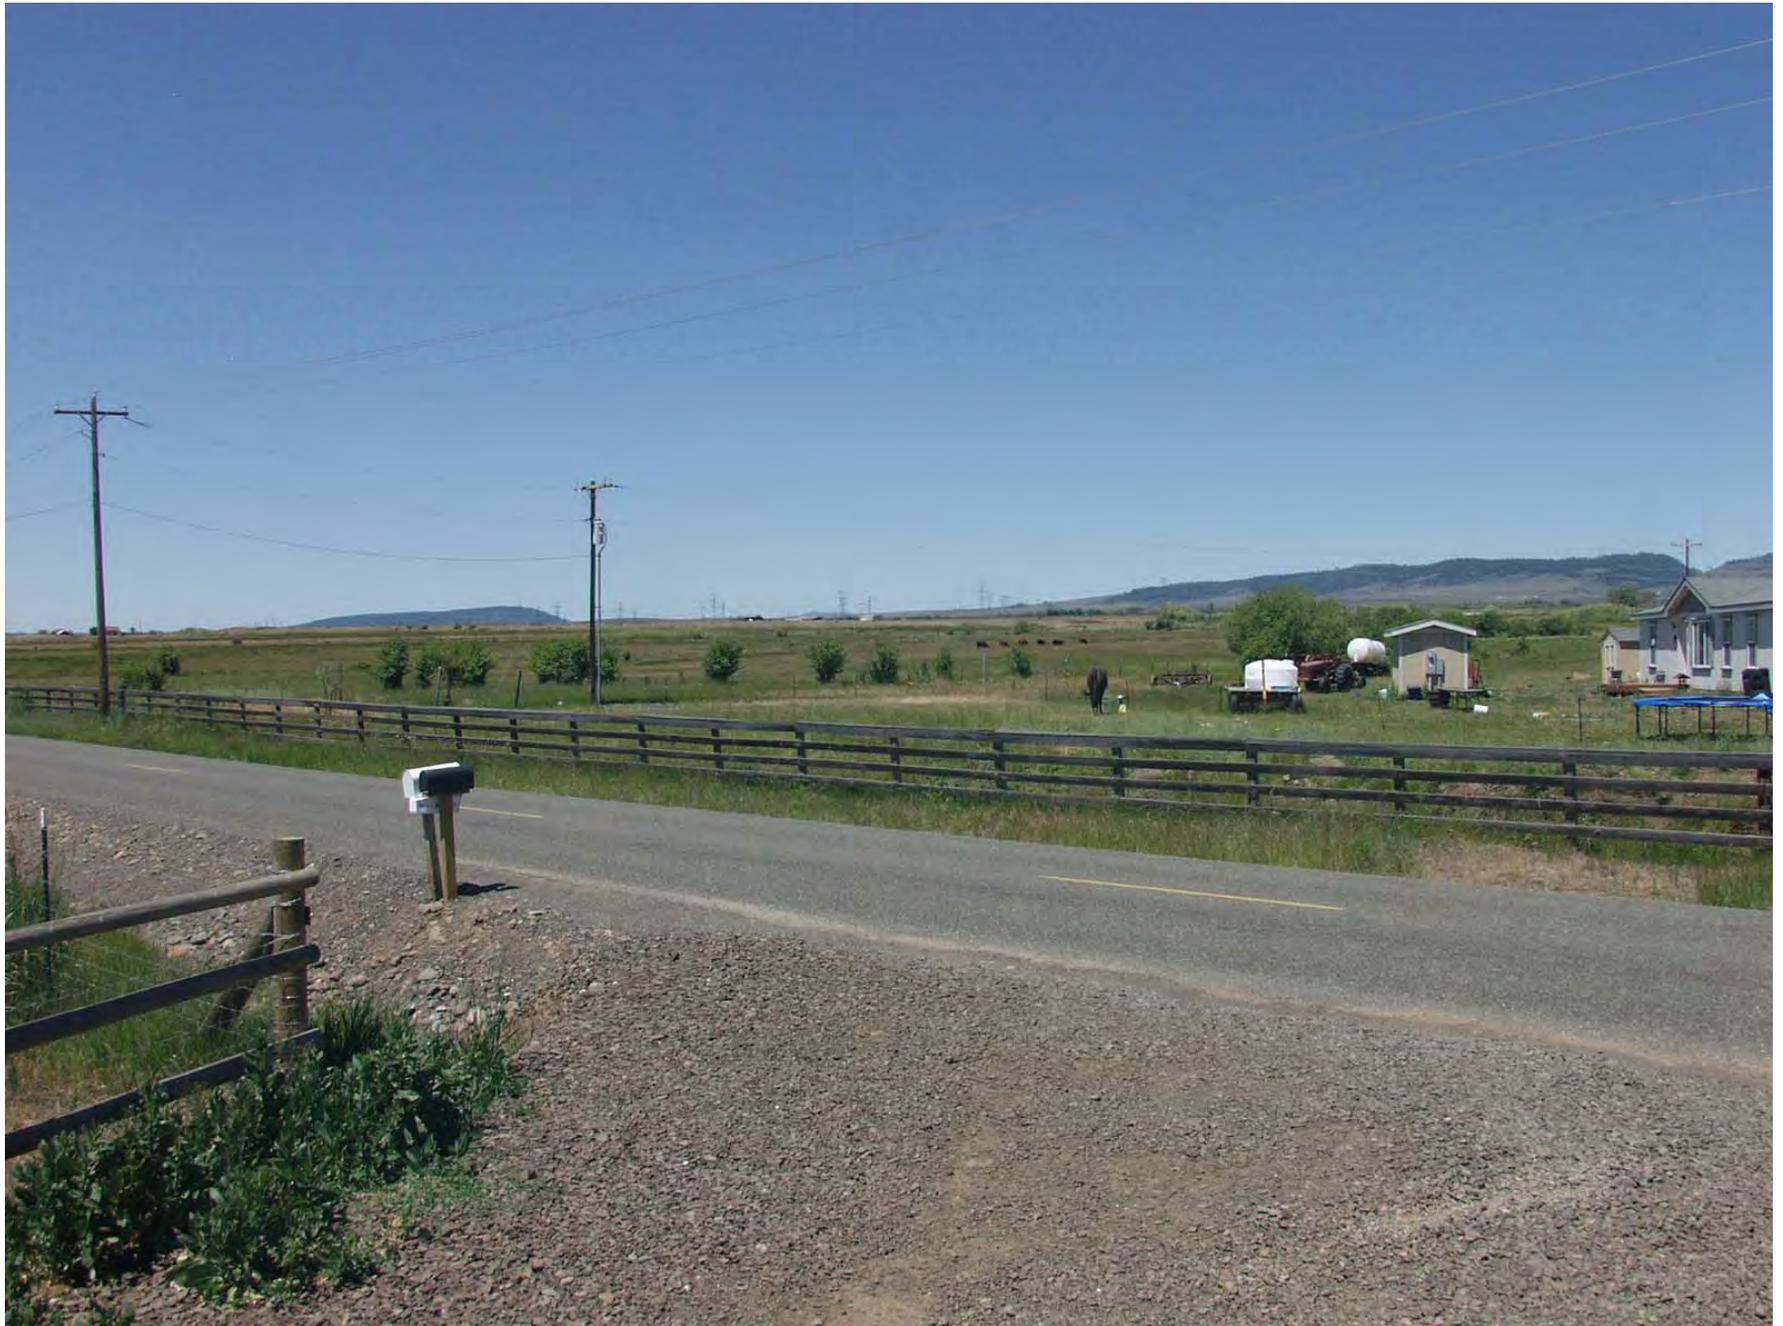
Figure G13
Supplementary Key View 1F – Existing view looking northwest across the Northwest Valley Visual Assessment Unit from Smithson Road near CTC farm.

Key View 1F: **Figure G13** shows an existing view looking northwest across the Northwest Valley Visual Assessment Unit from Smithson Road at the CTC Farm.

Vividness: 2—Wenatchee Mountains foothills are present, but low vegetation diversity in foreground and middleground. Distinct visual patterns exist of field, farmstead, and mountains.

Intactness: 2—Wide open, but interrupted somewhat by cluttered ranch homes. Power lines compromise the horizon line.

Unity: 3—Clear progression from foreground through background along diagonals over farms and fields.

Overall Visual Quality: 2.33—Moderate.

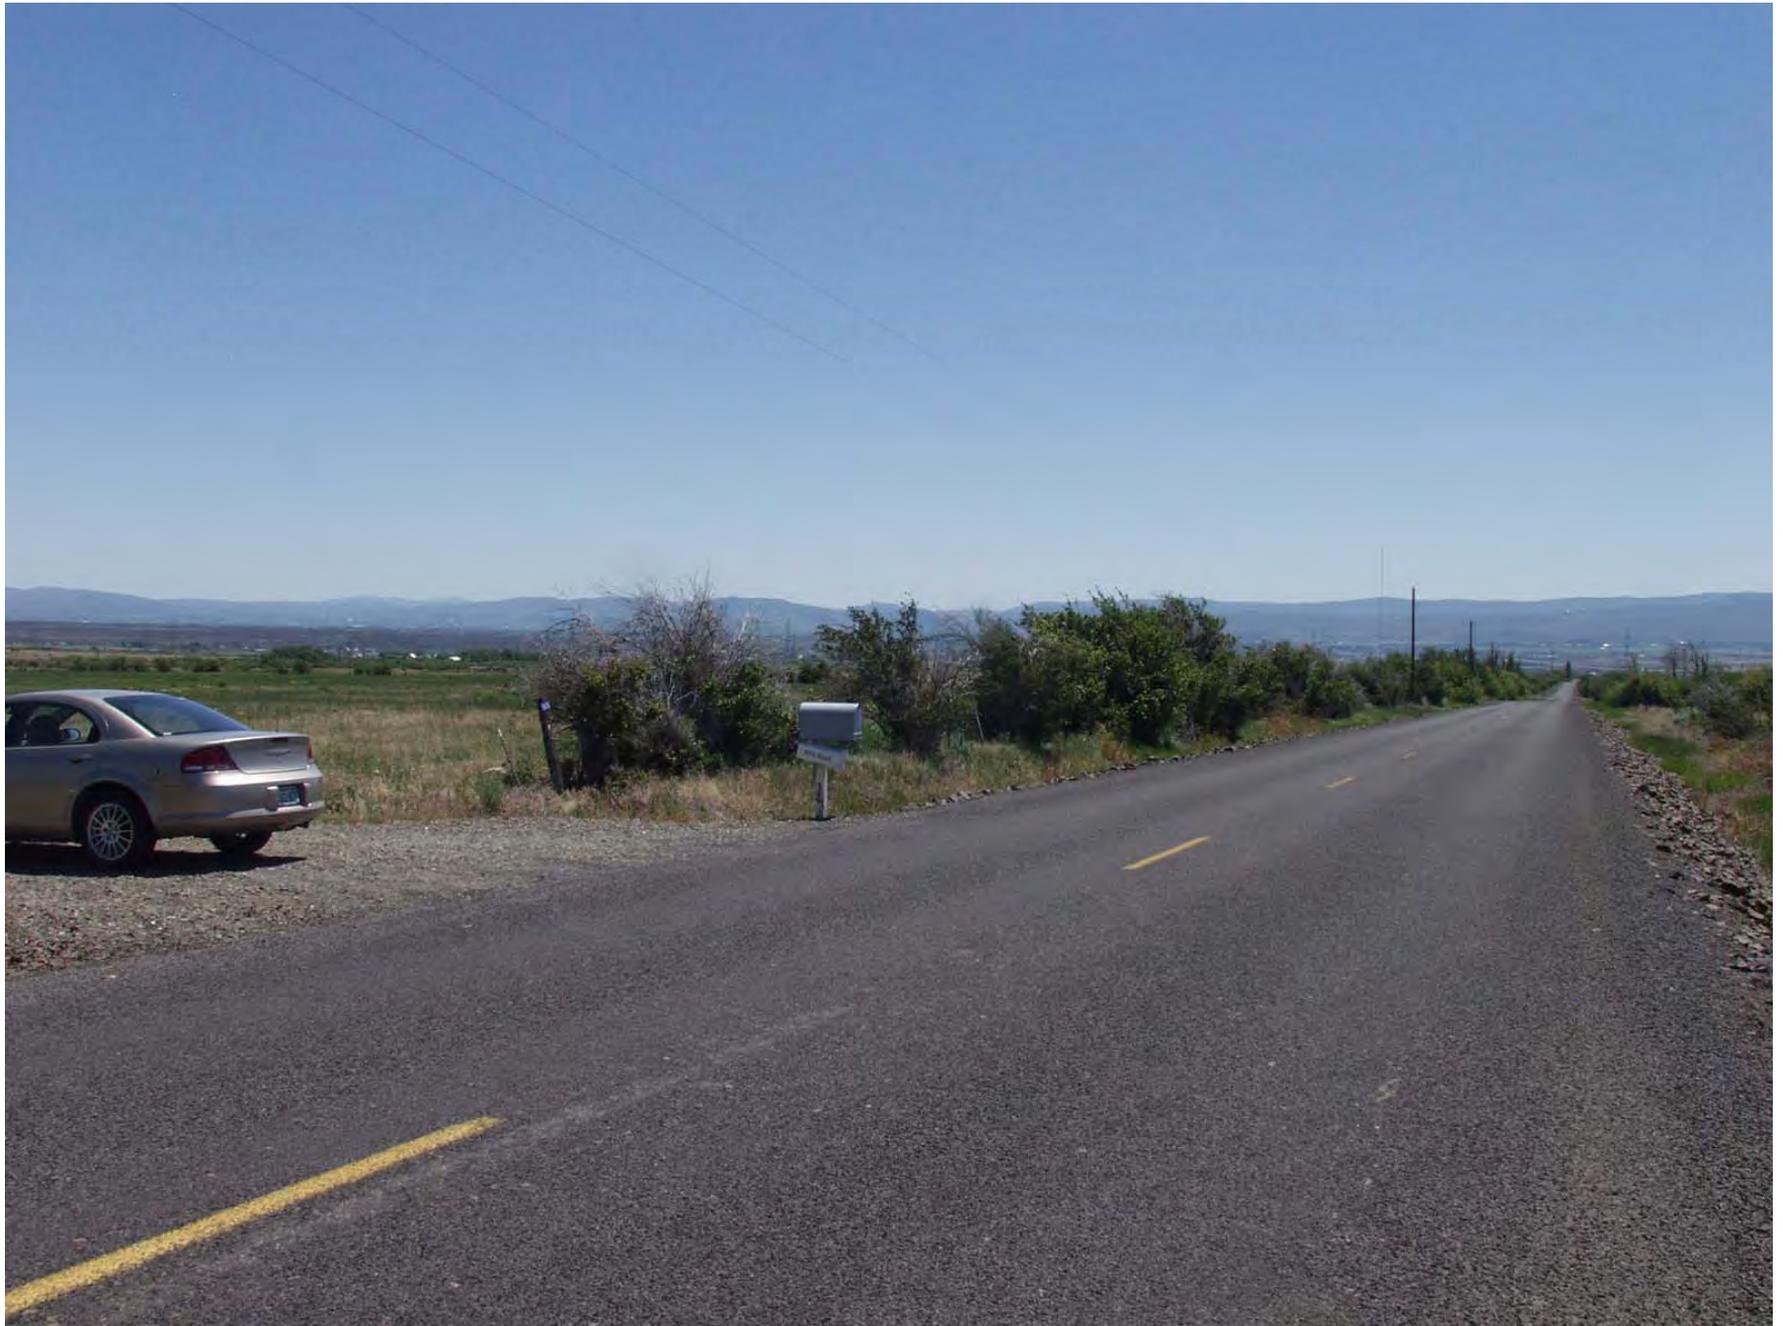
Figure G14
Supplementary Key View 1G – Existing view looking southeast across the Northwest Valley Visual Assessment Unit from Reecer Creek Road immediately north of project boundary.

Key View 1G: **Figure G14** shows an existing view looking southeast across the Northwest Valley Visual Assessment Unit from Reecer Creek Road just north of the project boundary.

Vividness: 2— View across the valley to Manastash Ridge allows an appreciation of the larger form of the valley. Visual patterns of non-native hedgerow and irrigated fields are unremarkable.

Intactness: 2—Wide open view beyond hedgerow. Rural buildings at great distance are not intrusive.

Unity: 2—Hedgerow blurs distinction between foreground and middleground, but general progression beyond hedgerow is clear and unified.

Overall Visual Quality: 2.0—Moderate.
