APPENDIX G

Aesthetics

AESTHETICS

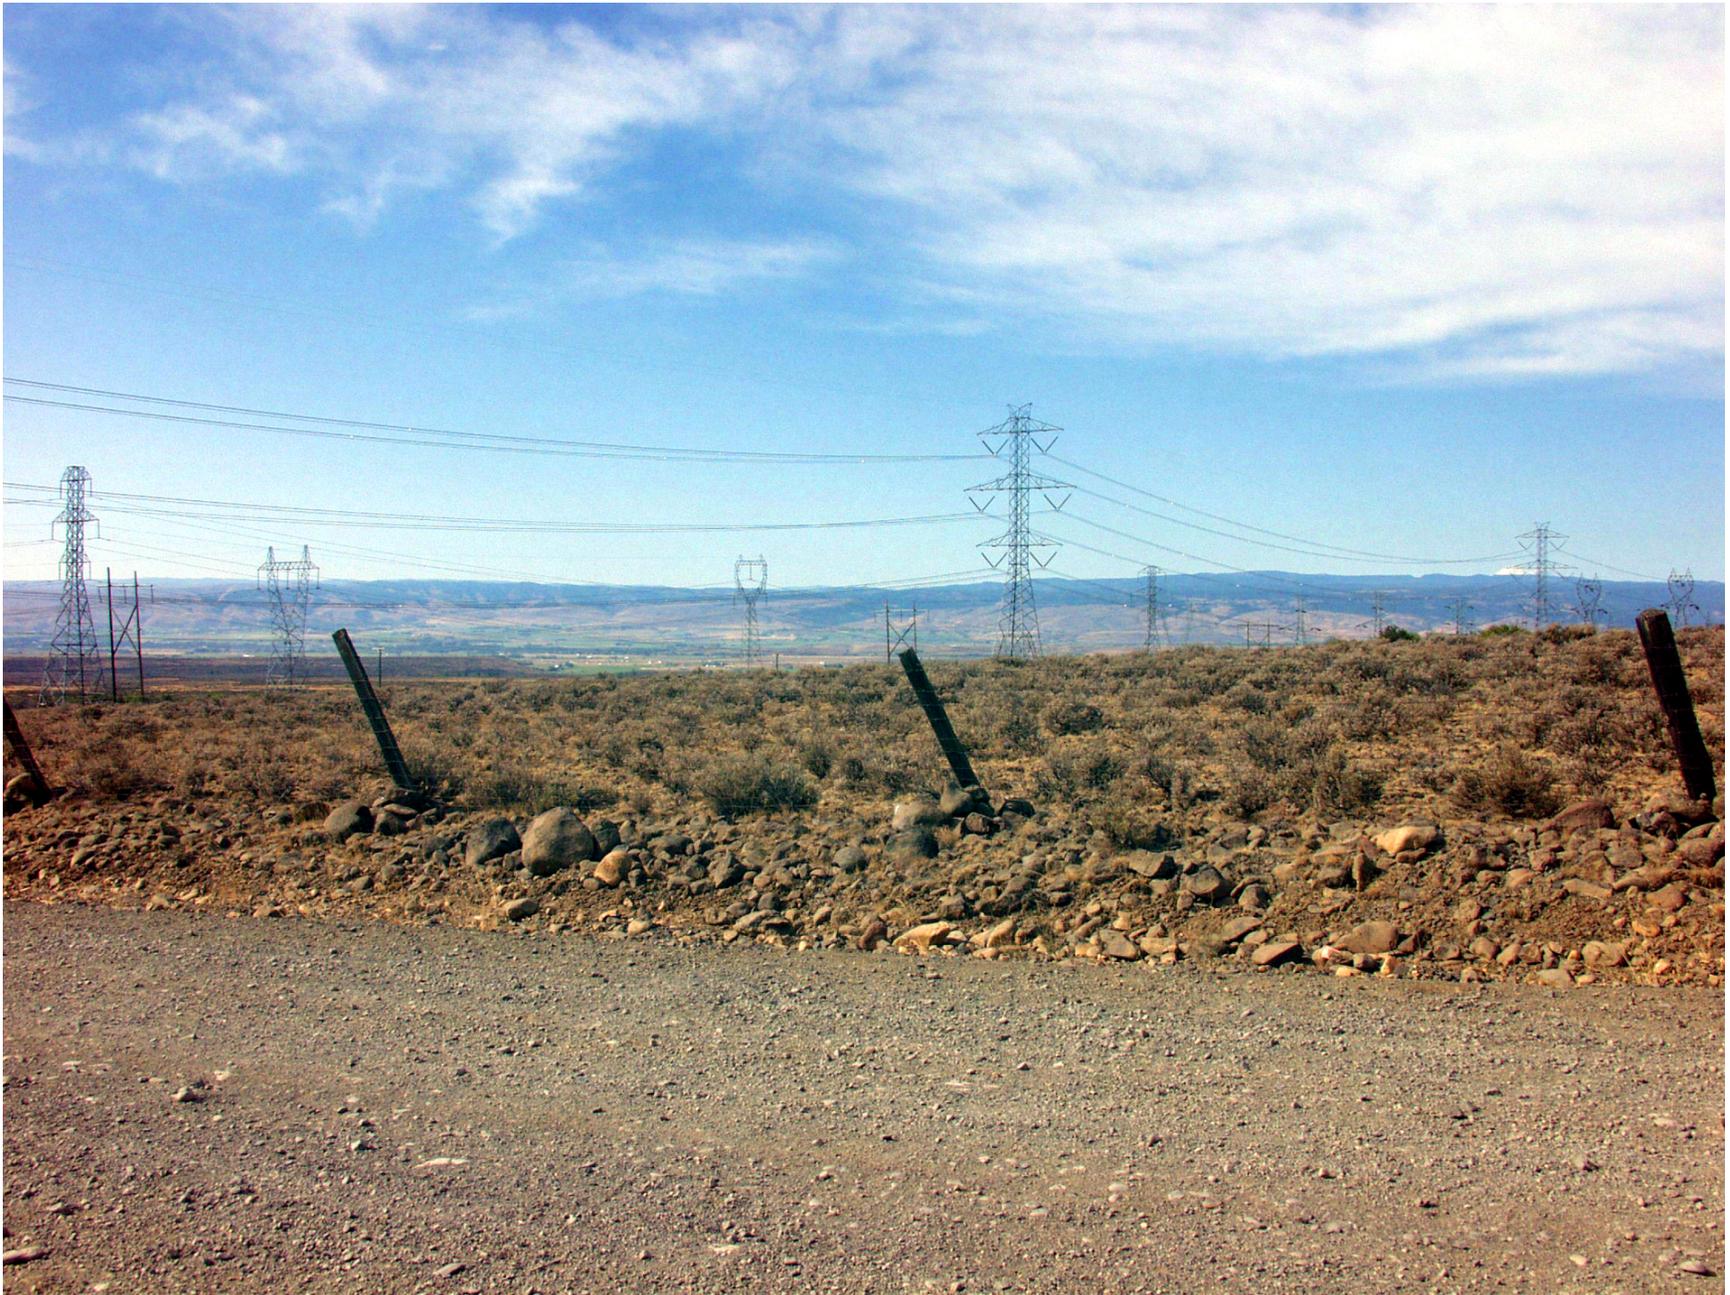
Figure G16
Key View 2A – Existing view of project area looking southwest across the Northeast Valley Visual Assessment Unit from Wilson Creek Road.

Key View 2A: Figure G16 shows an existing view looking southwest across the Northeast Valley Visual Assessment Unit from Wilson Creek Road.

Vividness: 2—Distinct visual patterns of the mountain background and the shrub-steppe vegetation foreground. Full expression of native vegetation diversity. Power lines diminish appreciation of natural diversity.

Intactness: 1—The power lines are very intrusive elements in the landscape.

Unity: 2—The background mountains and the power lines are competing dominant elements. Power lines dissect progression from foreground to background especially where the valley floor and the lower foothills meet.

Overall Visual Quality: 1.67—Moderate.

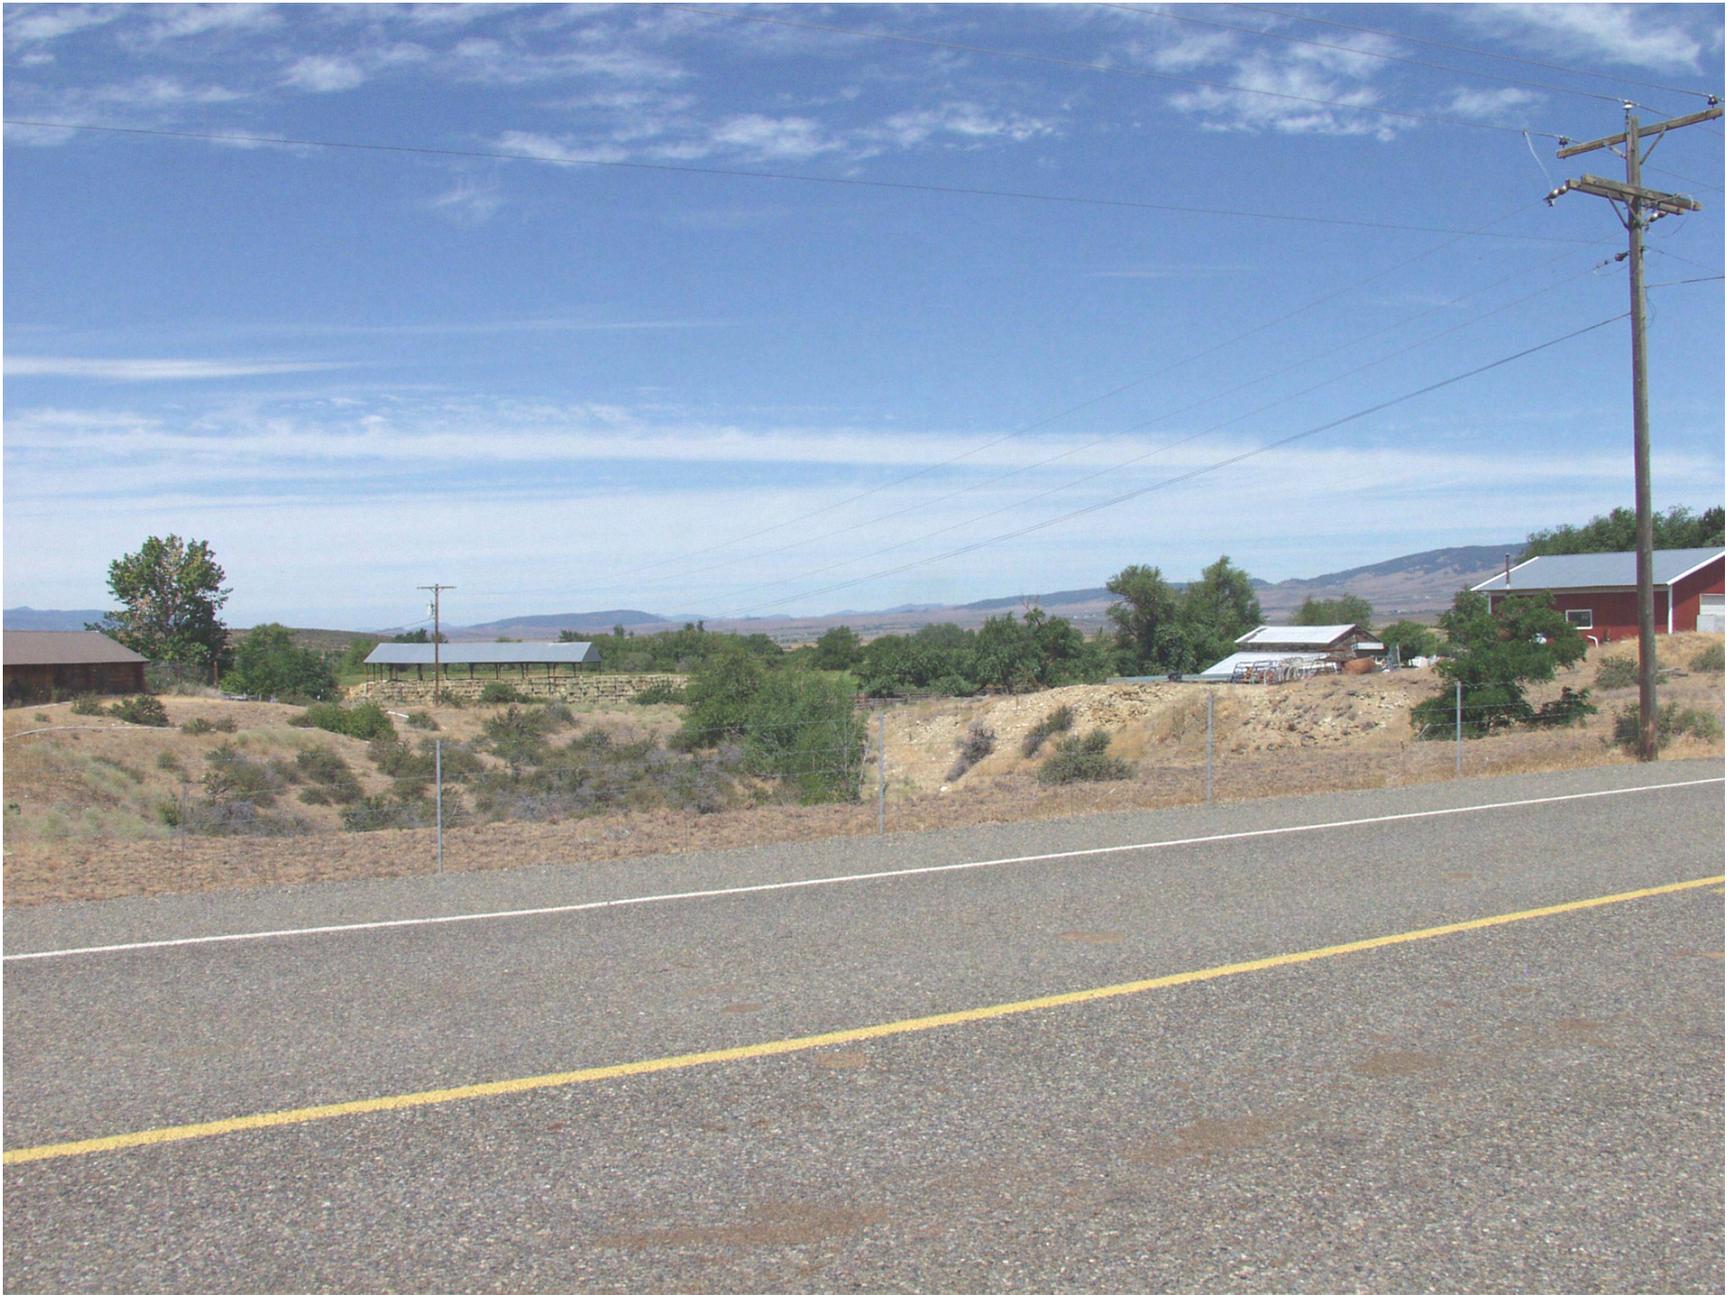
Figure G17
Key View 2B – Existing view looking southwest across the Northwest Valley Visual Assessment Unit from Wilson Creek Road.

Key View 2B: Figure G17 shows an existing view looking west across the Northeast Valley Visual Assessment Unit from Wilson Creek Road on Rabbit Hill.

Vividness: 2—Limited view of distant mountains. Distinctive patches of native vegetation and riparian corridor along Wilson Creek.

Intactness: 2—Continuous band of riparian vegetation associated with Wilson Creek and native shrub-steppe vegetation surrounding farm. Some landform disturbance around the foreground farm.

Unity: 2—Manmade structures not integrated with the landscape so somewhat cluttered visual pattern in the foreground.

Overall Visual Quality: 2.0—Moderate.

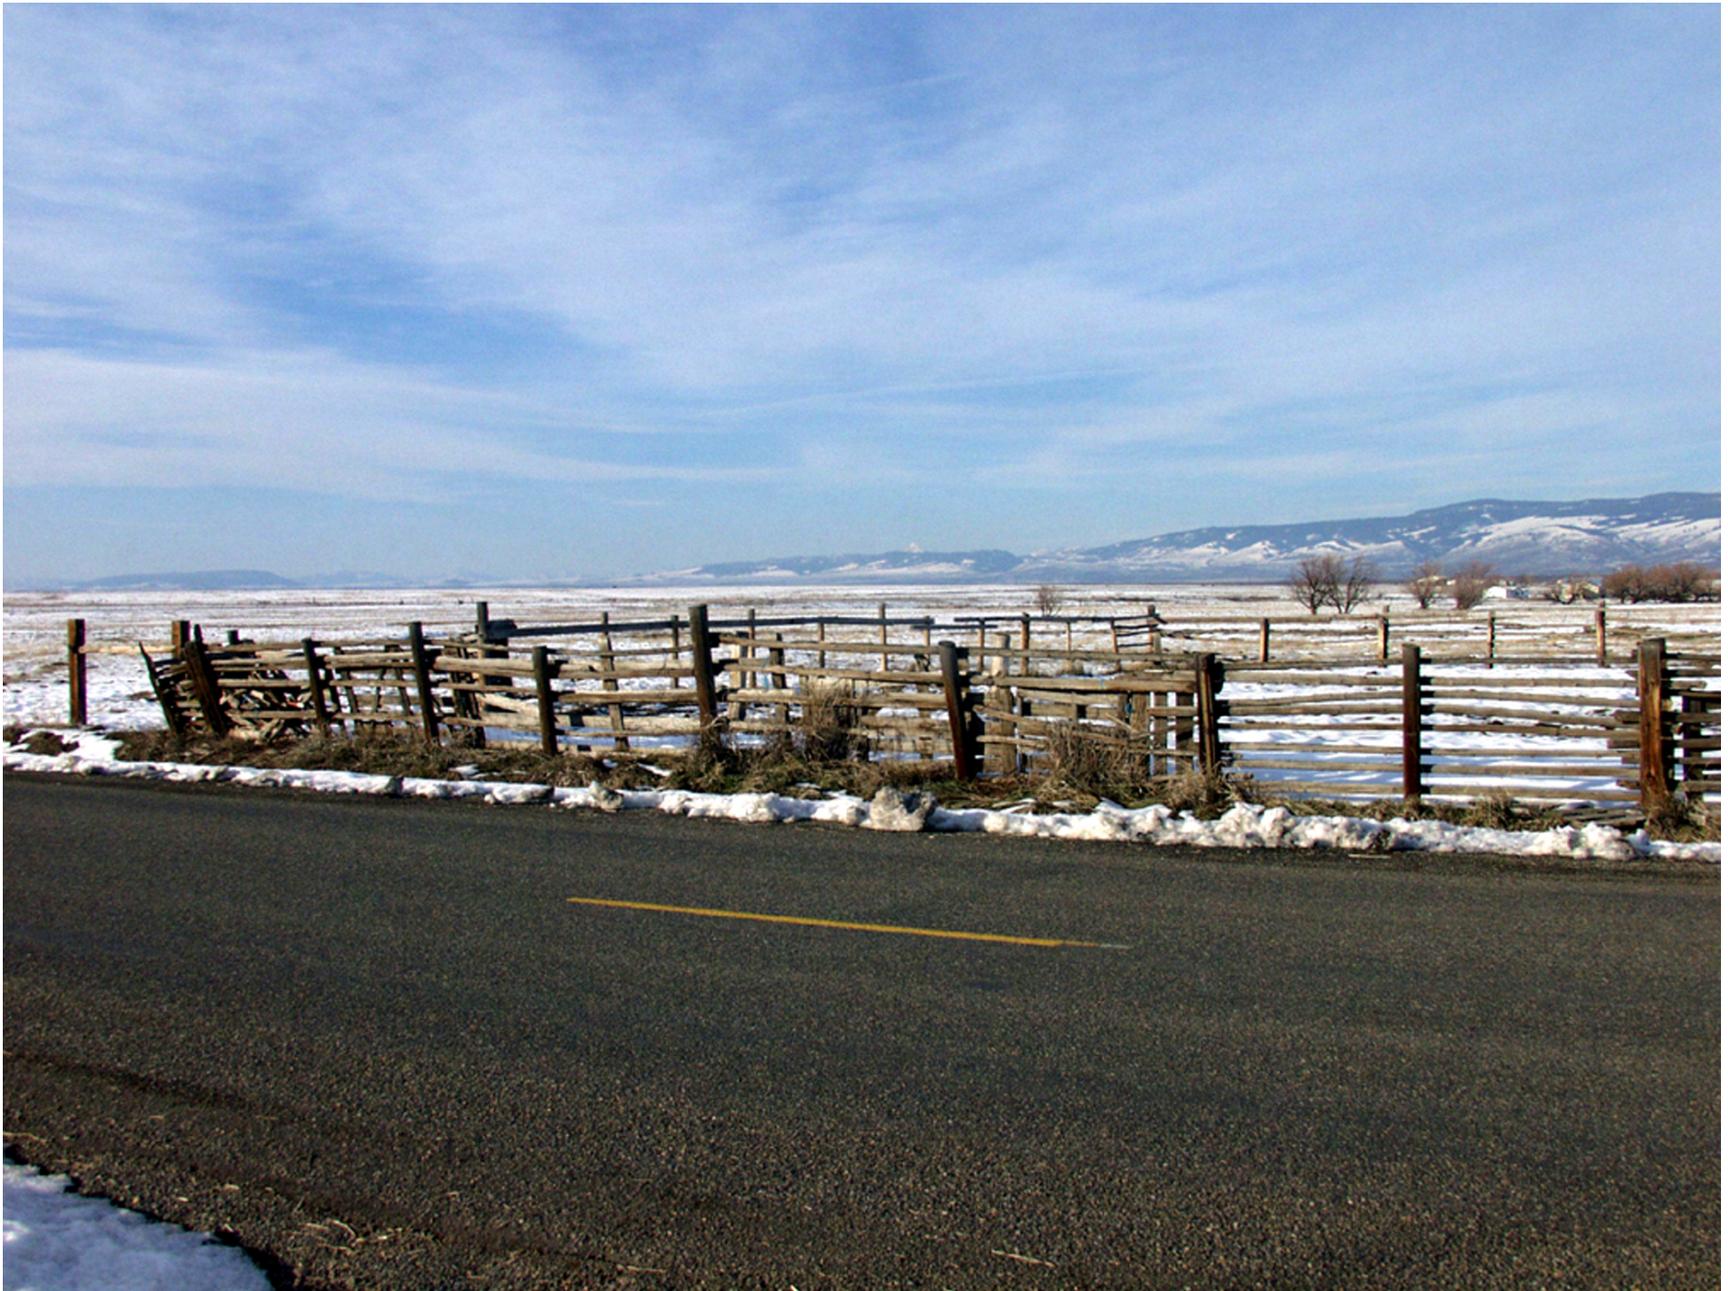
Key View 2C – Key view looking northwest across the Northeast Valley Visual Assessment Unit from the north end of Bowers Field at Hungry Junction Road.

Key View 2C: Figure G18 shows an existing view looking northwest across the Northeast Valley Visual Assessment Unit from the north end of Bowers Field at Hungry Junction Road.

Vividness: 2—Partial expression of the Wenatchee Mountains and Mount Stuart in the background, but undifferentiated plane of fields against foothills and mountain backdrop. Low vegetation species diversity. Memorable historic farm fencing.

Intactness: 3—Strong and established visual character as the fence, windrows, and pasture are all elements part of the working landscape. View to the mountains free of obstruction.

Unity: 3—Clear visual composition and integration of built and natural elements.

Overall Visual Quality: 2.67—High.

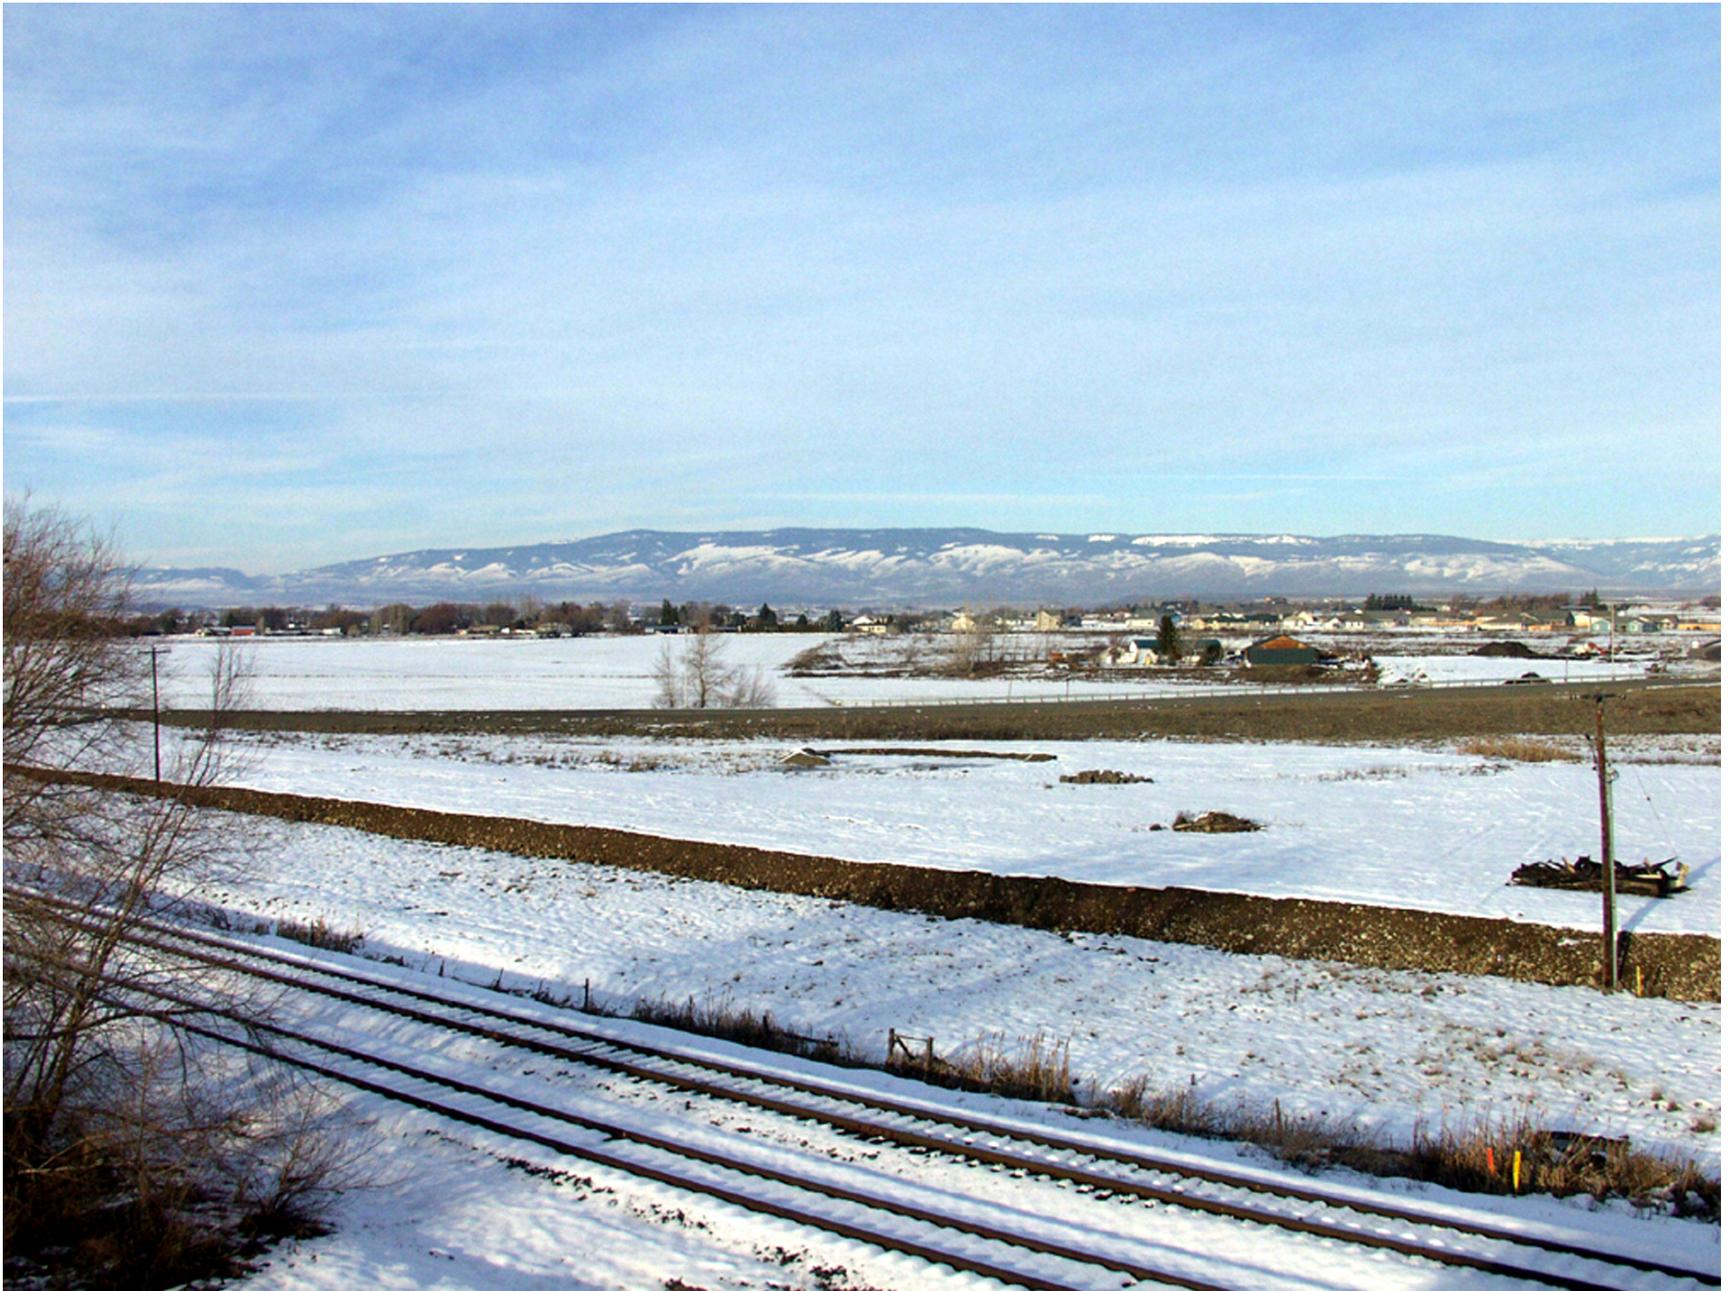
Figure G20
Key View 3A – Existing view north across the Greater Ellensburg Visual Assessment Unit
over the Burlington Northern Railroad near U.S. Highway 97 and Cascade Way.

Key View 3A: Figure G20 shows an existing view looking north across the Greater Ellensburg Visual Assessment Unit over the Burlington Northern Railroad near U.S. Highway 97 and Cascade Way.

Vividness: 2—Memorable expression of the intrinsic foothills and mountains. Bold patterns of mountain background and urban fabric. Low vegetation species diversity relating to pasture and urban setting.

Intactness: 1—Discordance between suburban development and the rural landscape.

Unity: 1—Ellensburg's outskirts interrupt the natural visual progression from valley to mountains.

Overall Visual Quality: 1.33—Low.

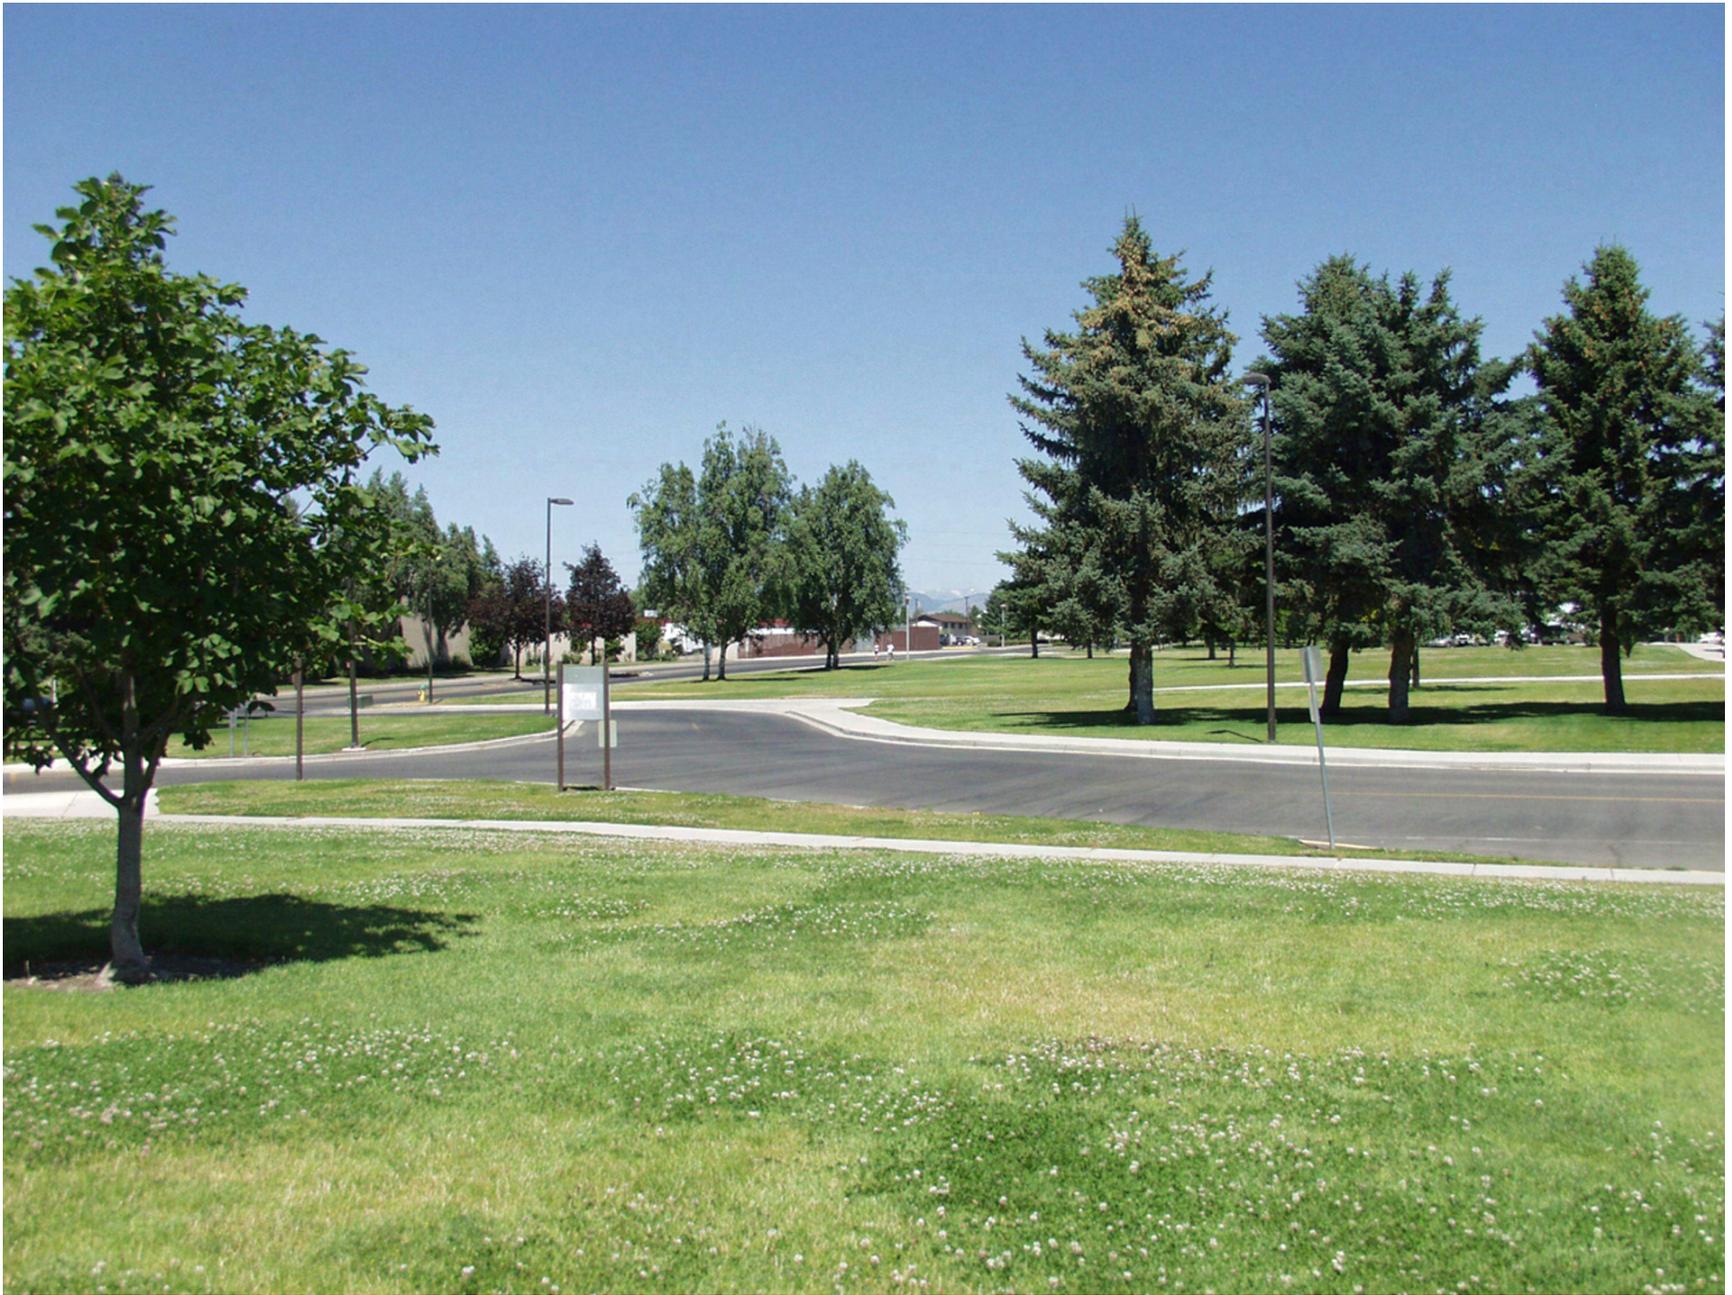
Figure G21
Key View 3B – Existing view across the Greater Ellensburg Visual Assessment Unit
from the Central Washington University campus.

Key View 3B: Figure G21 shows an existing view looking northwest across the Greater Ellensburg Visual Assessment Unit from a hill on the Central Washington University campus.

Vividness: 1—Exotic trees, lawn, and institutional buildings populate this bland landscape.

Intactness: 2—Consistently flat lawn with some clusters of trees obscuring surrounding landscape.

Unity: 1—Built features do not fit with the character of the region.

Overall Visual Quality: 1.33—Low.

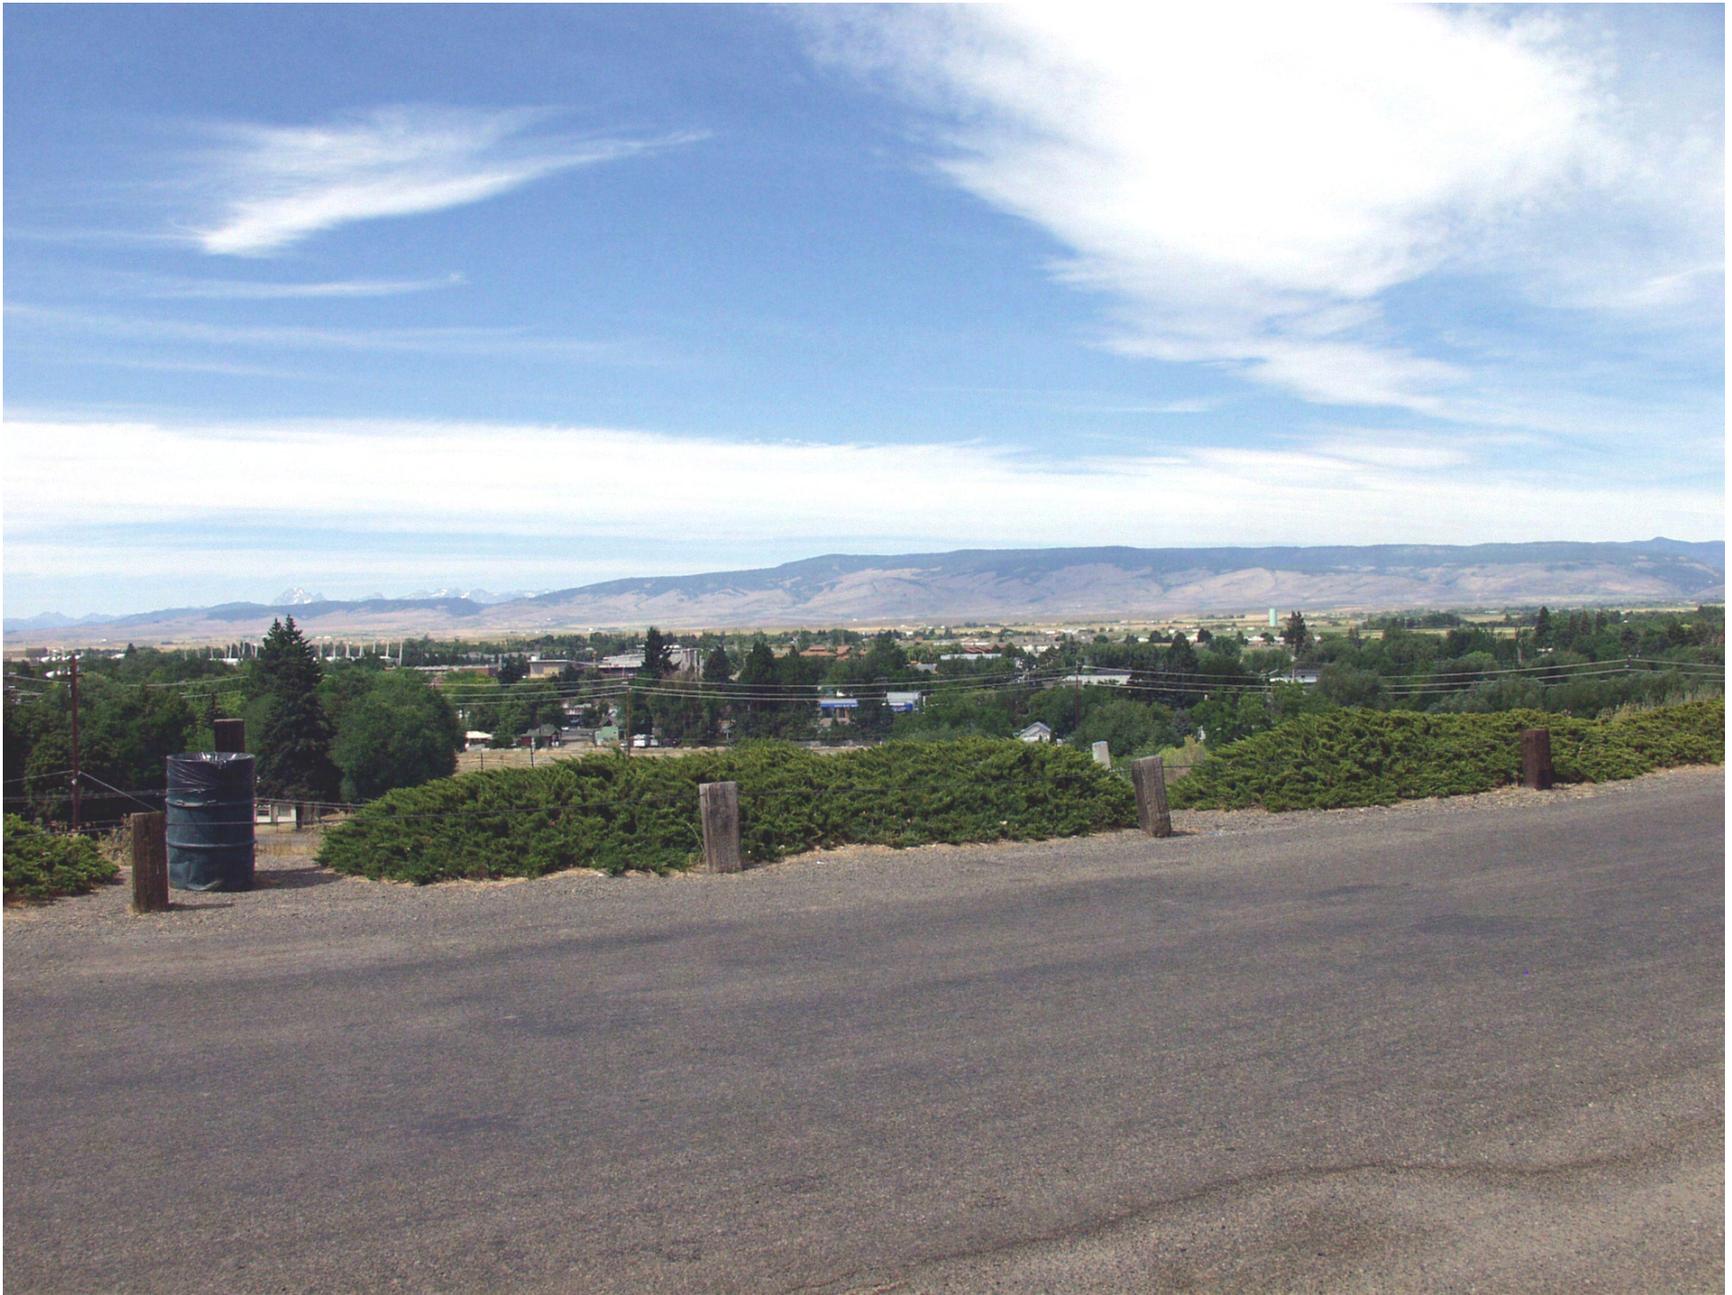
Figure G22
Key View 3C – Existing view looking northwest across the Greater Ellensburg Visual Assessment Unit
from Reed Park in Ellensburg.

Key View 3C: Figure G22 shows an existing view looking northwest across the Greater Ellensburg Visual Assessment Unit from Reed Park in Ellensburg.

Vividness: 3—Memorable juxtaposition of city and mountains. Rare view out from the city.

Intactness: 2—City view disrupted by power lines, but overall grouping of green city and brown hills is retained.

Unity: 3—Continuous view across the city, over the valley floor, and up to the foothills and mountains conveys the range of valley conditions in one view.

Overall Visual Quality: 2.67—High.

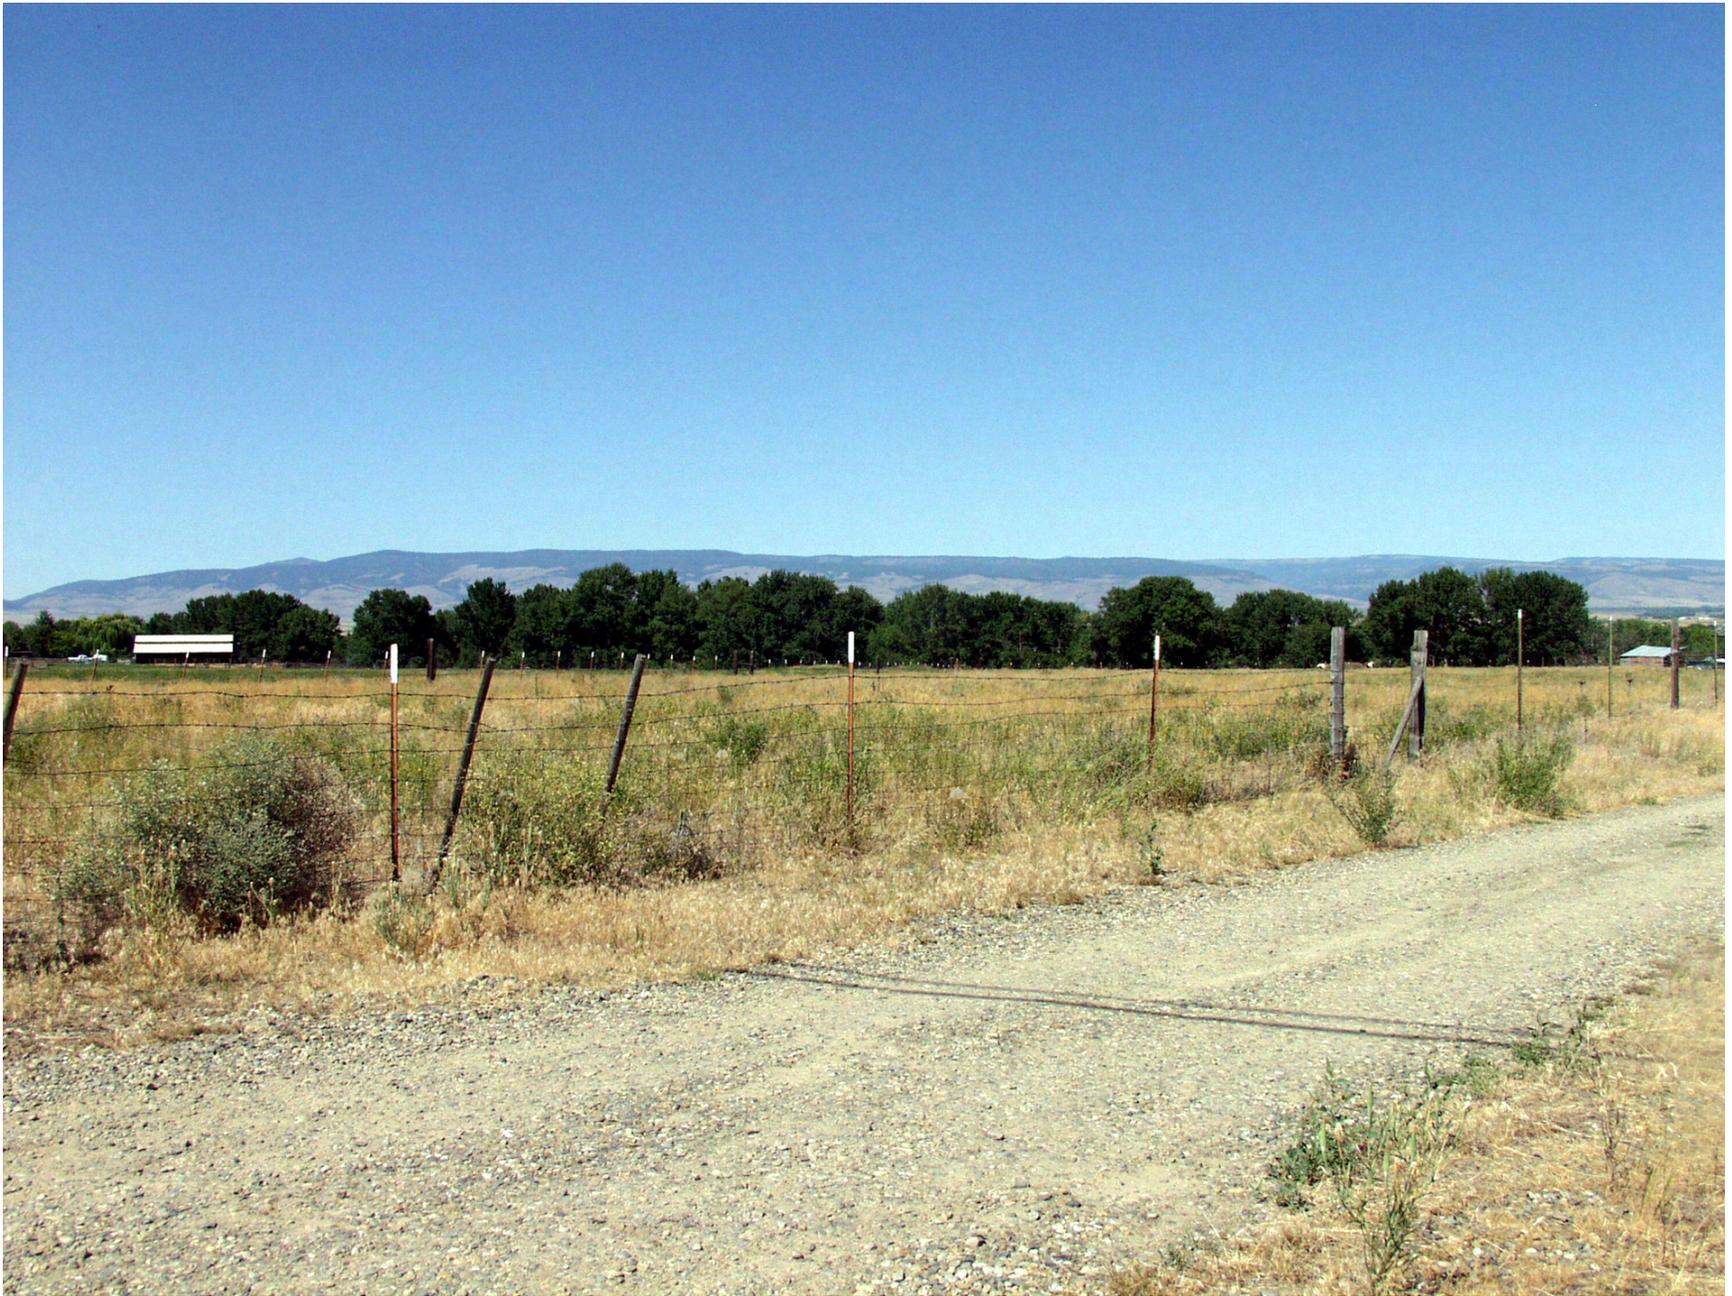
Figure G24
Key View 4A – Existing view looking north across the Yakima River Visual Assessment Unit
from the intersection of the Thorp Highway and Weaver Road.

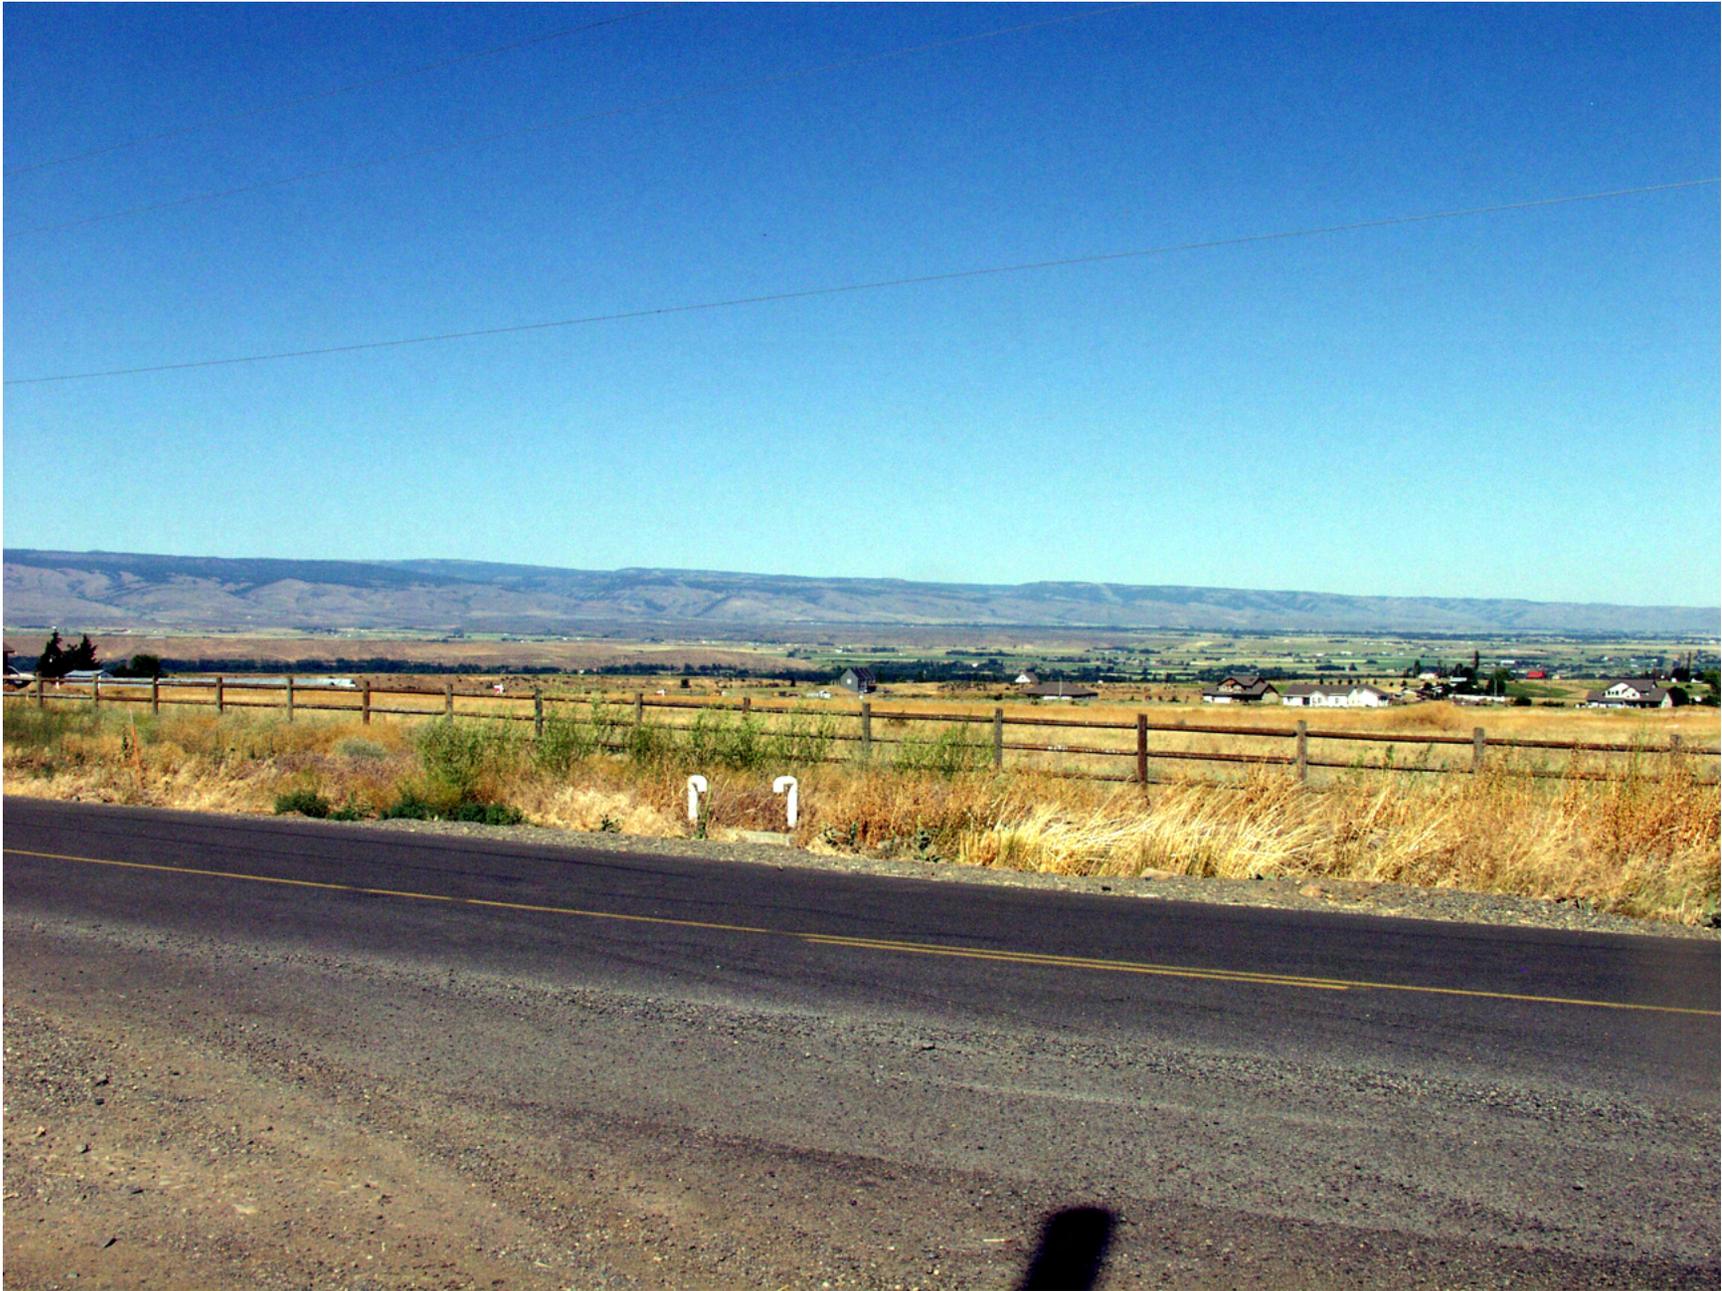
Figure G26
Key View 5A – Existing view looking north from the Southwest Visual Assessment Unit at the intersection of Killmore Road and Robinson Road.

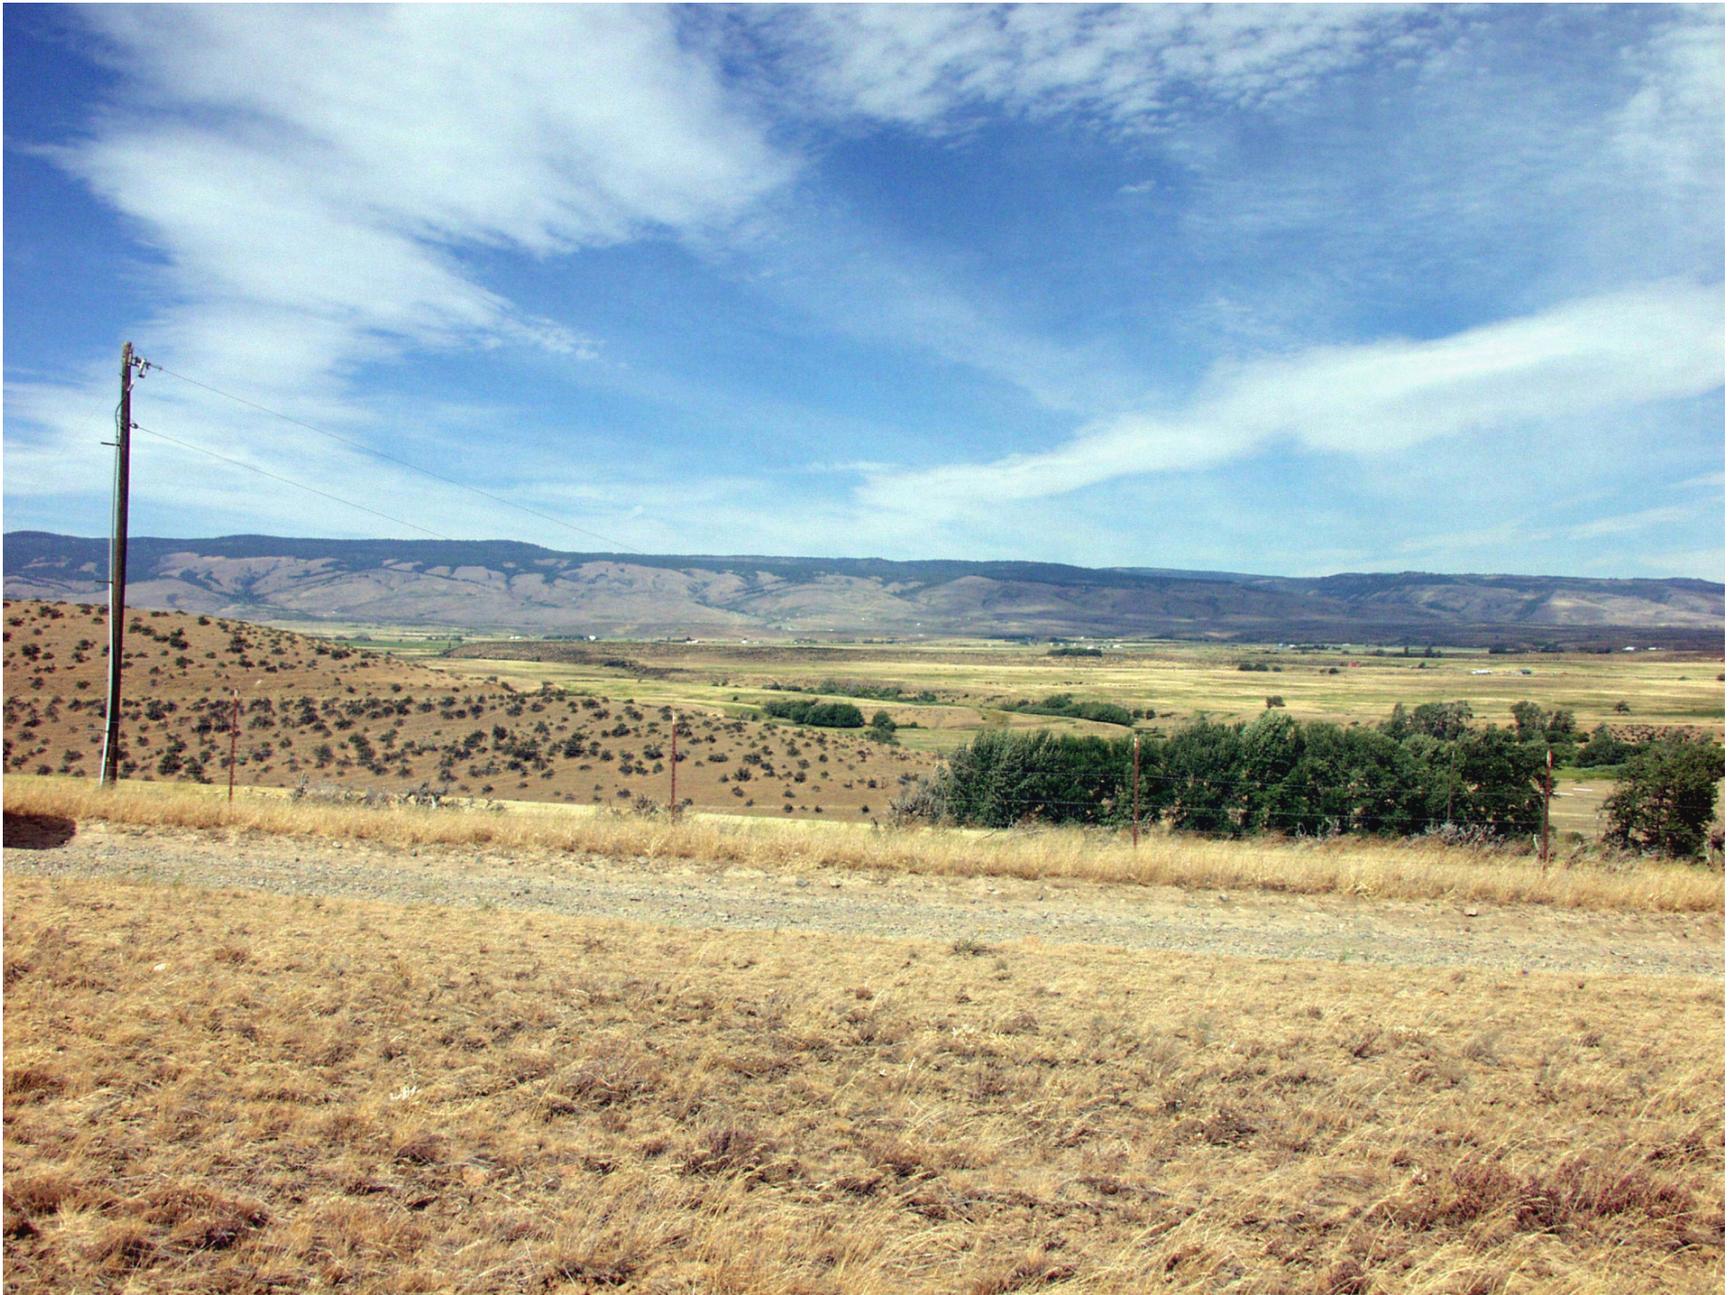
Figure G28
Key View 6A – Existing view looking east from the Hayward Hill Visual Assessment Unit at the top of the hill.
