APPENDIX G

Aesthetics

AESTHETICS

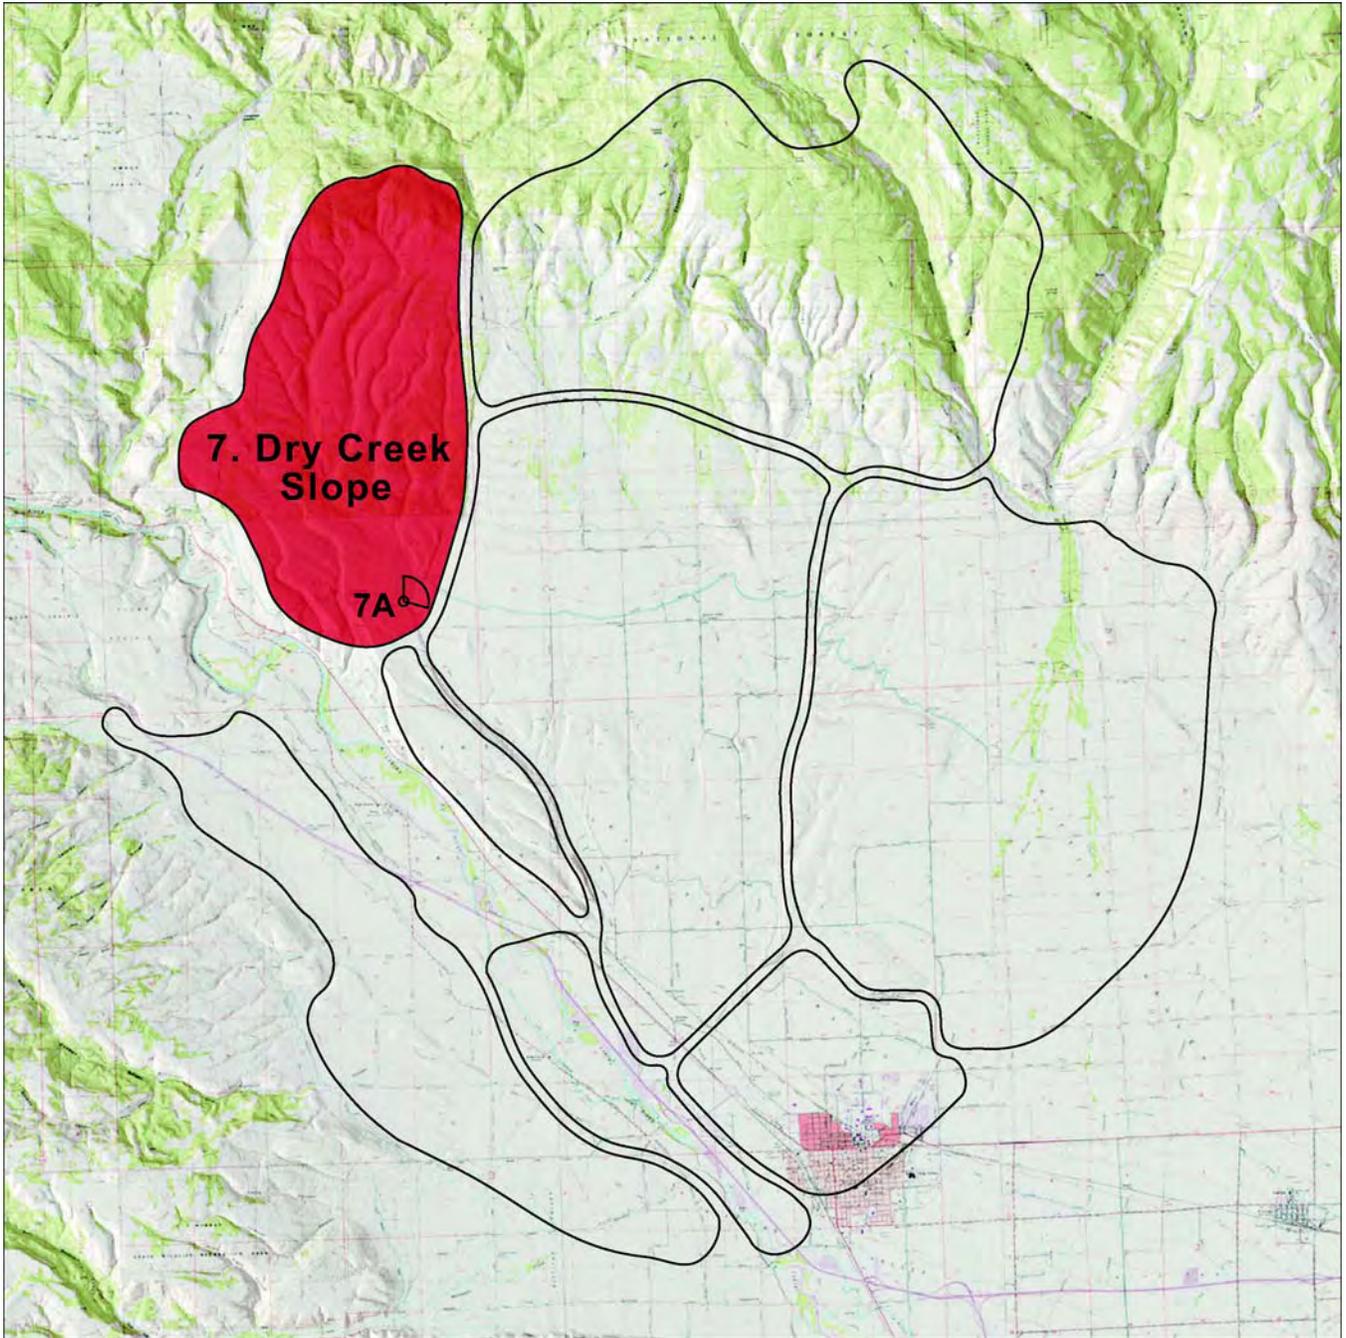
Figure G29
Visual Assessment Unit 7: Dry Creek Slope

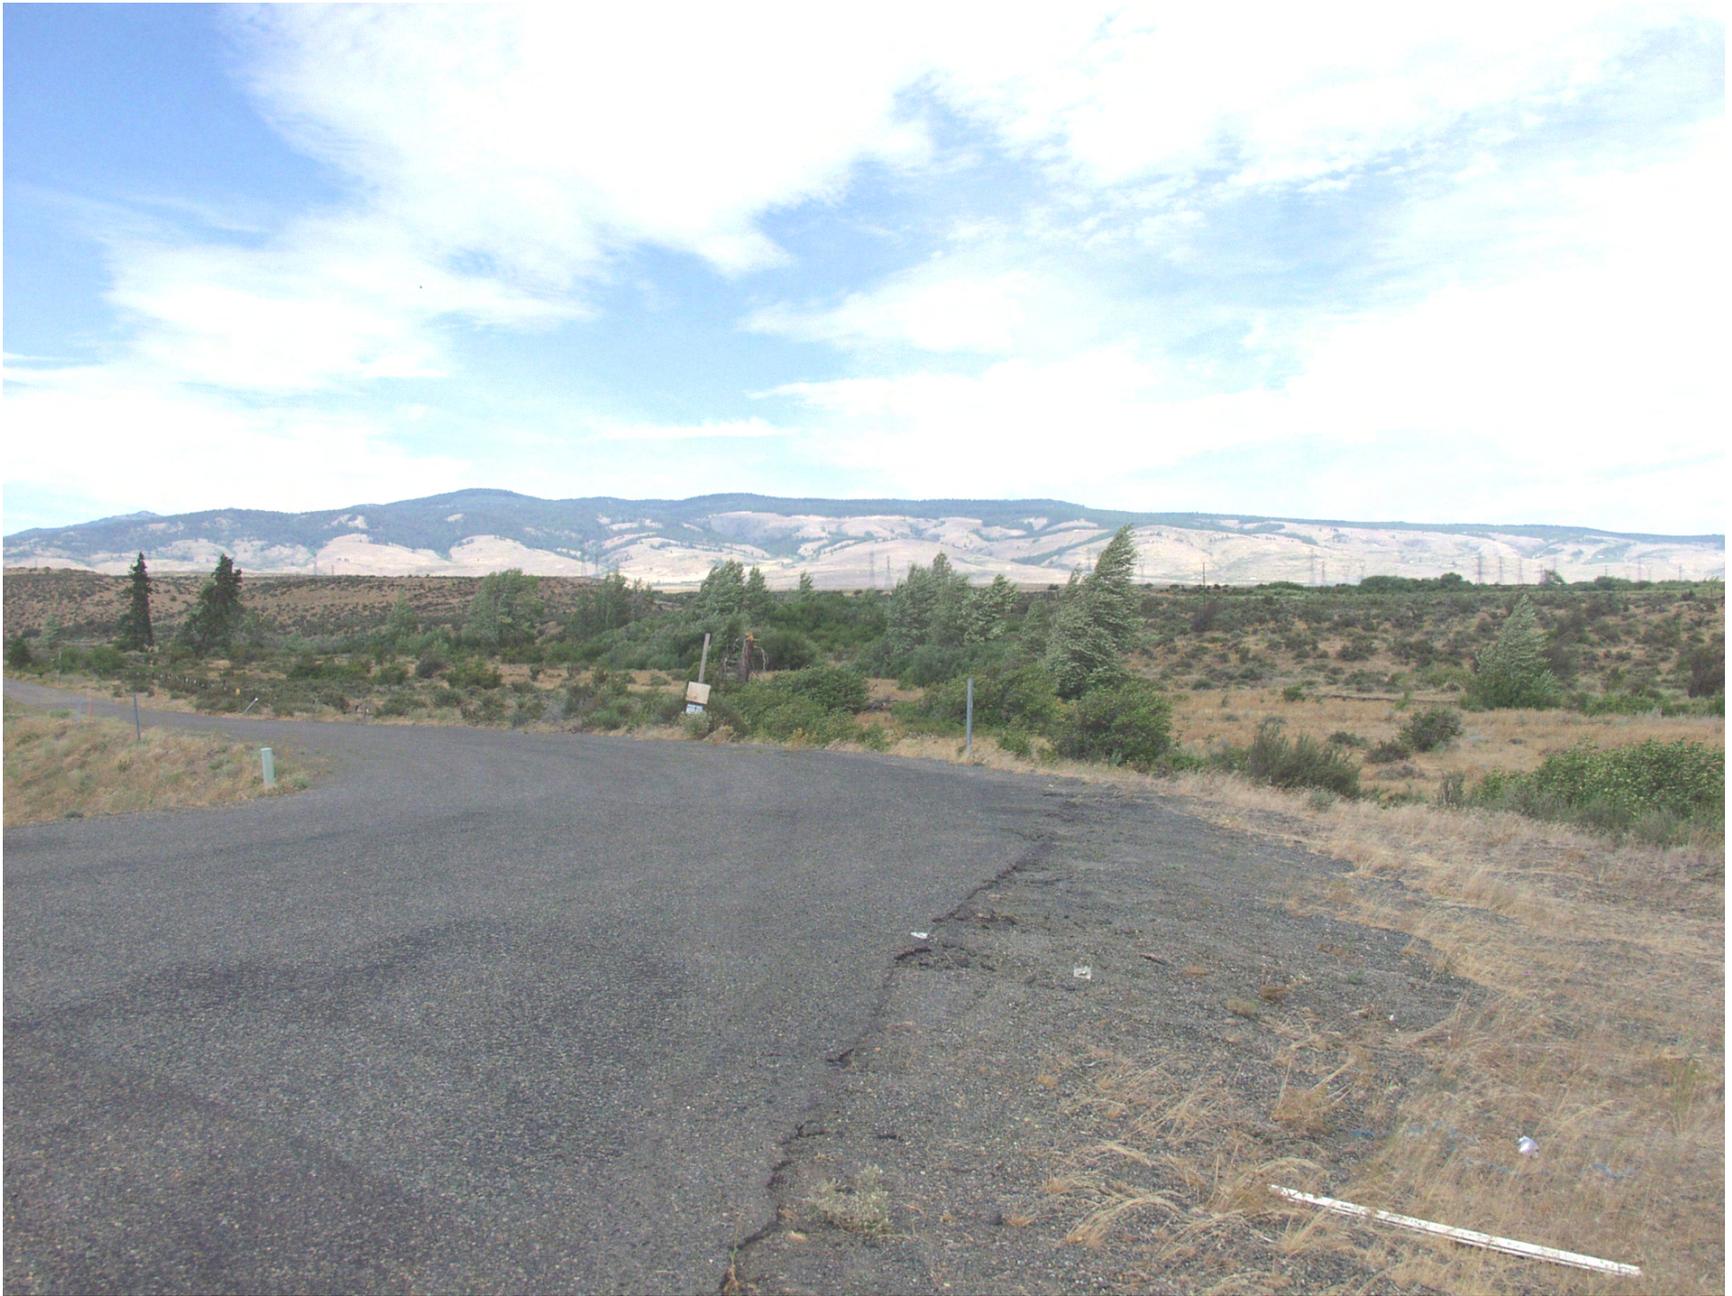
Figure G30
Key View 7A – Existing view looking northwest from the Dry Creek Slope Visual Assessment Unit off U.S. Highway 97.

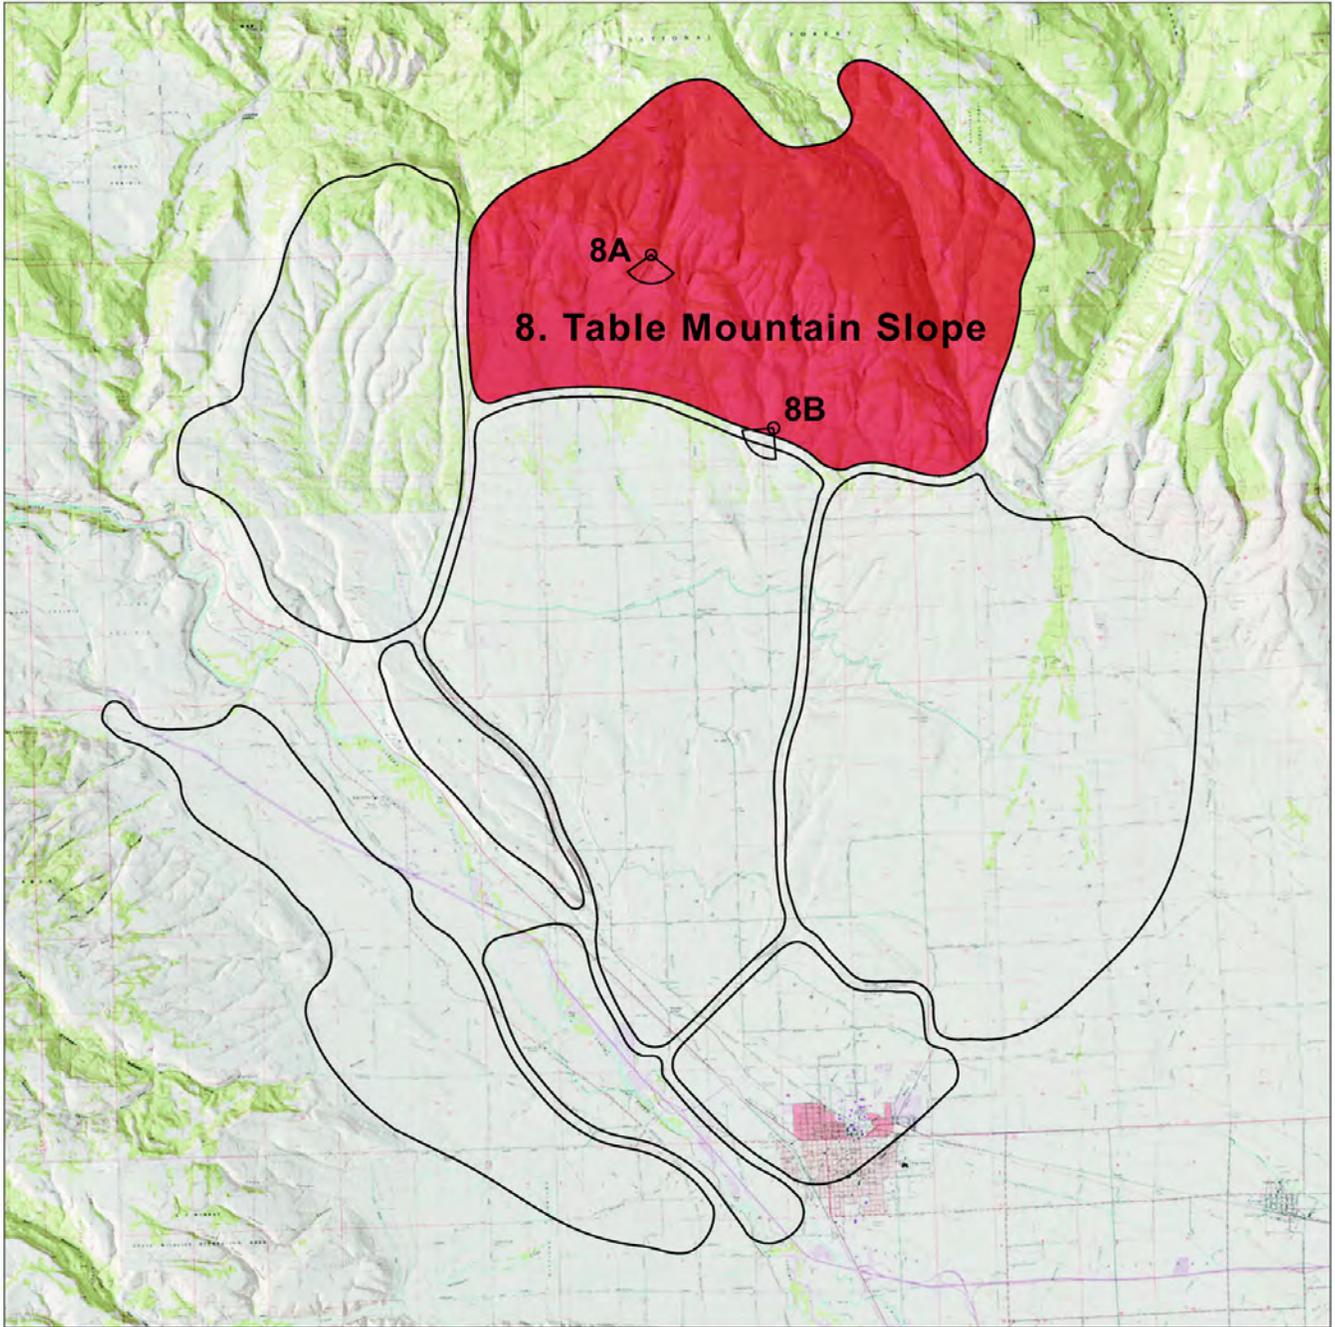
Figure G31
Visual Assessment Unit 8: Table Mountain Slope

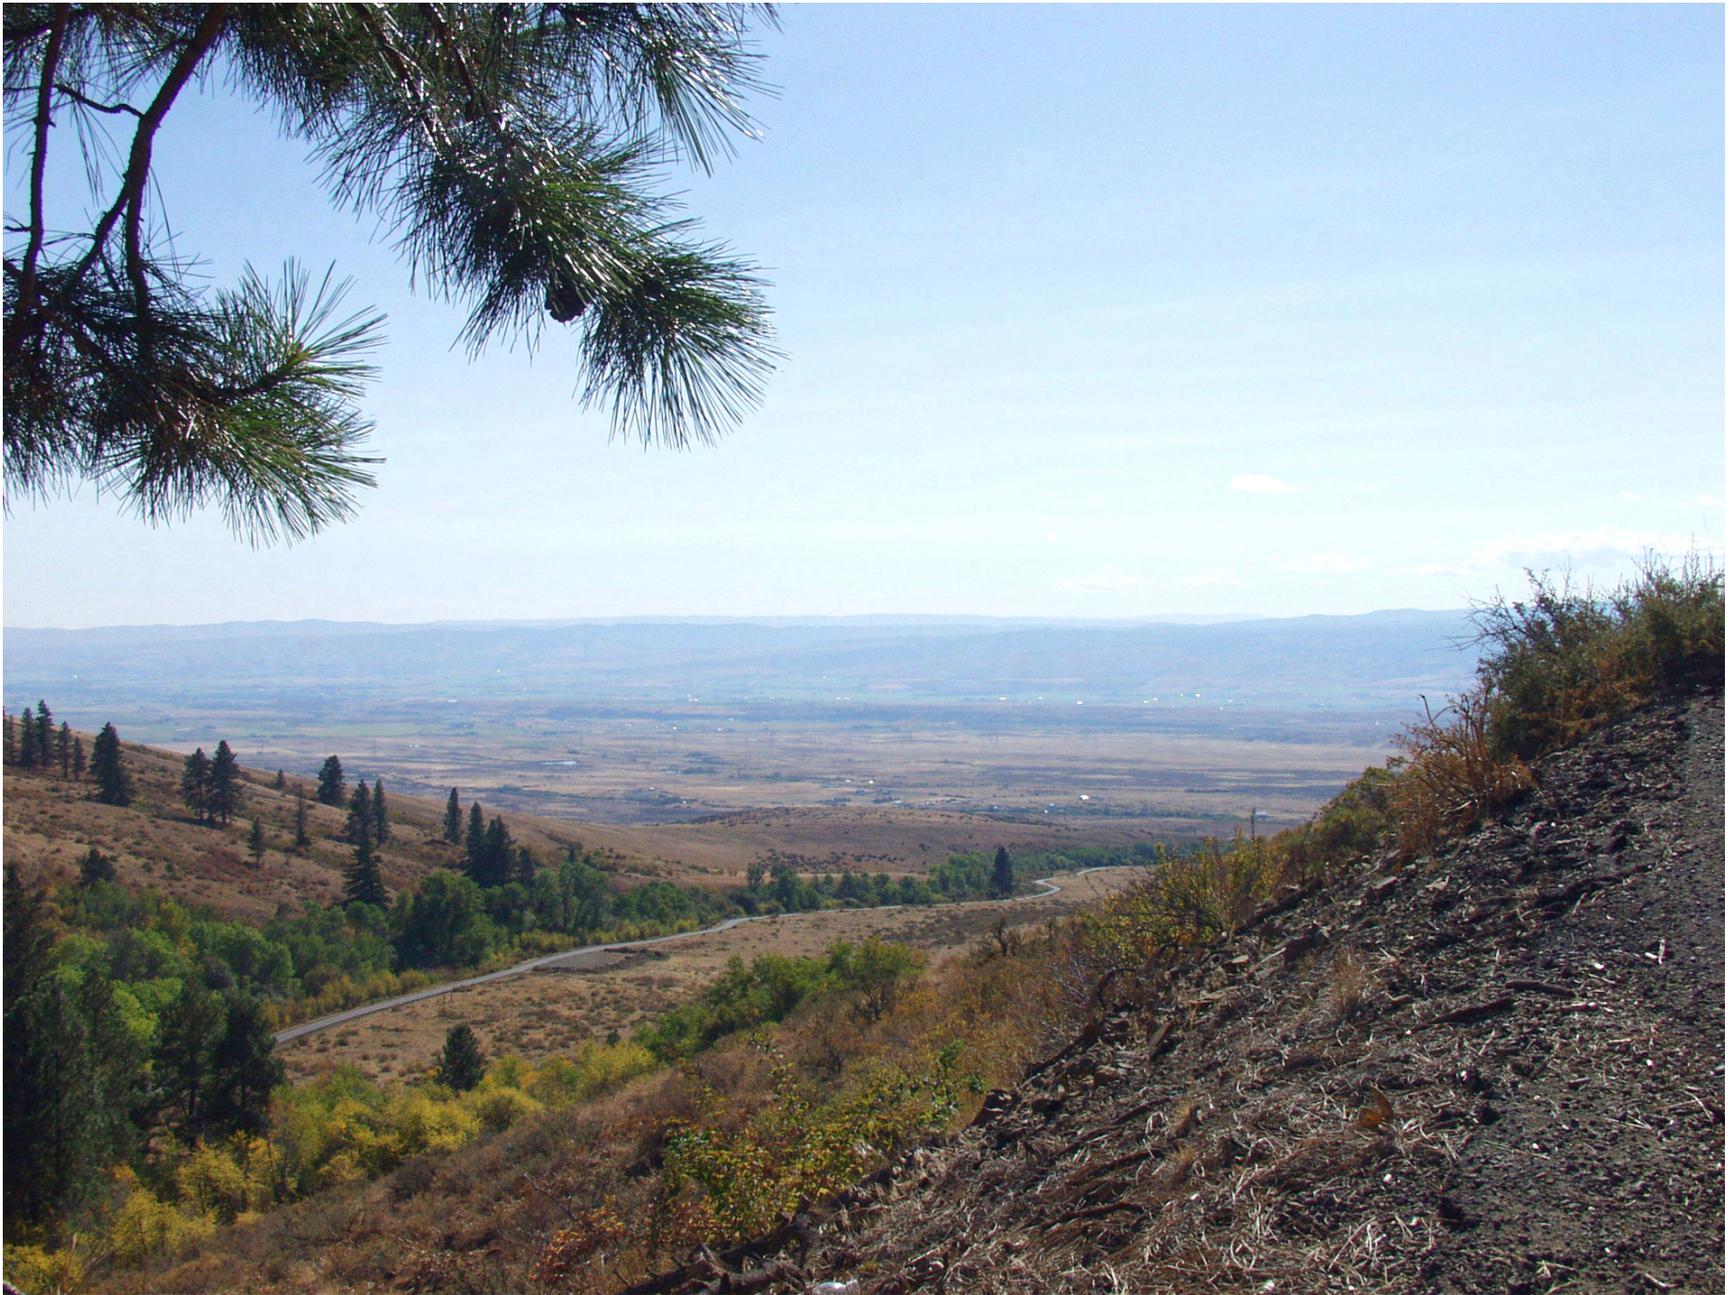
Figure G32
Key View 8A – Existing view looking south from the Table Mountain Slope Visual Assessment Unit
over the Kittitas Basin.

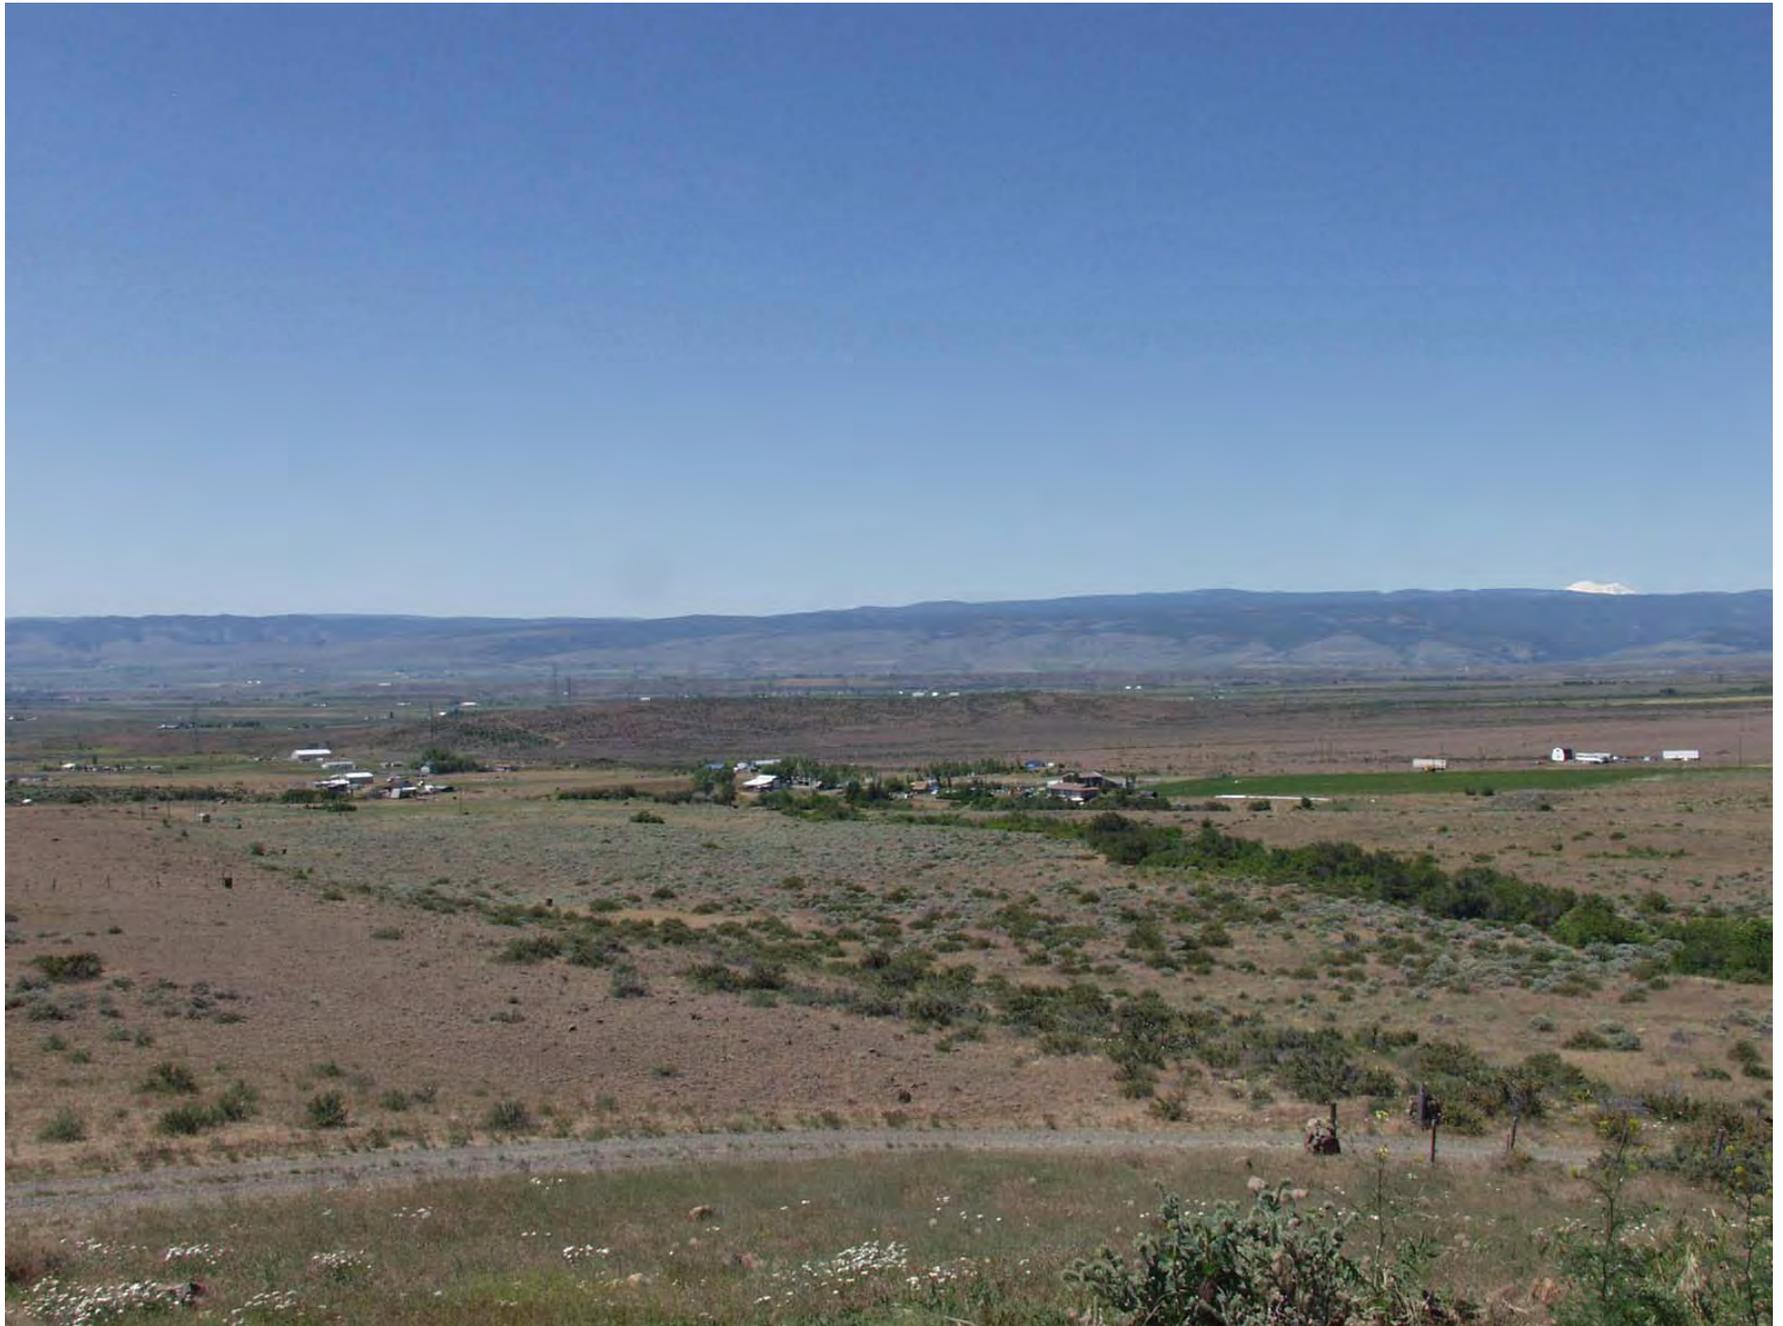
Figure G33

Key View 8B – Existing view looking southwest from the Table Mountain Slope Visual Assessment Unit near the Cole/Binette residence in Sun East

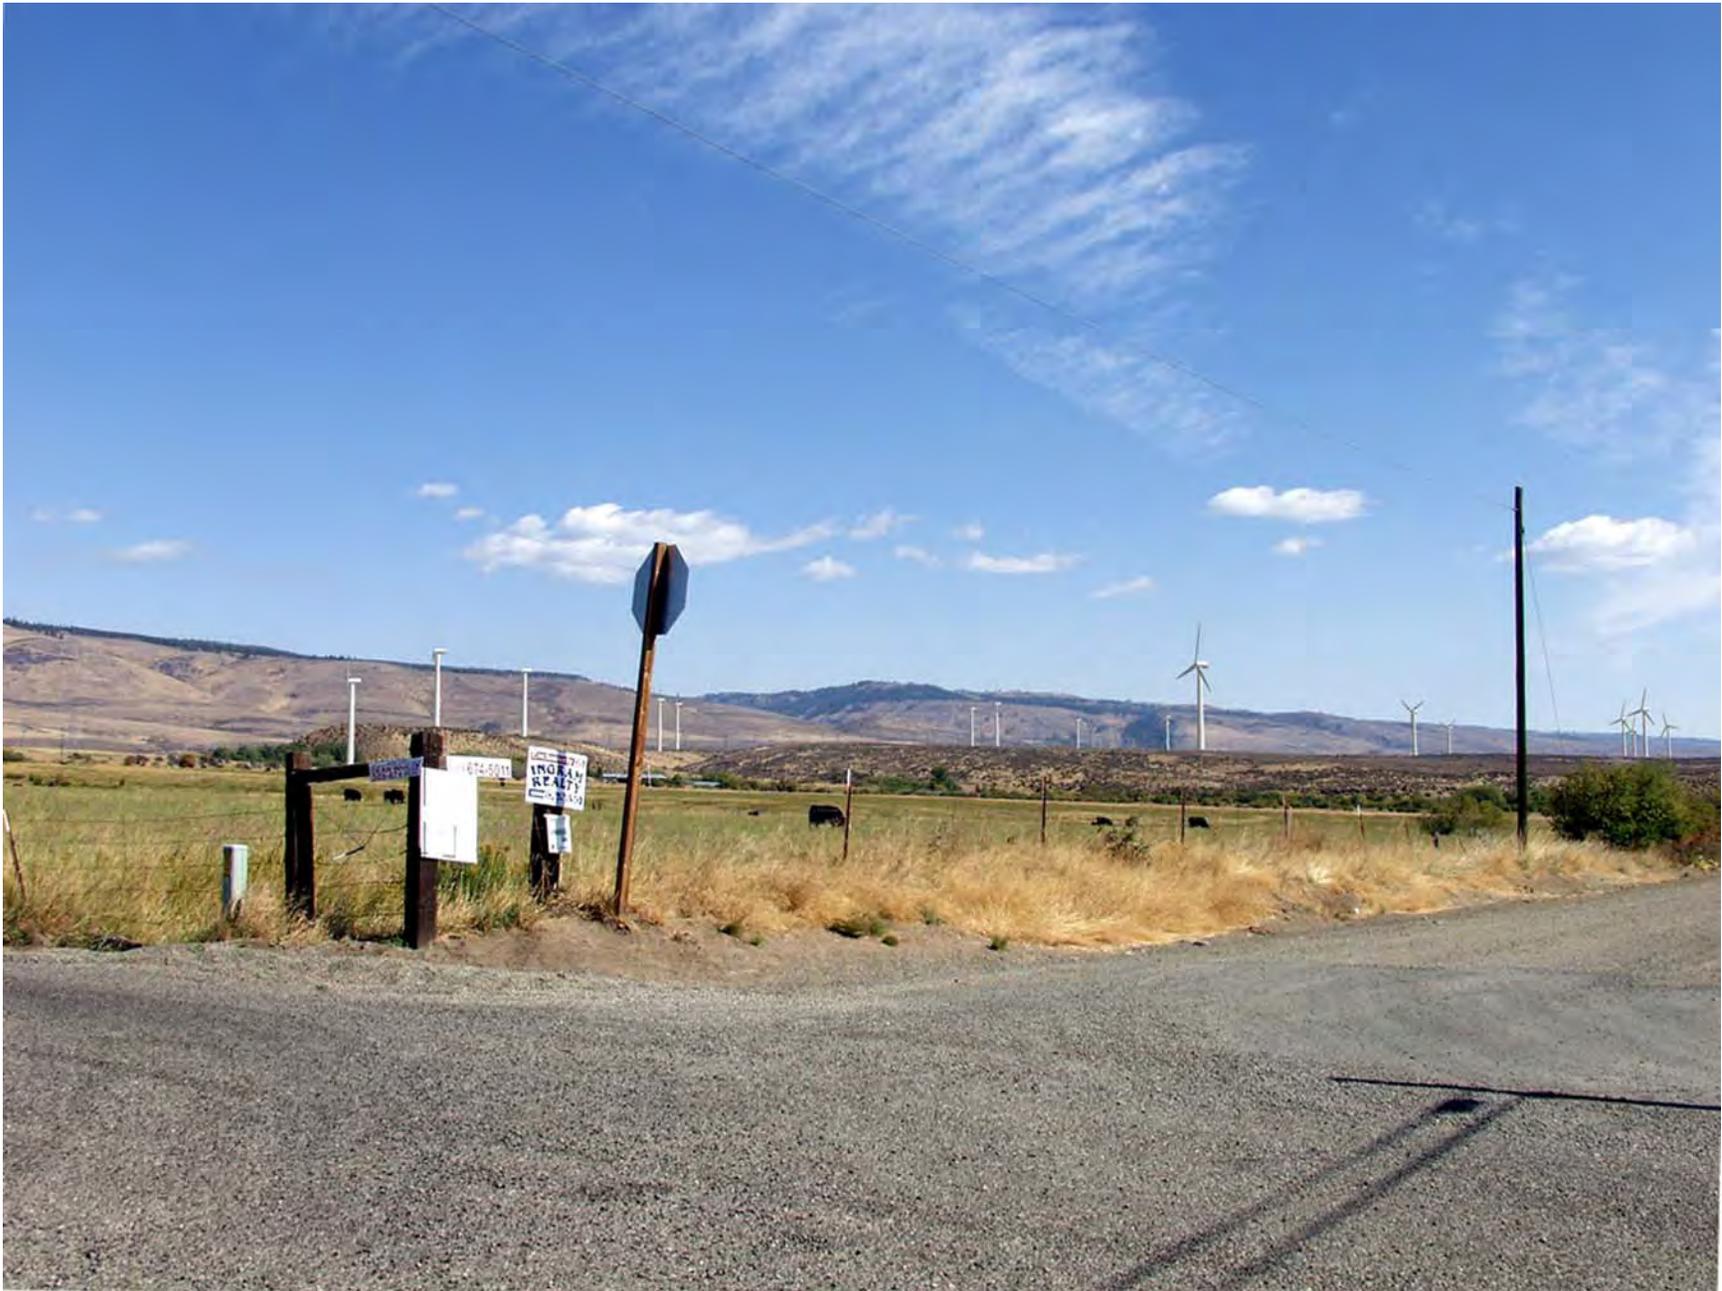
Figure G34
Key View 1A – Simulated view looking northeast across the Northwest Valley Visual Assessment Unit from the intersection of Smithson Road and Robbins Road.

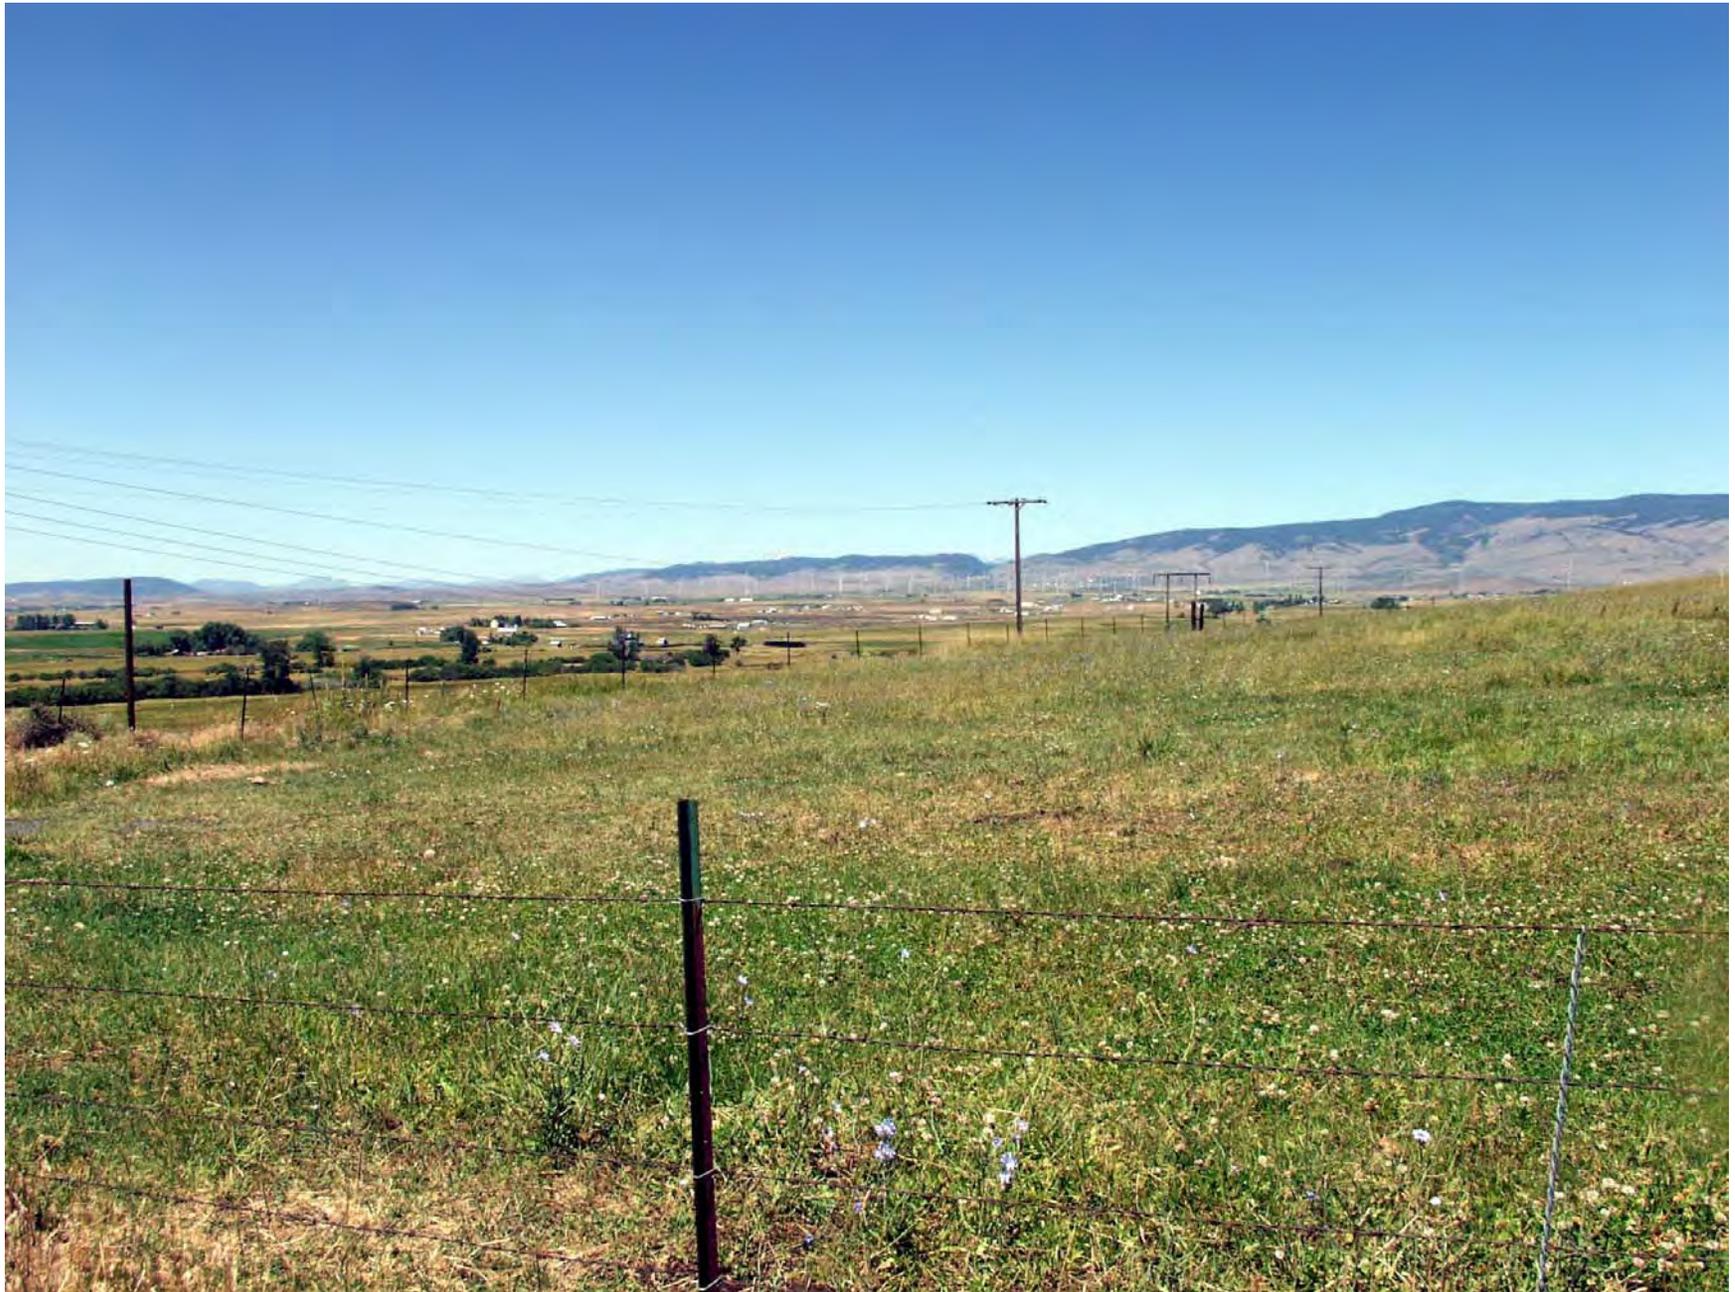
Figure G35
Key View 1B – Simulated view looking northwest across the Northeast Valley Visual Assessment Unit from the intersection of Hungry Junction and Lookabout Lane.

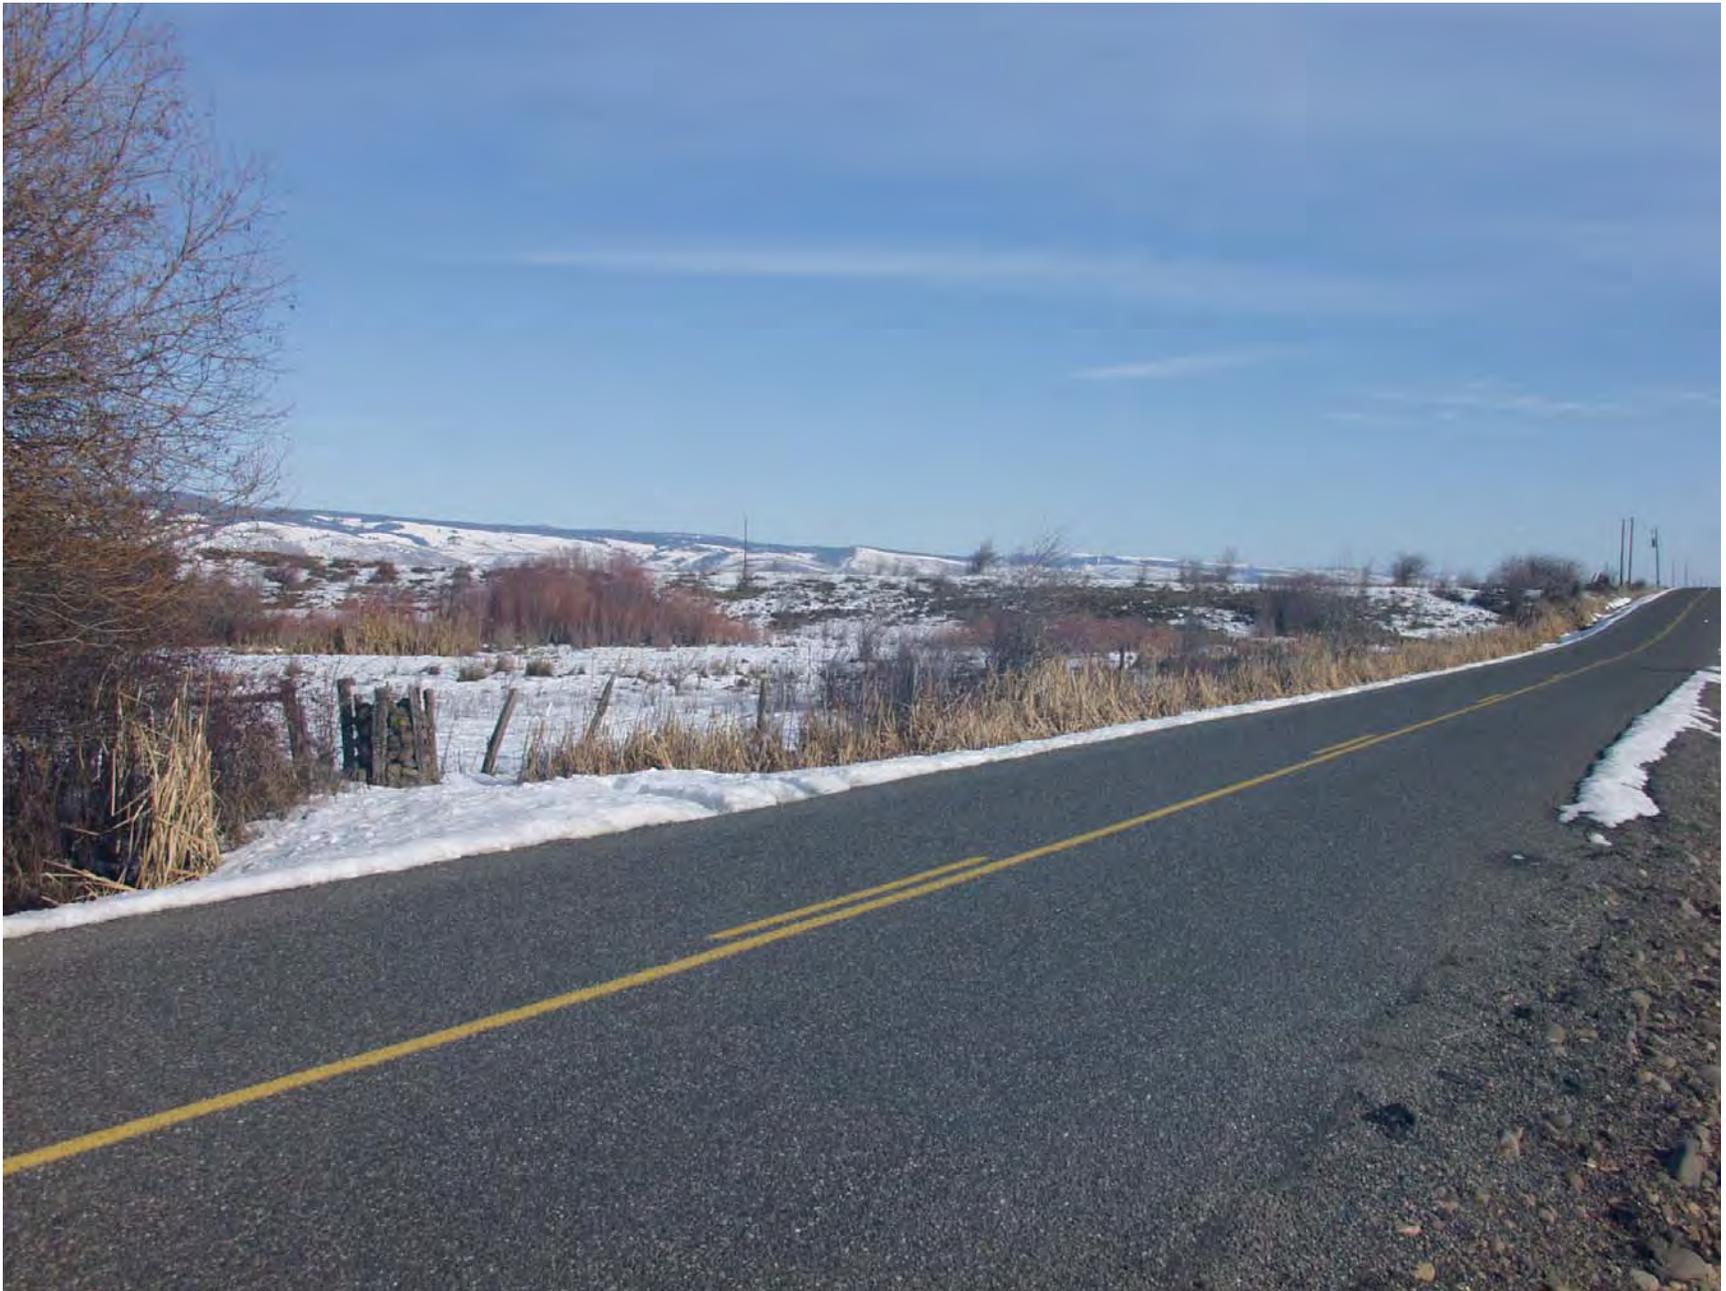
Figure G36
**Key View 1C – Simulated view looking northeast across the Northwest Valley Visual Assessment Unit
along Smithson Road near U.S. Highway 97.**

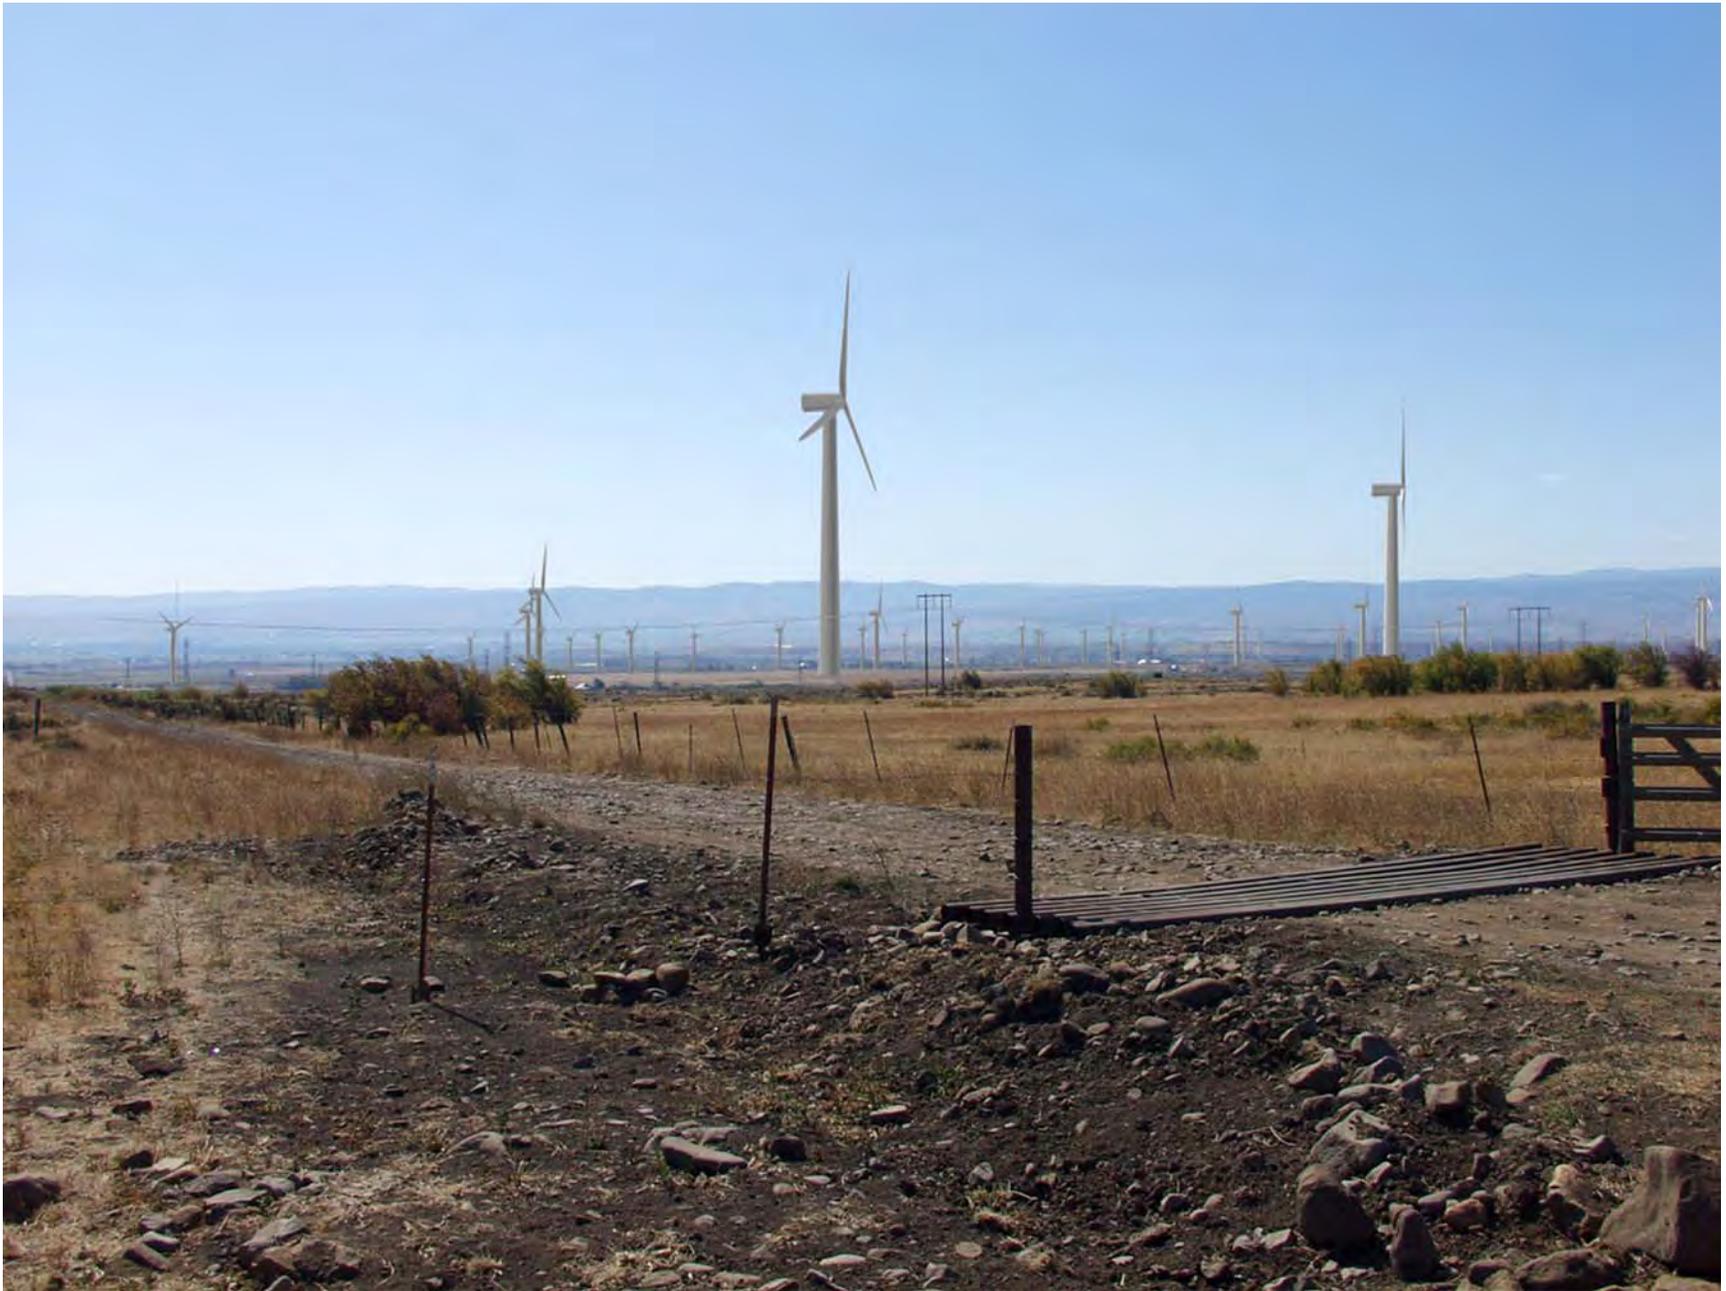
Figure G37
Key View 1D – Simulated view looking southwest across the Northwest Valley Visual Assessment Unit from immediately north of the project area.

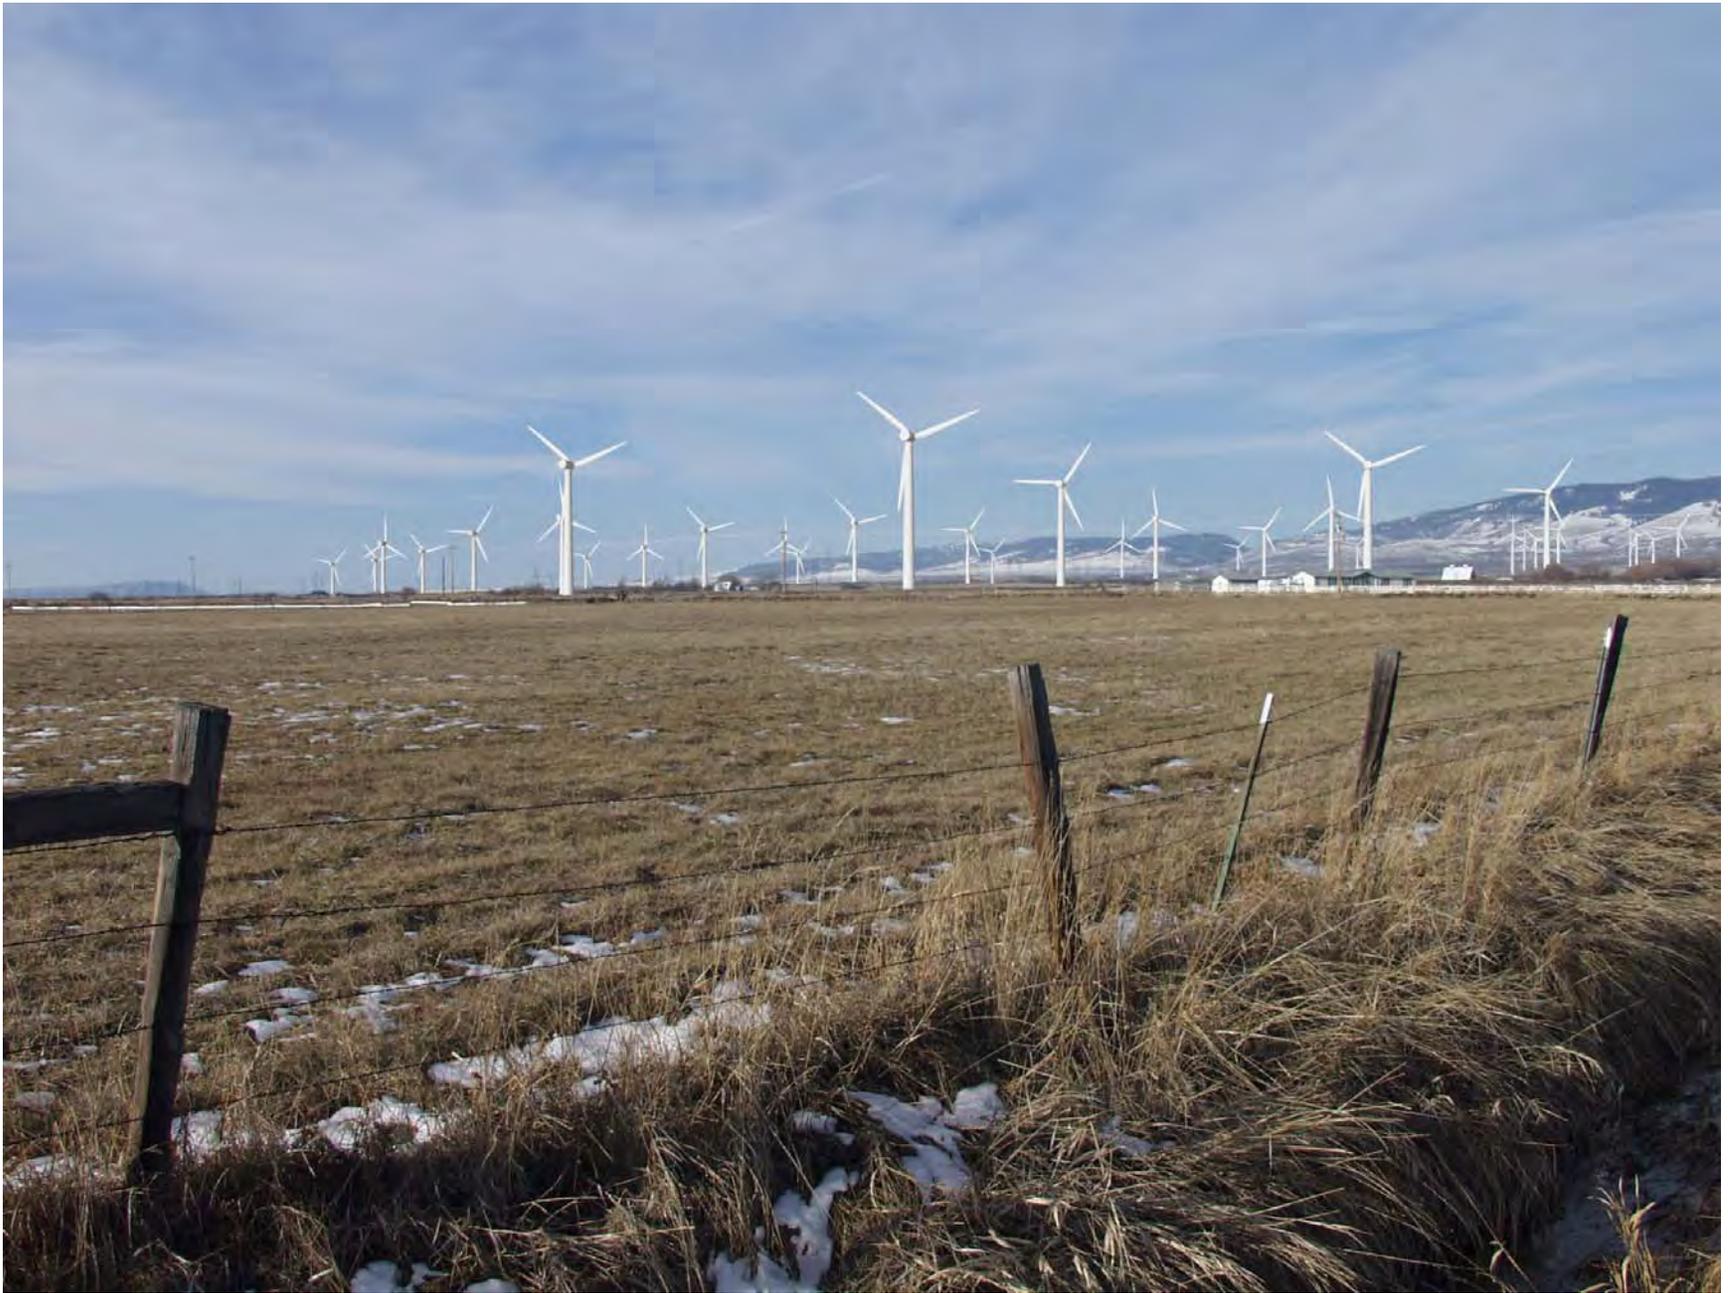
Figure G38
Key View 1E – Simulated view looking northwest across the Northwest Valley Visual Assessment Unit
from Reecer Creek Road.
