APPENDIX G

Aesthetics

AESTHETICS

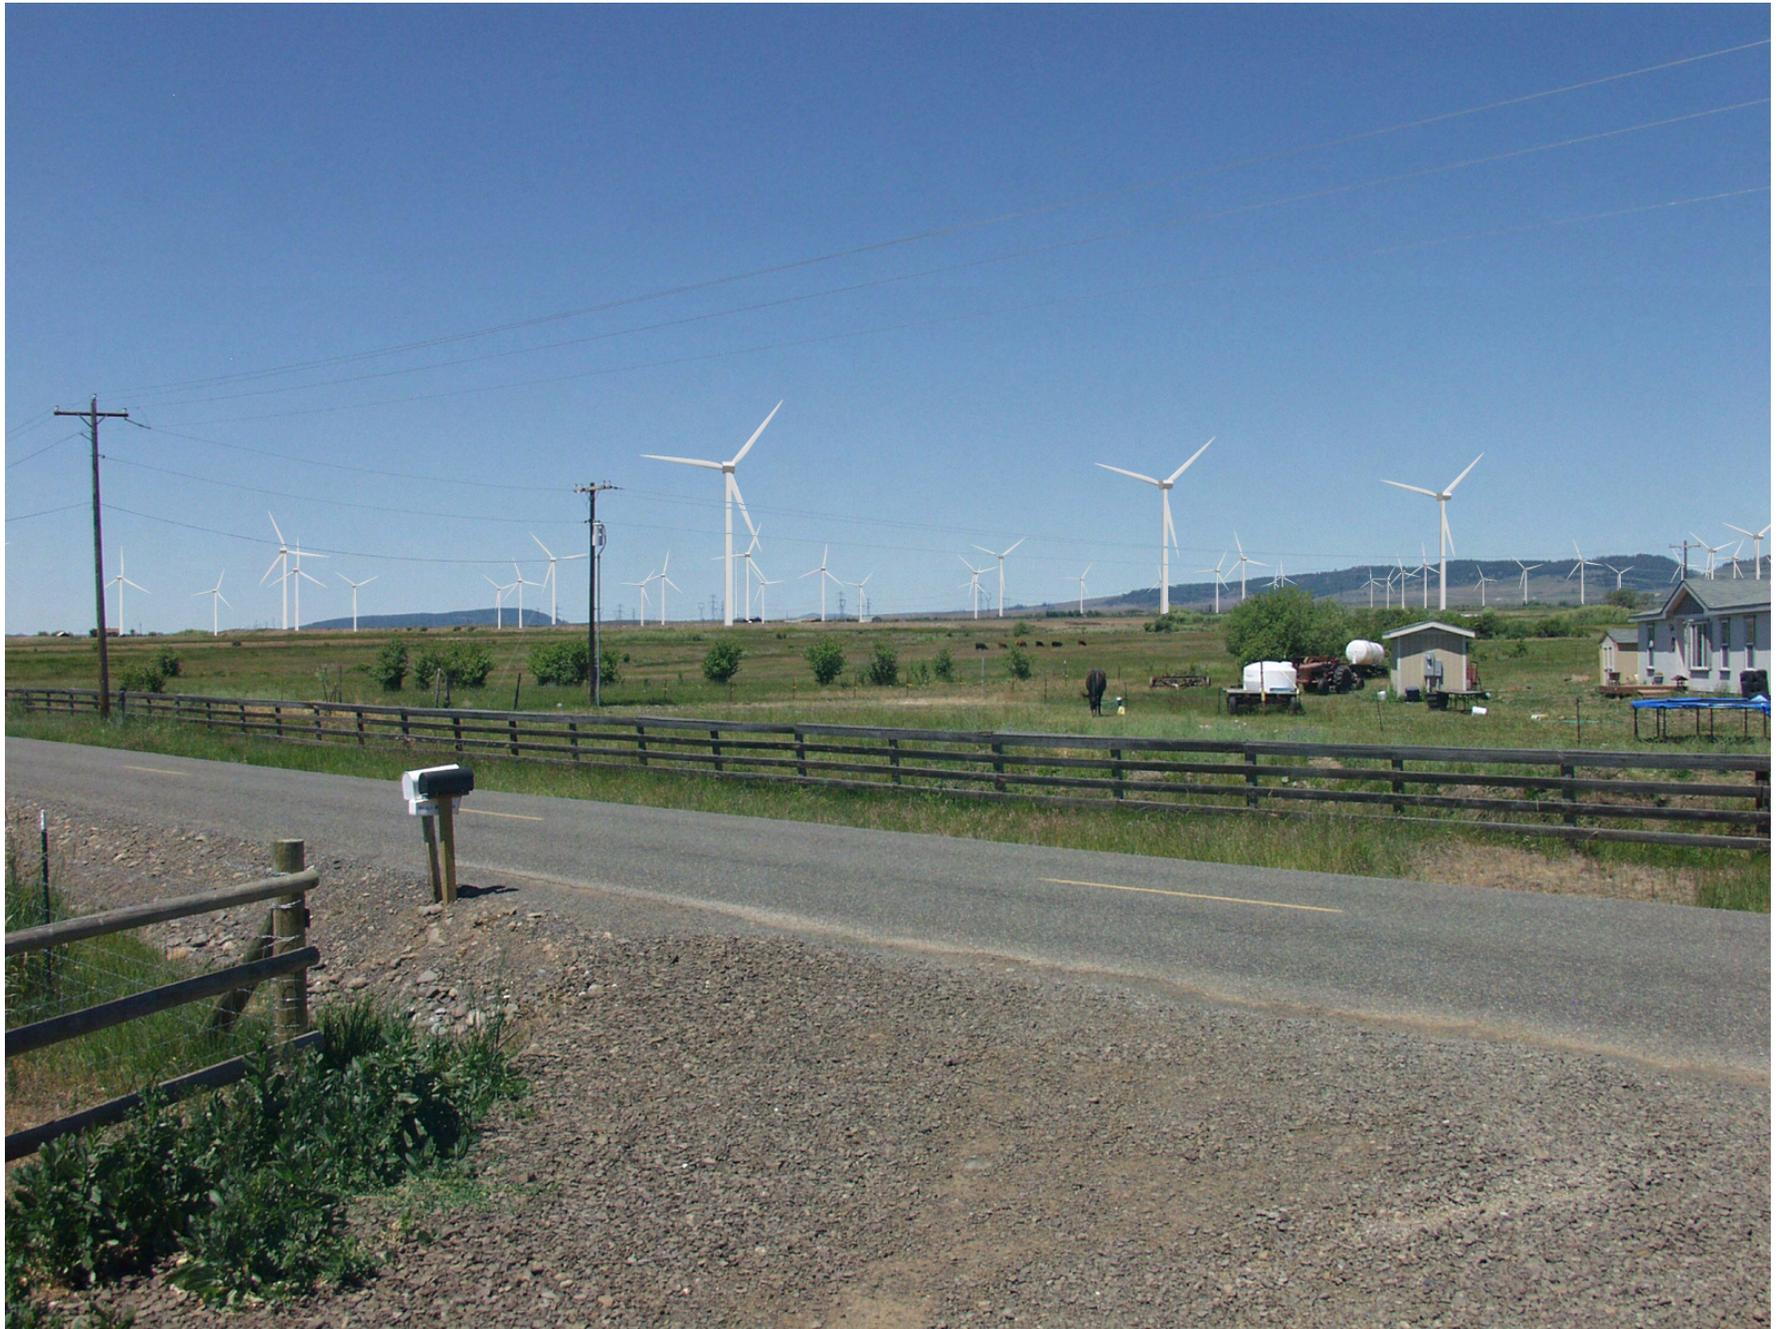
Figure G39
Key View 1E – Simulated view looking northwest across the Northwest Valley Visual Assessment Unit from Smithson Road near CTC farm.

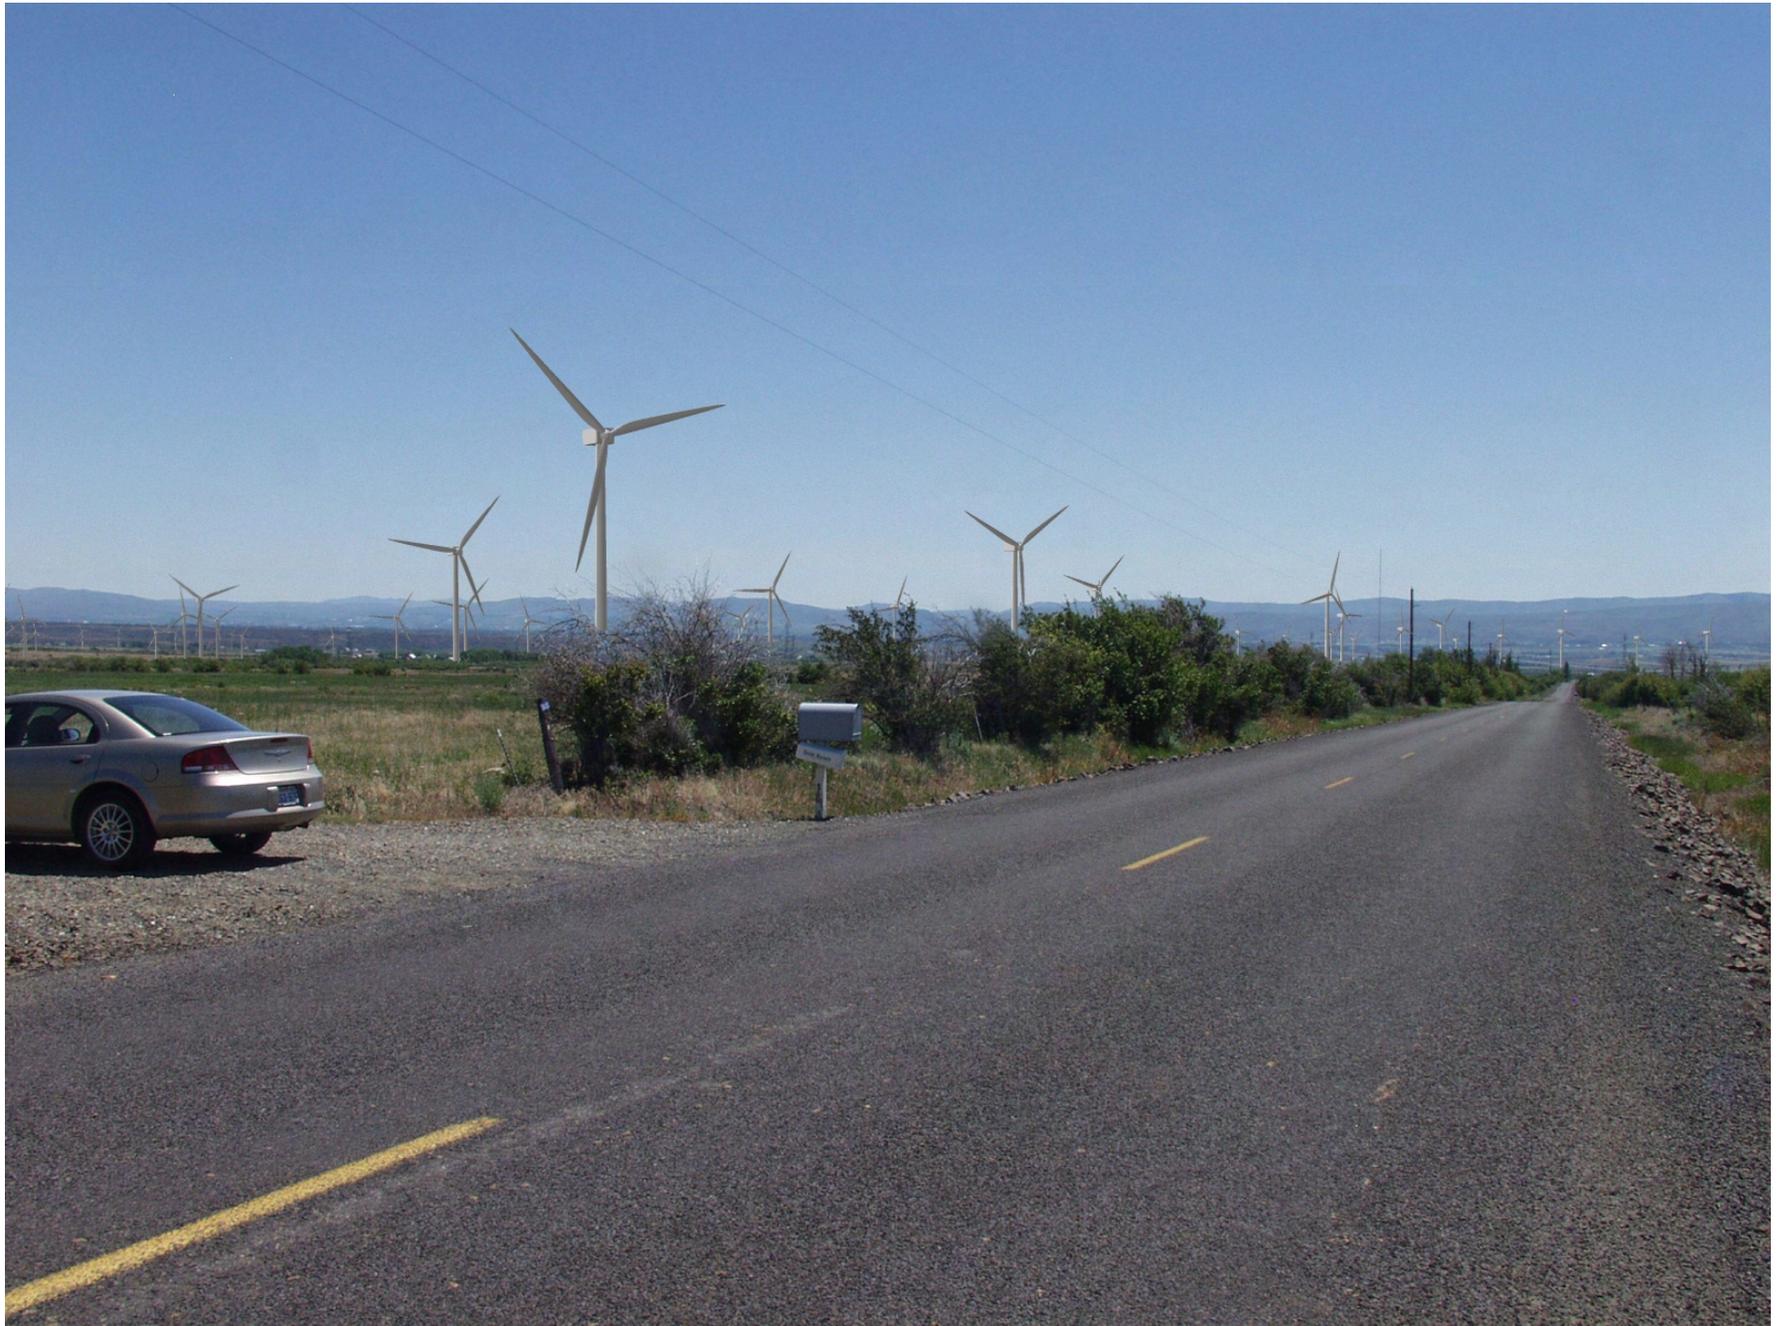
Figure G40
Supplementary Key View 1G – Simulated view looking southeast across the Northwest Valley Visual Assessment Unit from Reecer Creek Road immediately north of project boundary.

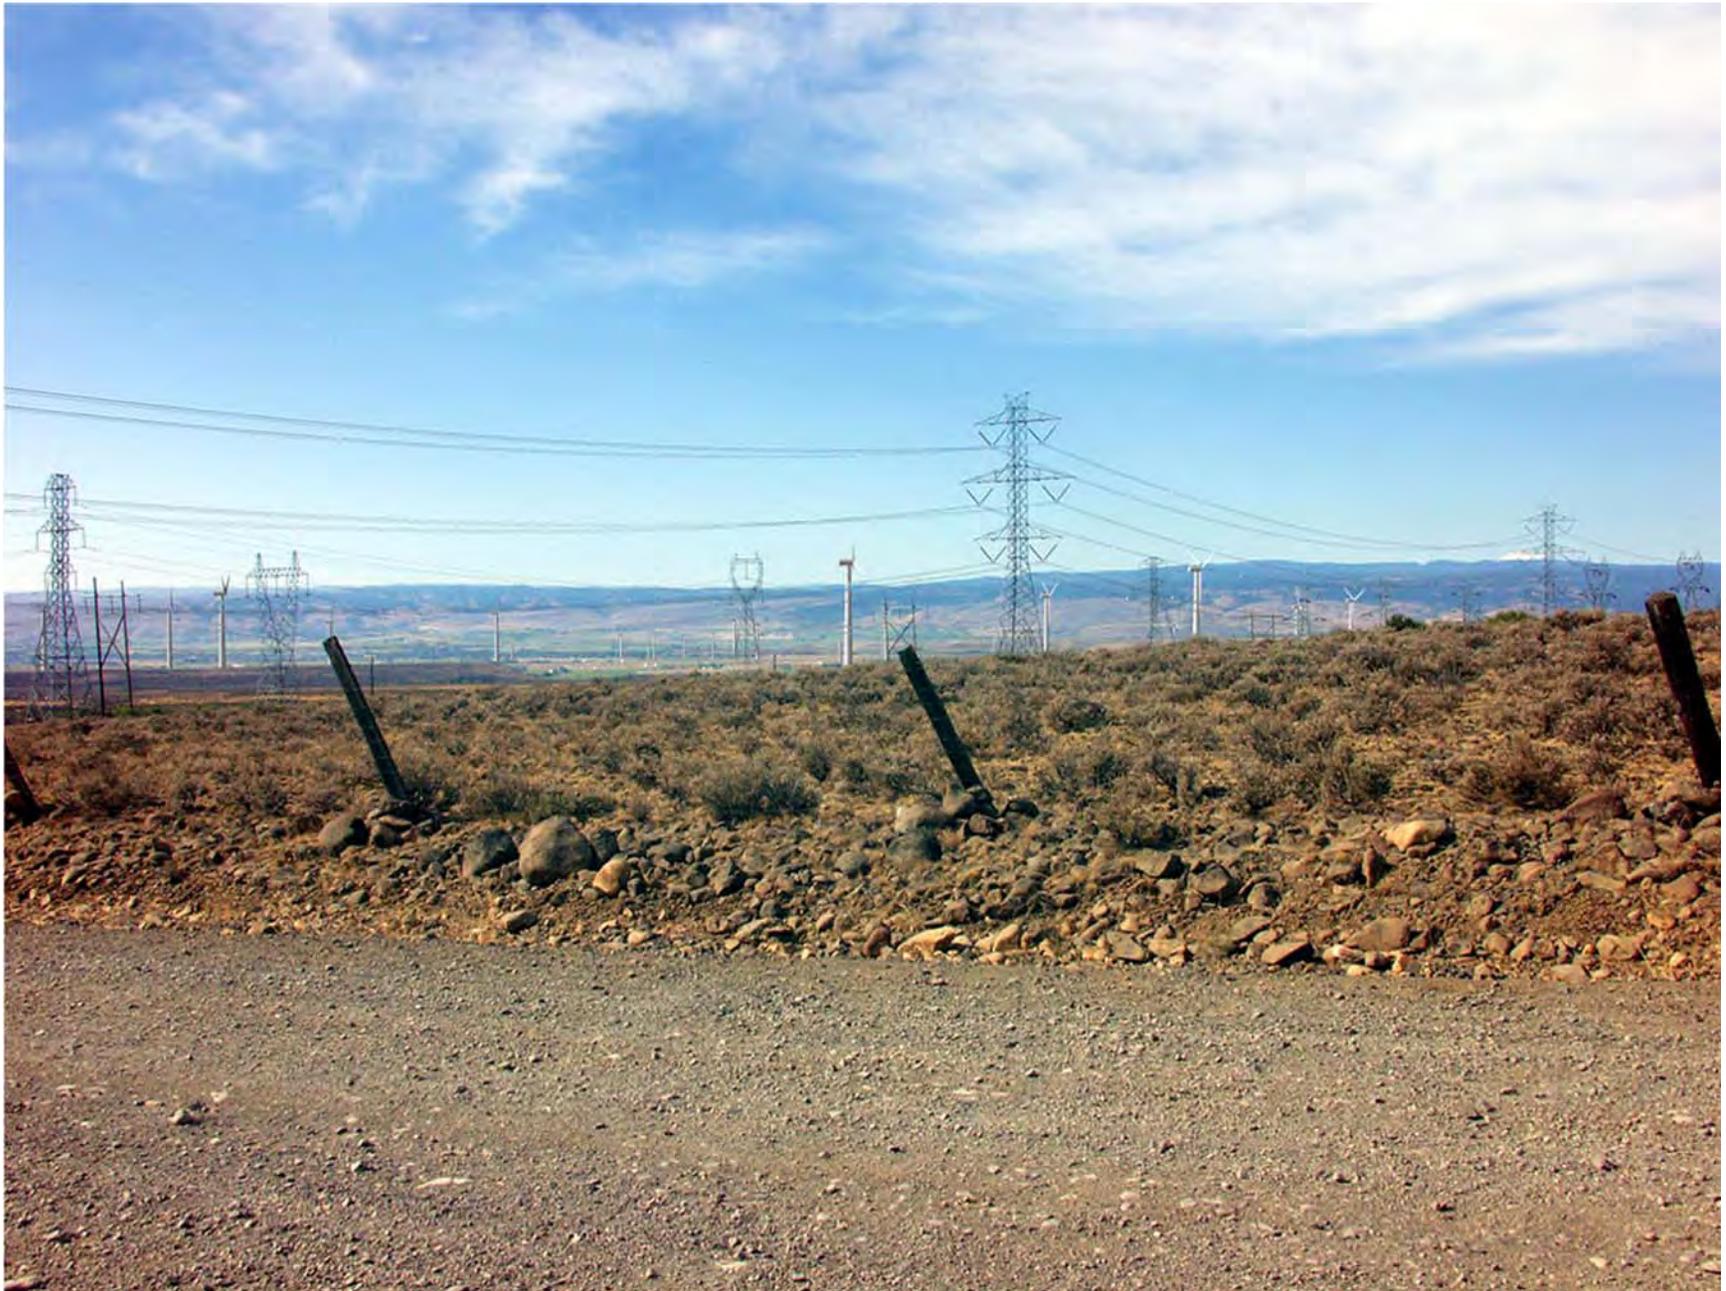
Figure G41
Key View 2A – Simulated view looking southwest across the Northwest Valley Visual Assessment Unit from Wilson Creek Road.

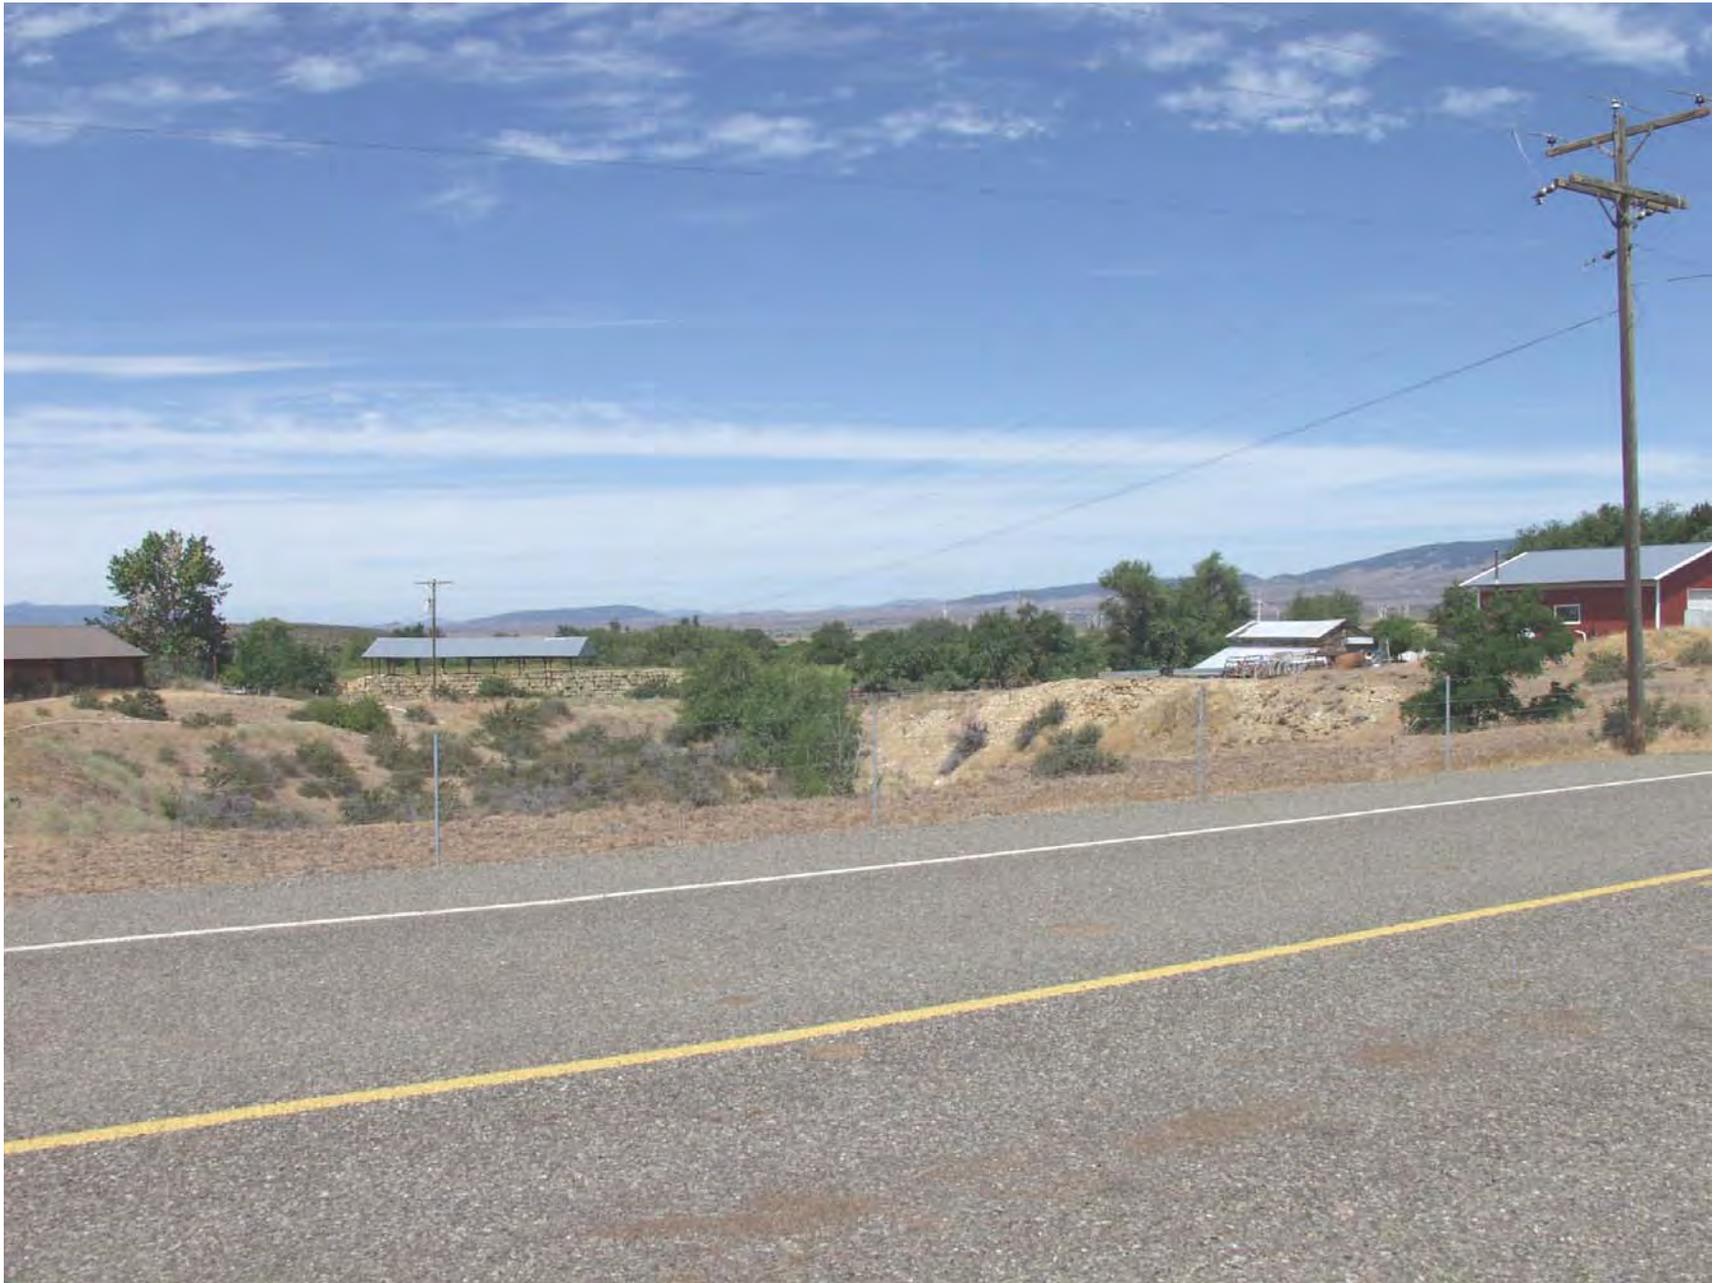
Figure G42
Key View 2B – Simulated view looking west across the Northeast Valley Visual Assessment Unit
from Wilson Creek Road on Rabbit Hill.

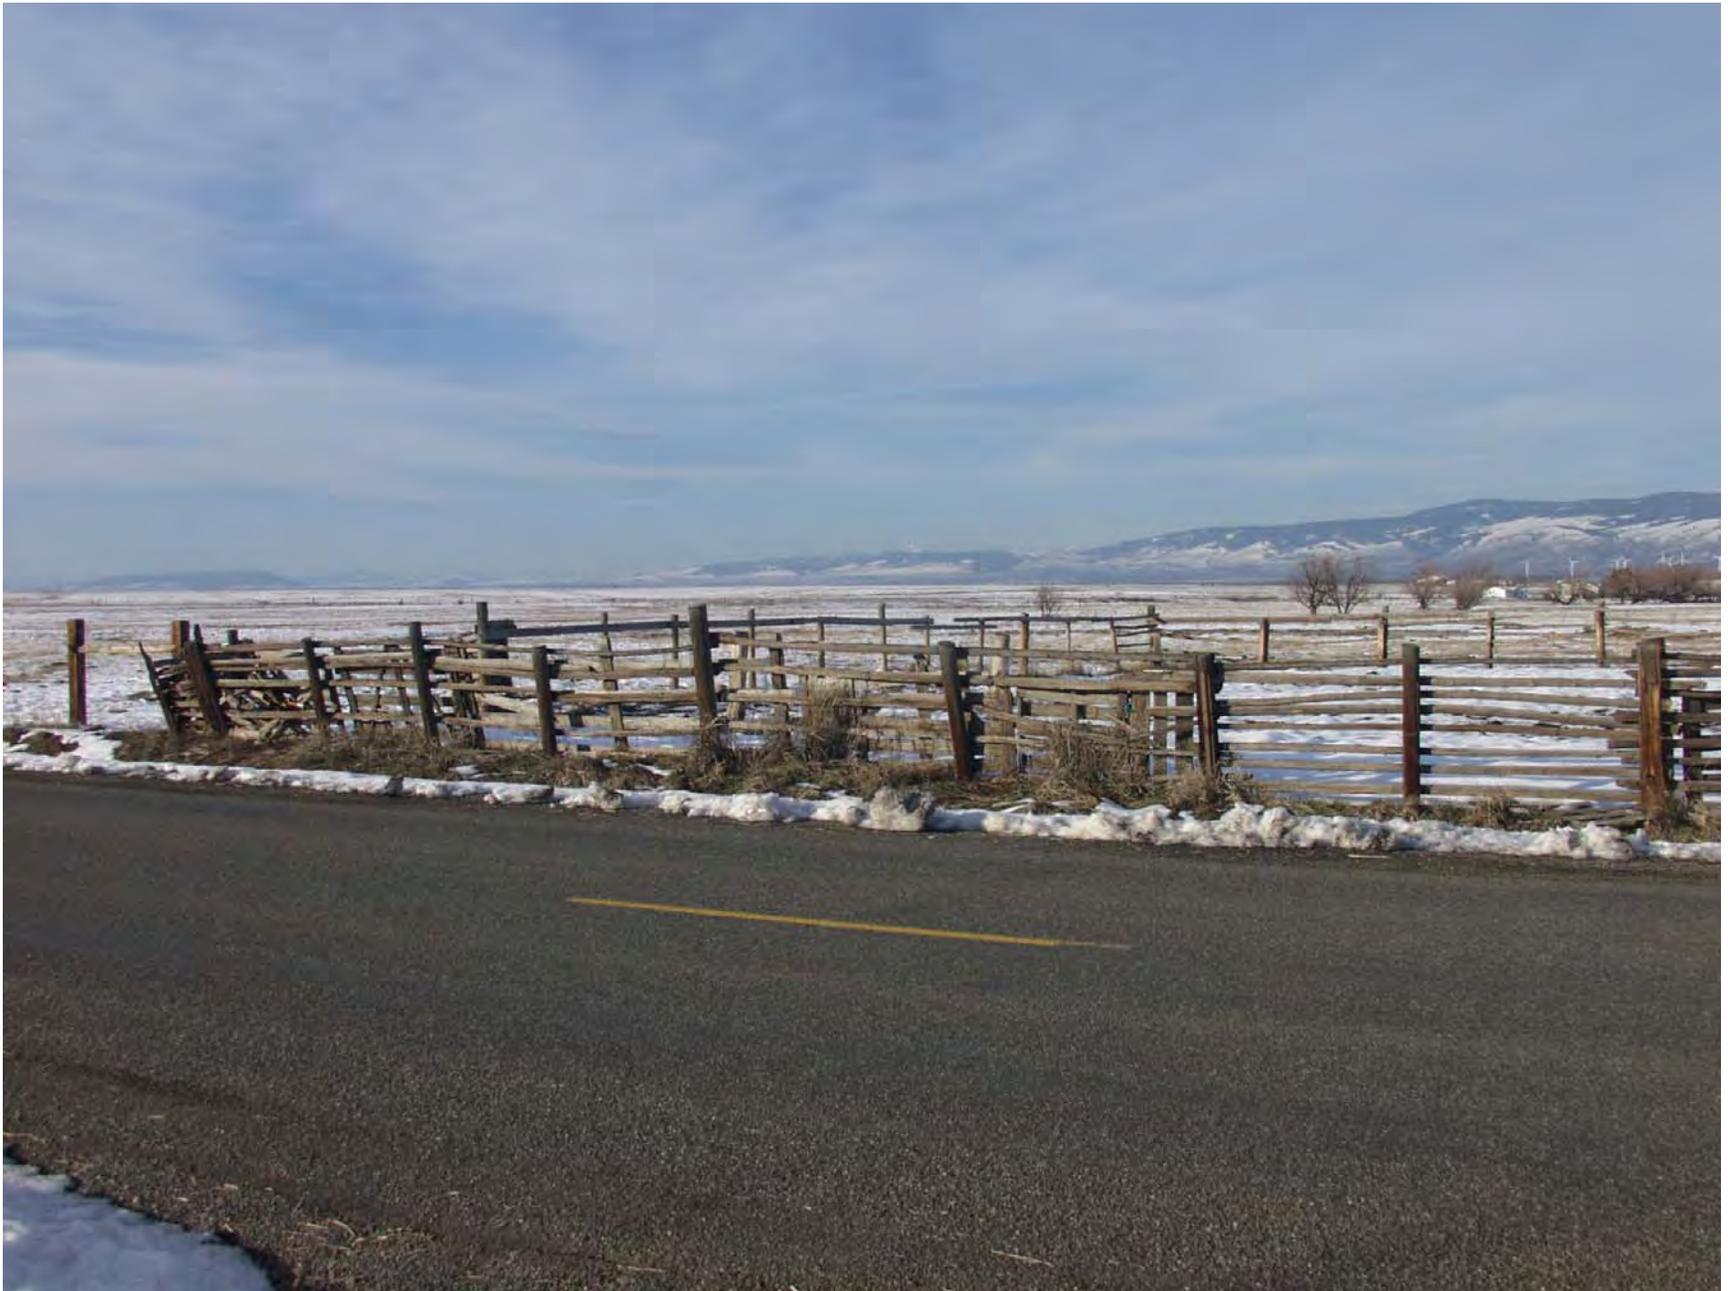
Figure G43
**Key View 2C – Simulated view looking northwest across the Northwest Valley Visual Assessment Unit
from the north end of Bowers Field at Hungry Junction Road.**

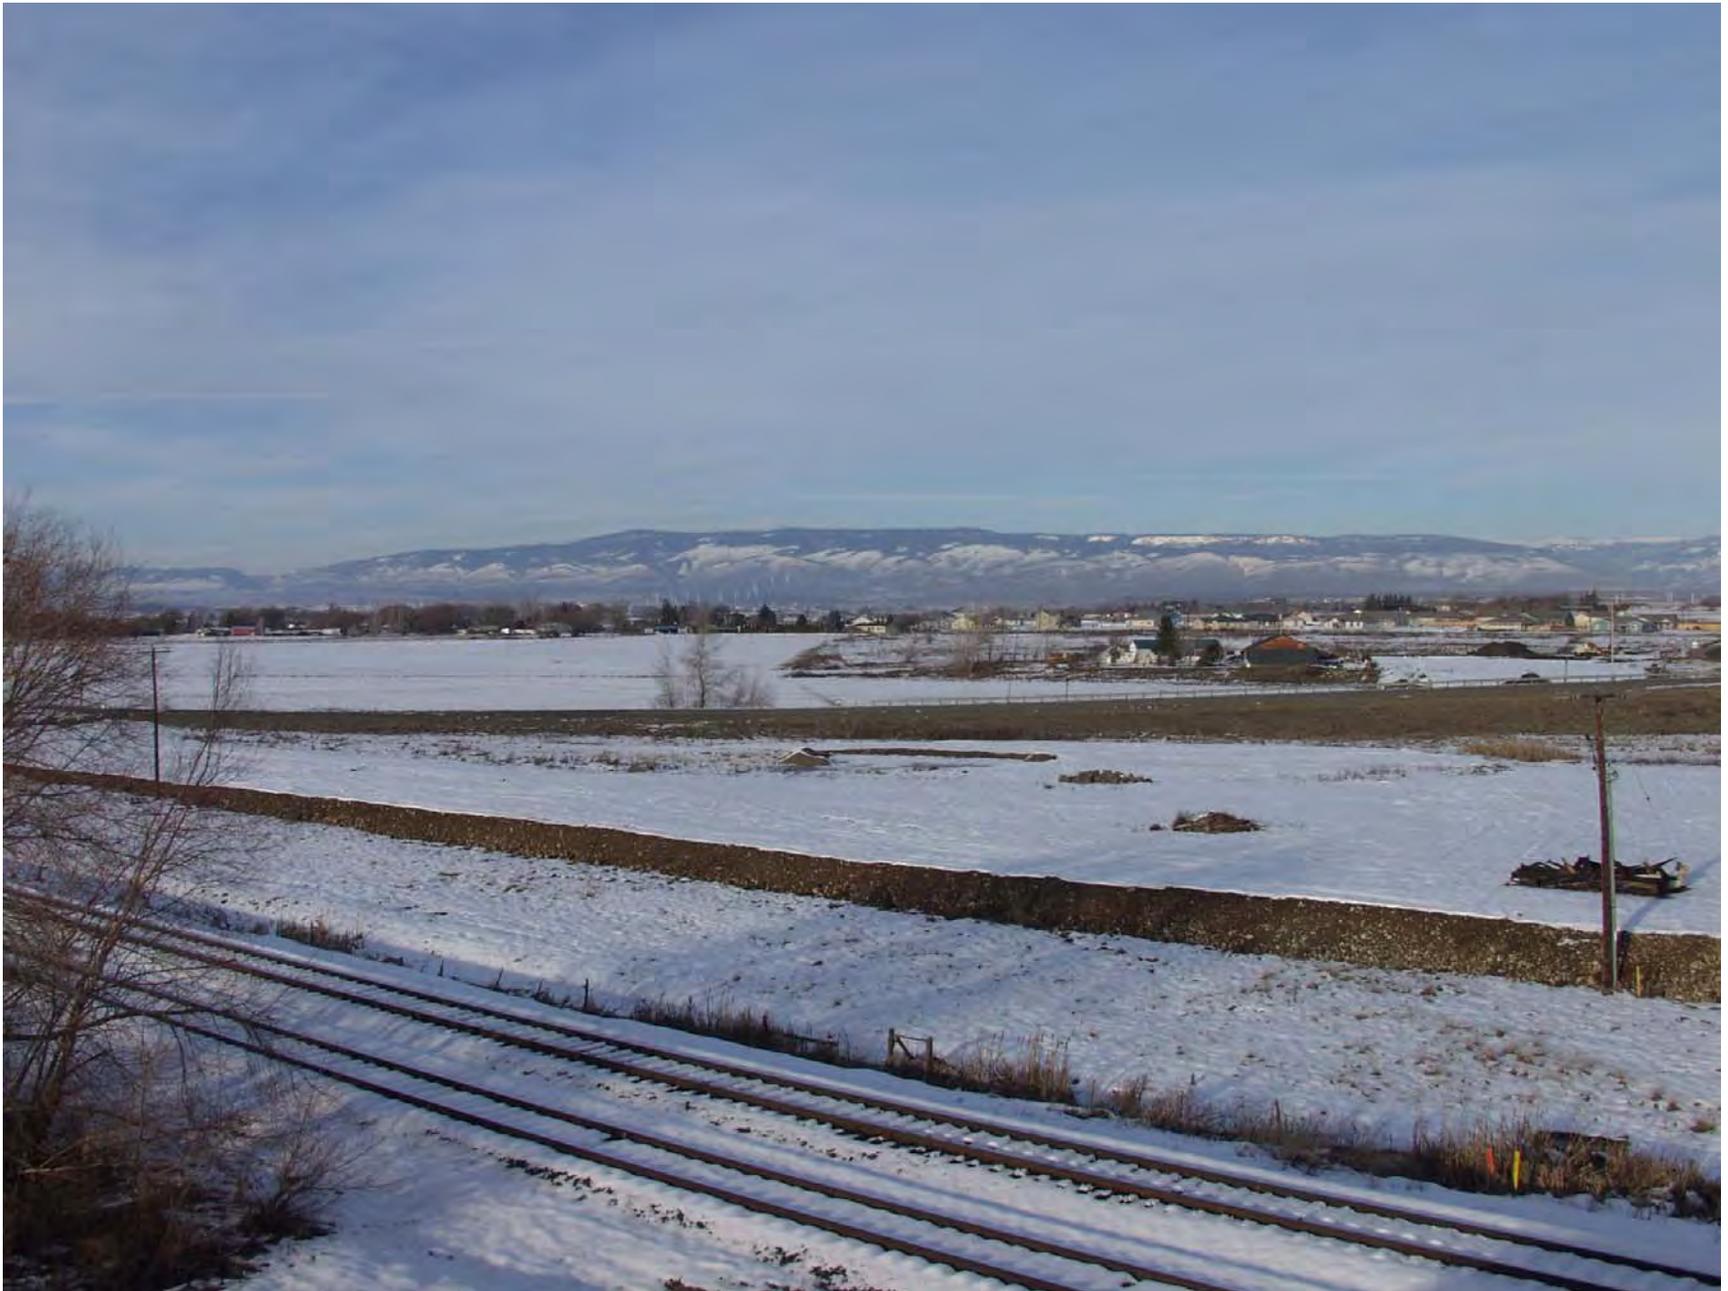
Figure G44
Key View 3A – Simulated view north across the Greater Ellensburg Visual Assessment Unit over the Burlington Northern Railroad near U.S. Highway 97 and Cascade Way.

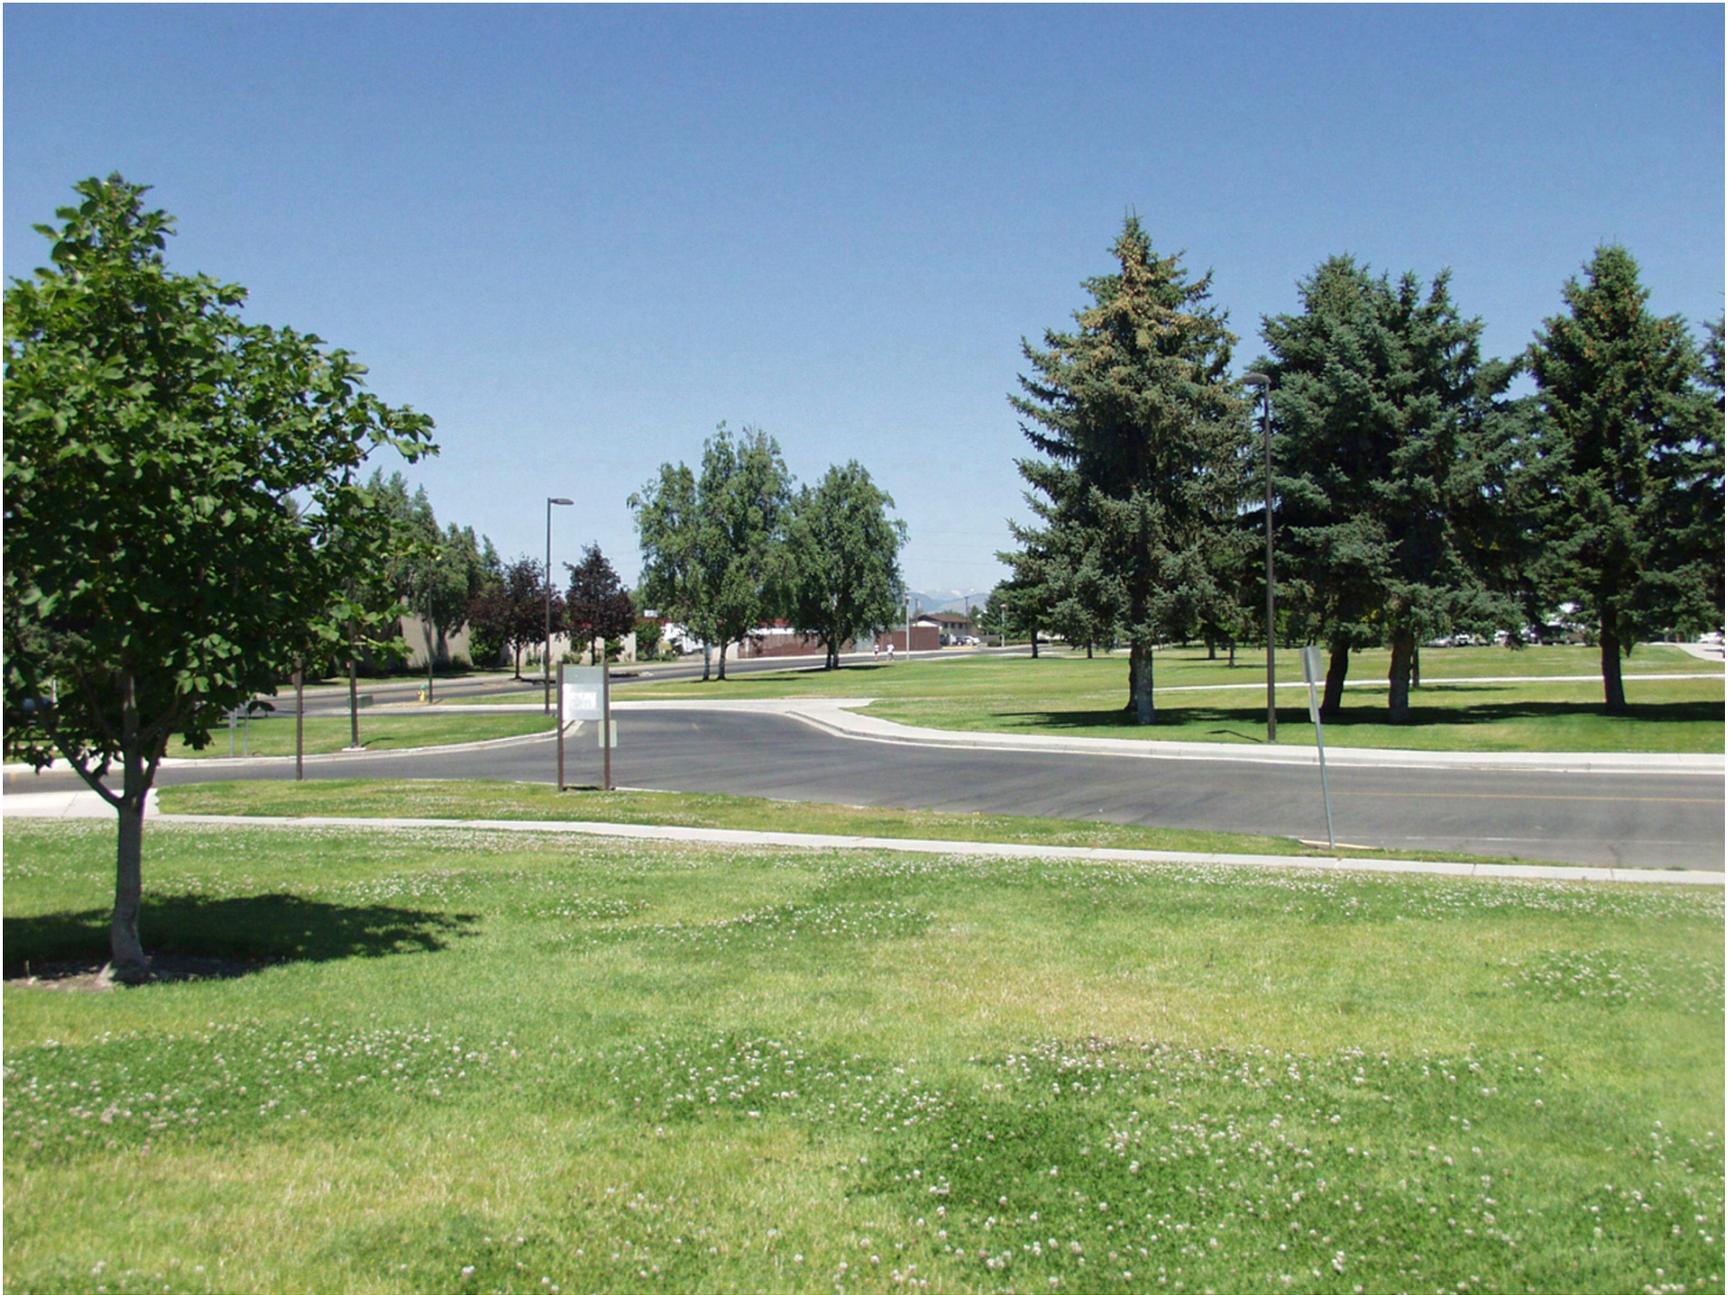
Figure G45

Key View 3B – Simulated view looking northwest across the Greater Ellensburg Visual Assessment Unit from the Central Washington University campus.

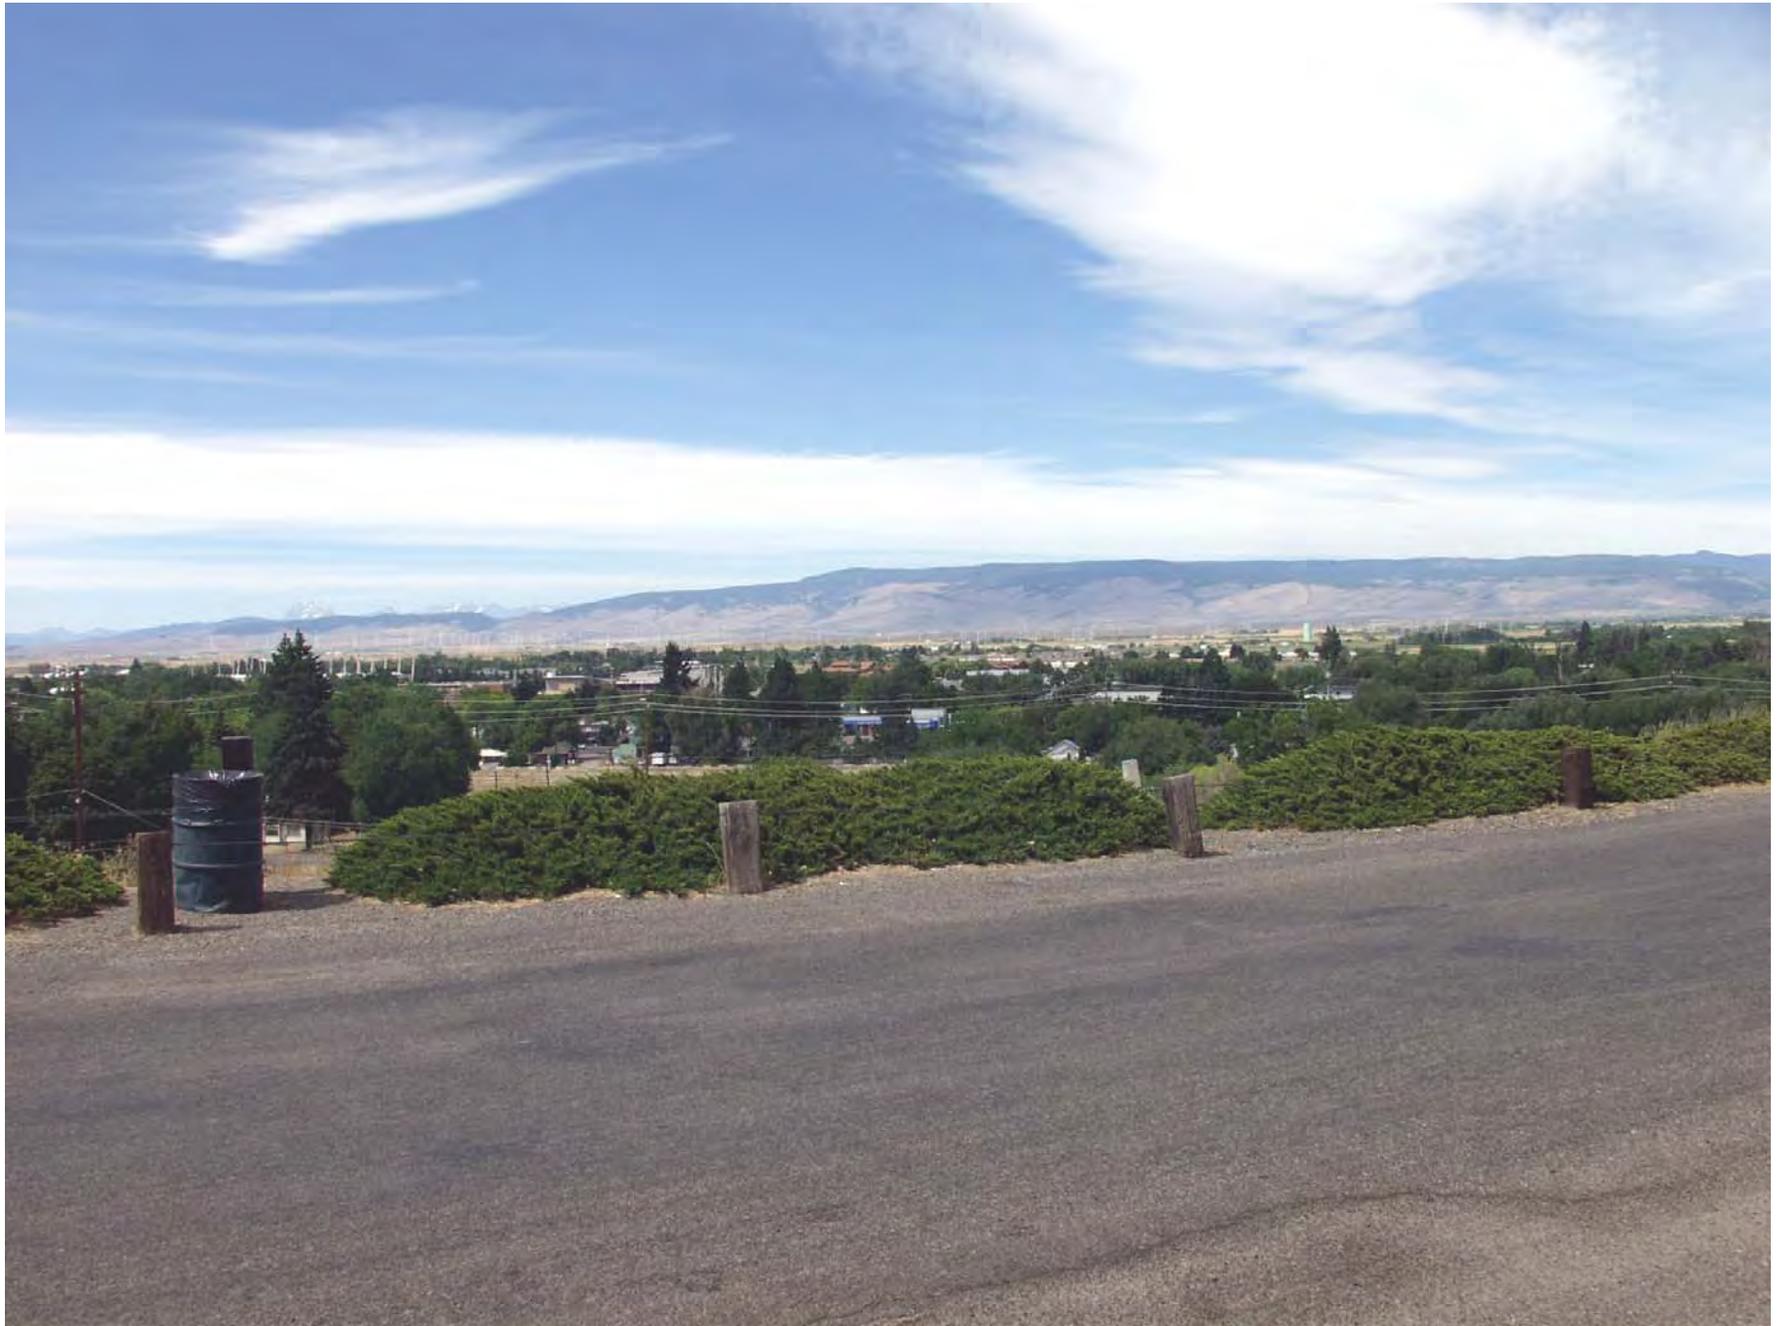
Figure G46
Key View 3C – Simulated view looking northwest across the Greater Ellensburg Visual Assessment Unit from Reed Park in Ellensburg.

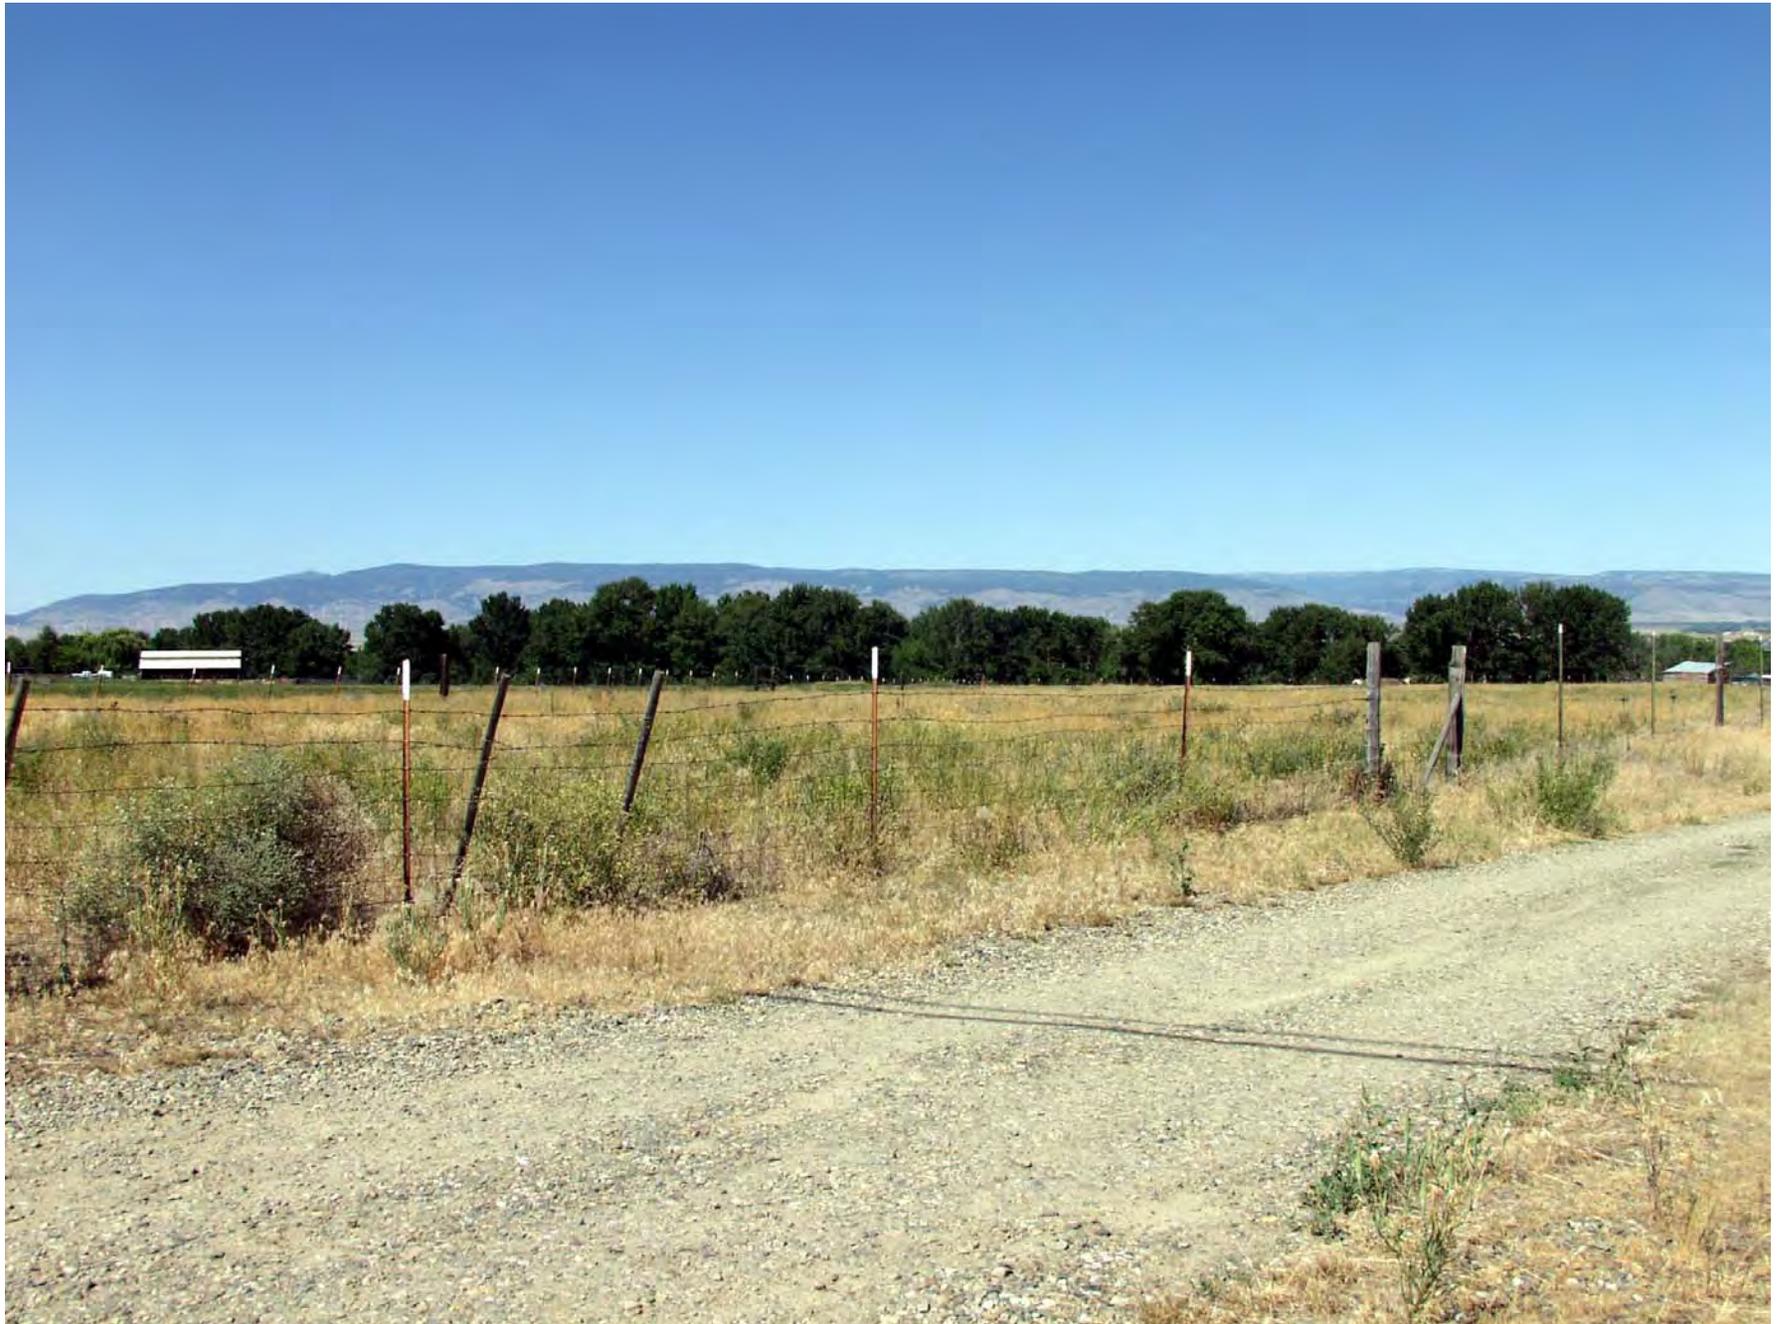
Figure G47

Key View 4A – Simulated view looking north across the Yakima River Visual Assessment Unit from the intersection of the Thorp Highway and Weaver Road.

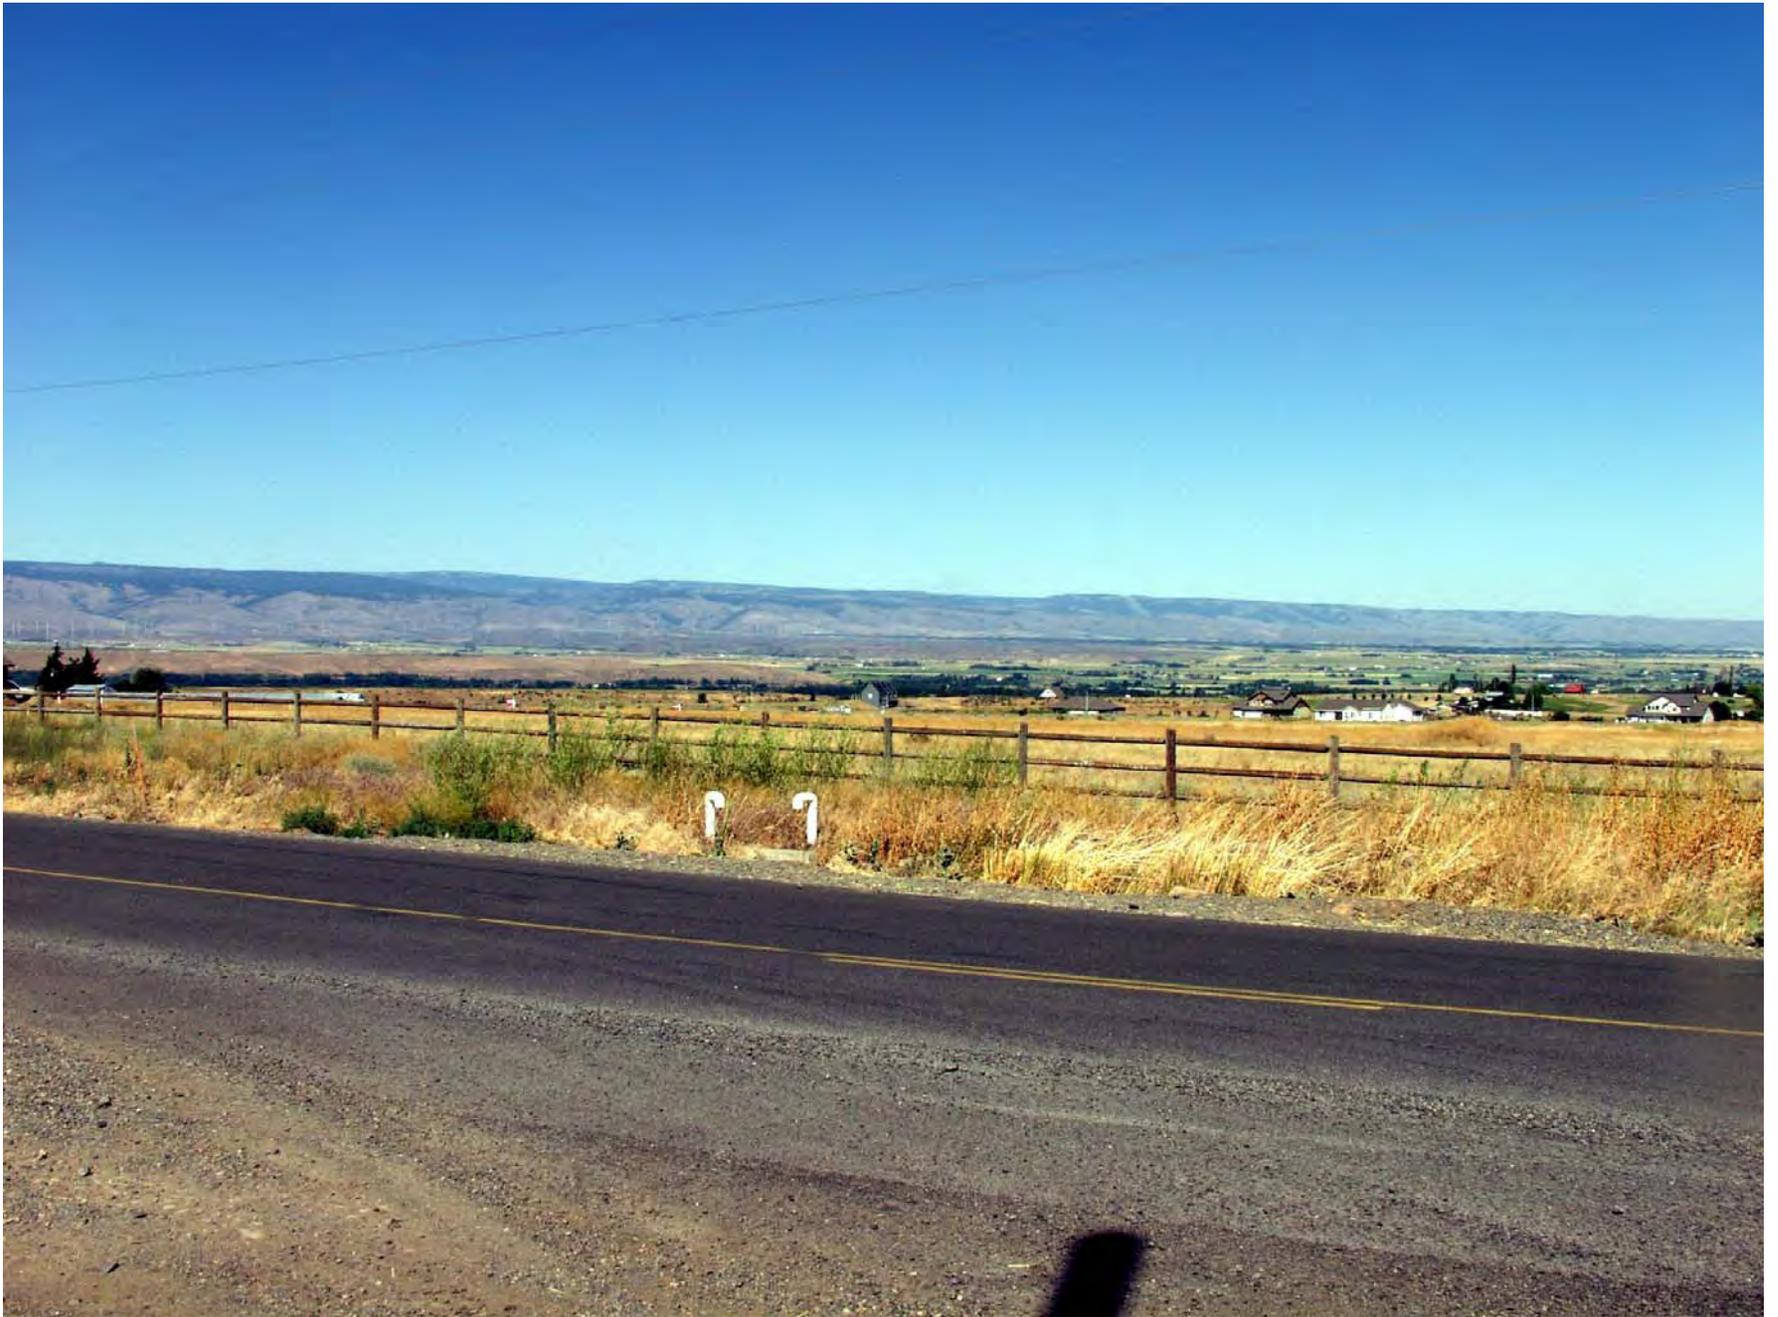
Figure G48
Key View 5A – Simulated view looking north from the Southwest Valley Visual Assessment Unit at the intersection of Killmore Road and Robinson Road.
