APPENDIX G

Aesthetics

AESTHETICS

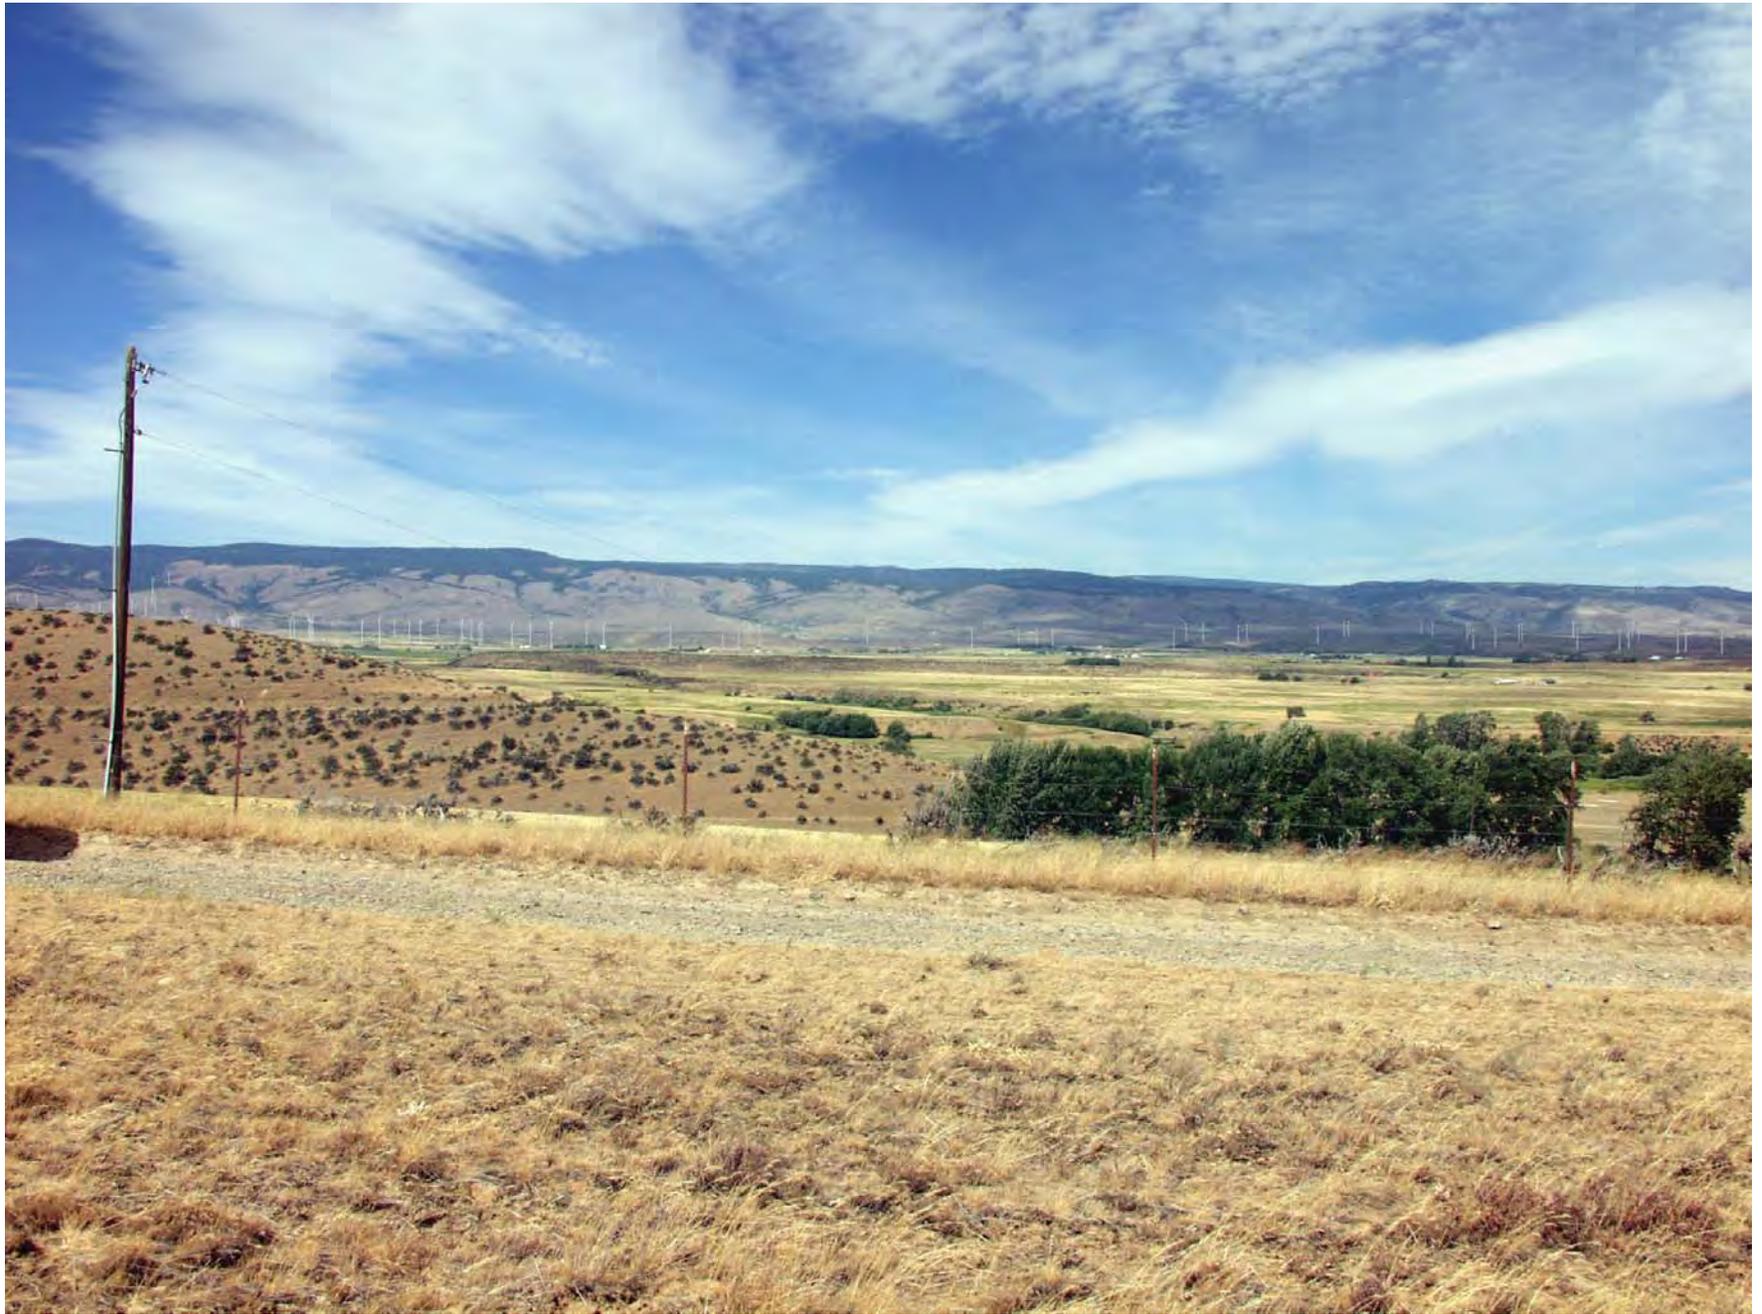
Figure G49
Key View 6A – Simulated view looking east from the Hayward Hill Visual Assessment Unit
at the top of the hill.

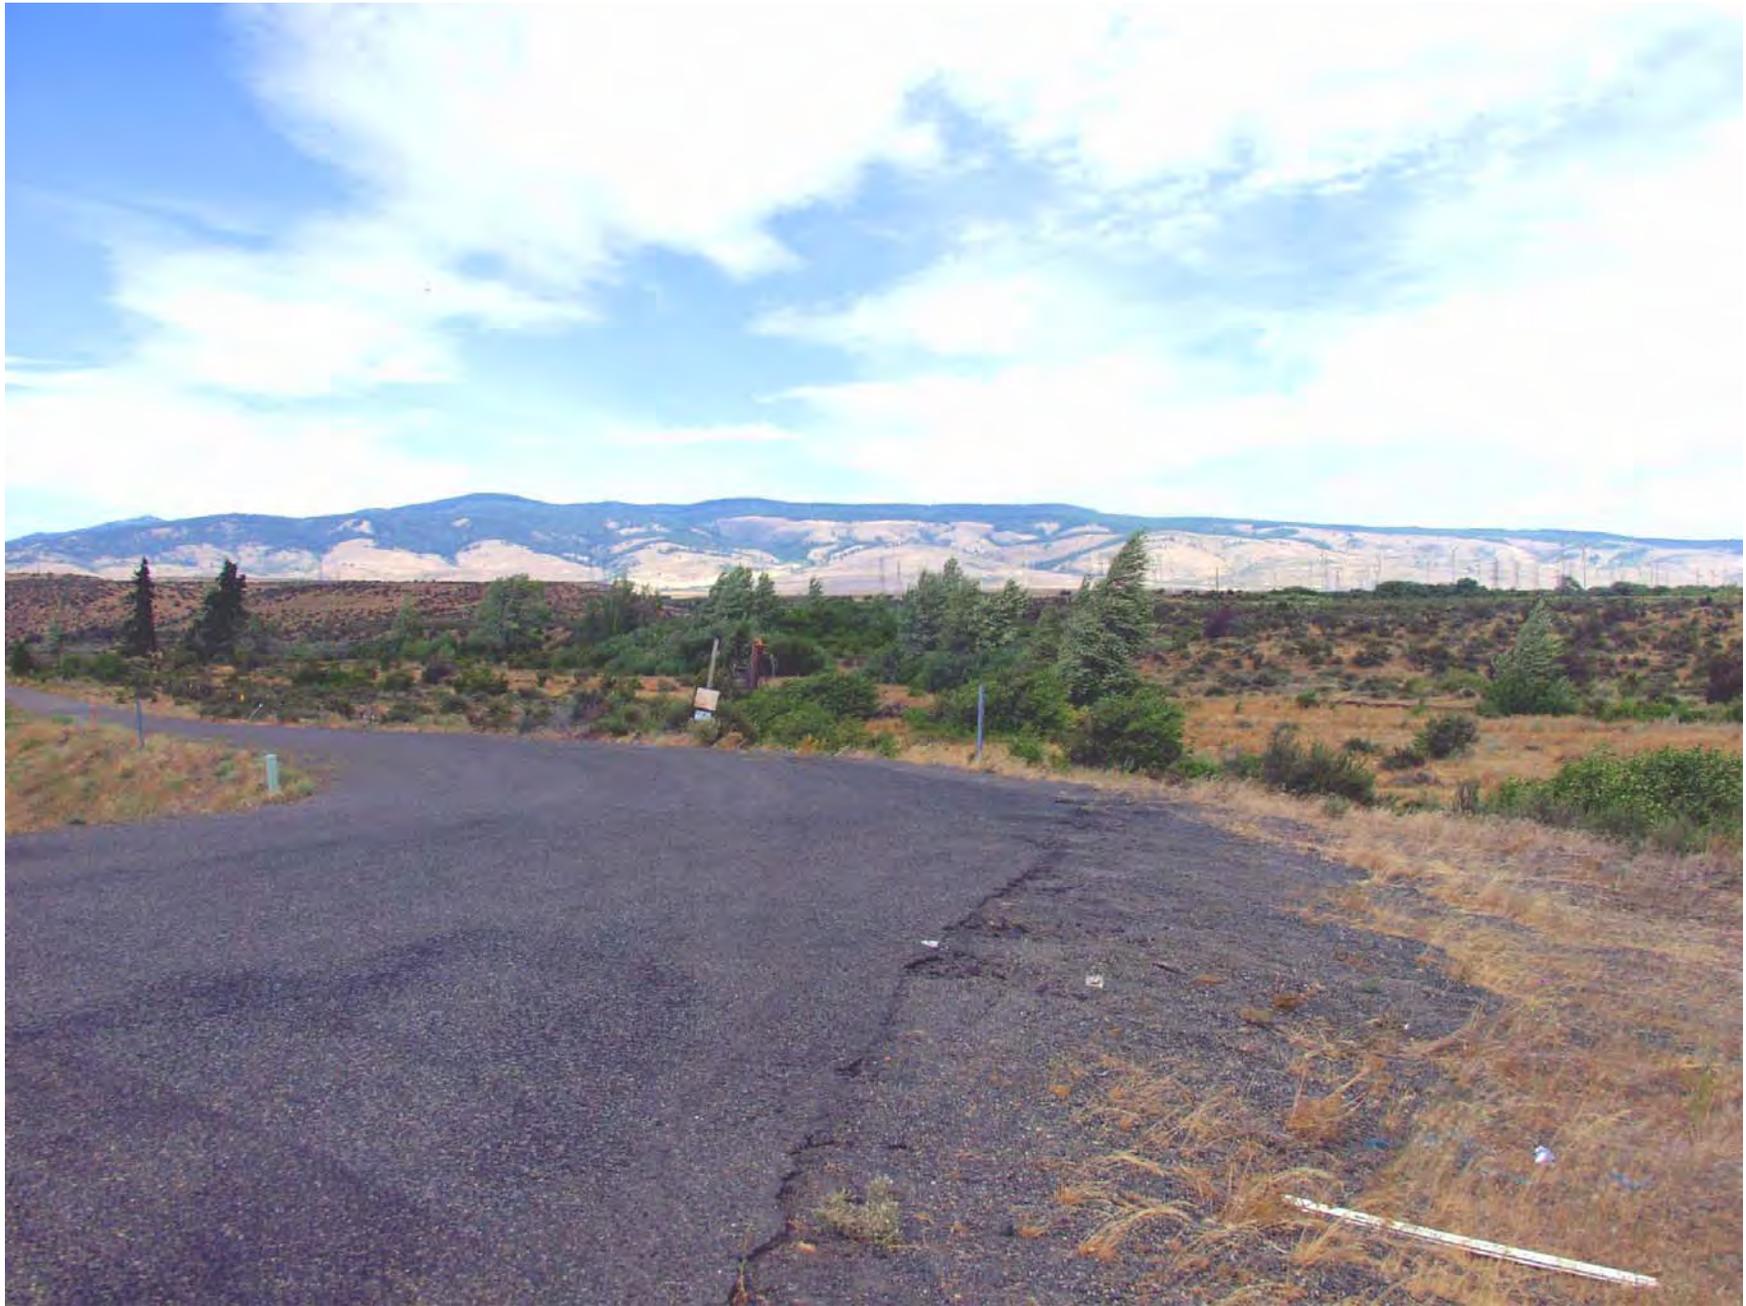
Figure G50
Key View 7A – Simulated view looking northwest from the Dry Creek Slope Visual Assessment Unit off U.S. Highway 97.

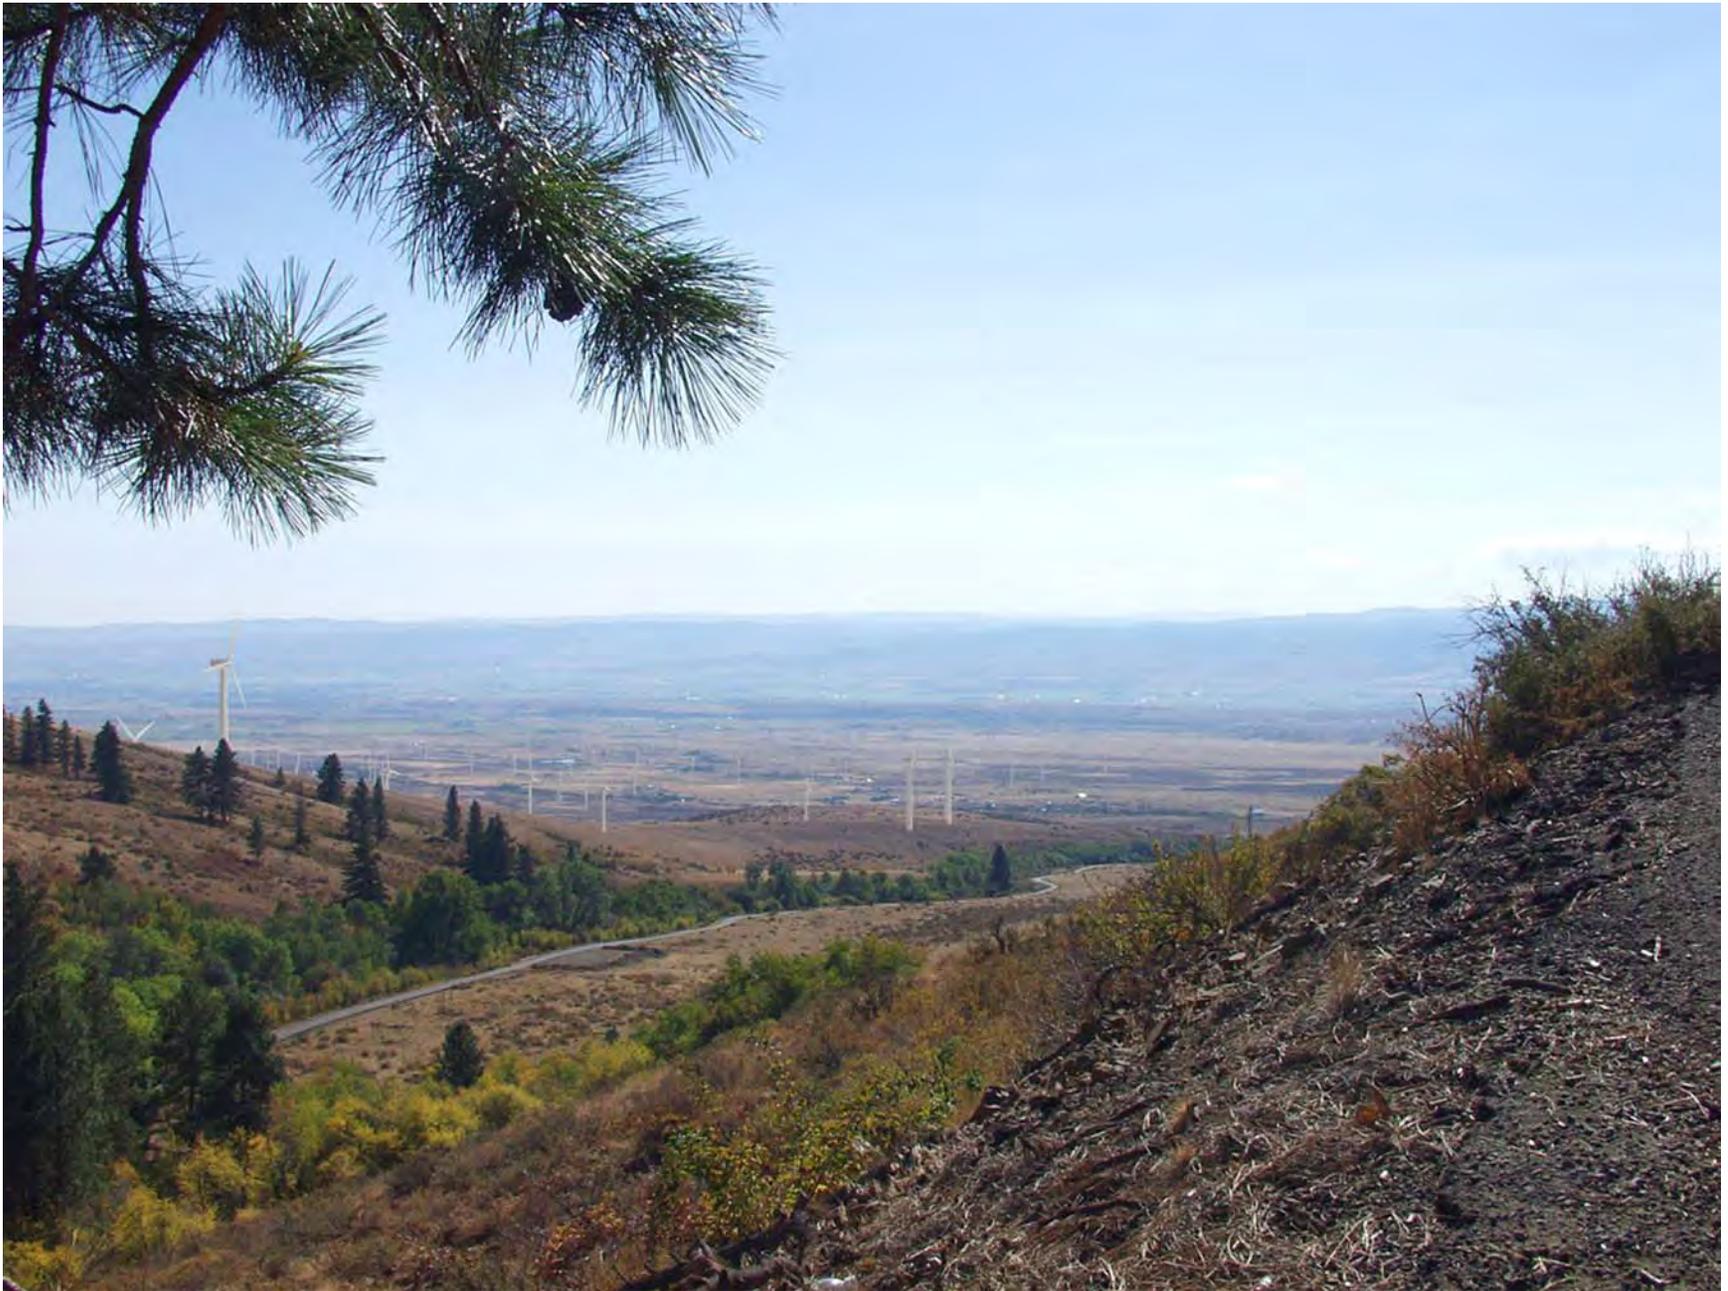
Figure G51
Key View 8A – Simulated view looking south from the Table Mountain Slope Visual Assessment Unit over the Kittitas Basin.

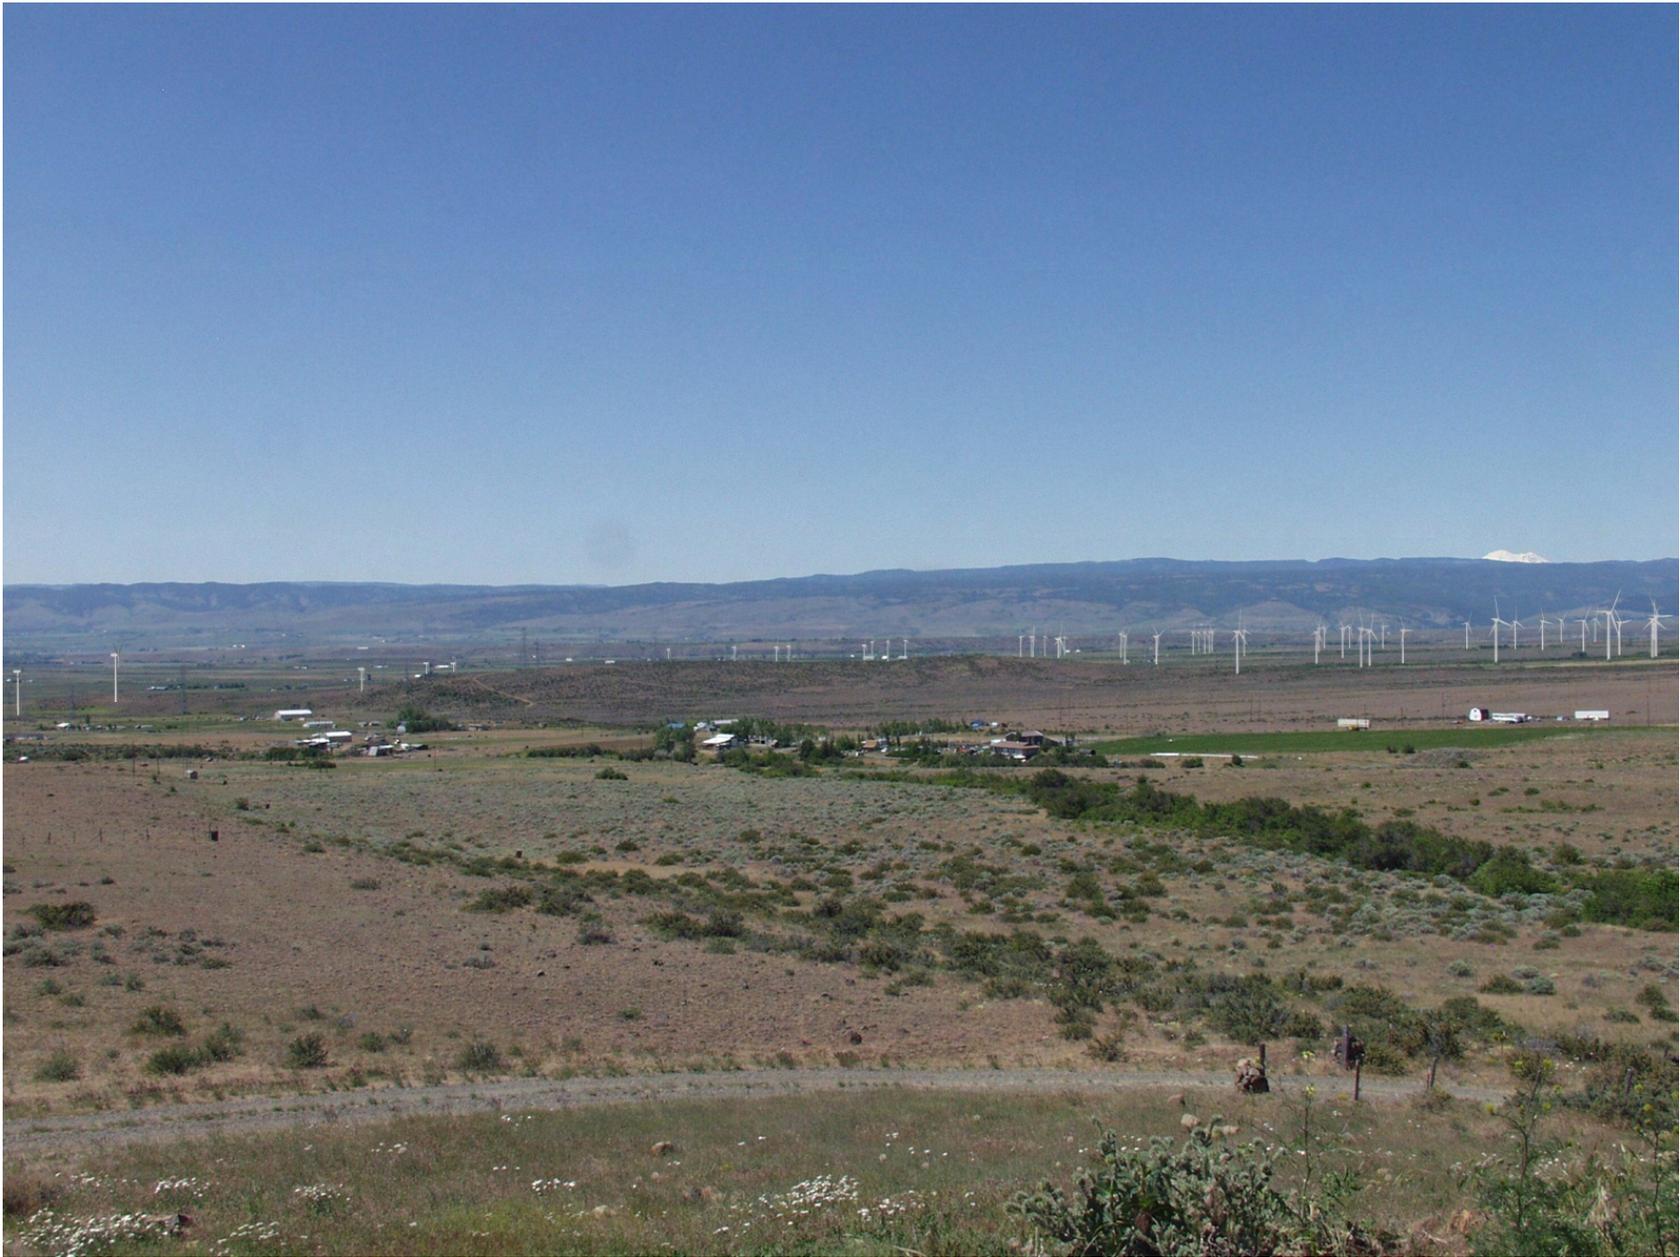
Figure G52
Key View 8B – Simulated View
