## APPENDIX F

May 18, 2000 Photographs by Bexar Environmental Consulting

## Memorandum

**To:** File  
**From:** John Wong  
**CC:** K. McGaffey, T. Pors, B. Clothier, K. Chaney, B. Thompson  
**Date:** June 16, 2000  
**Re:** May 18, 2000 Photo Record

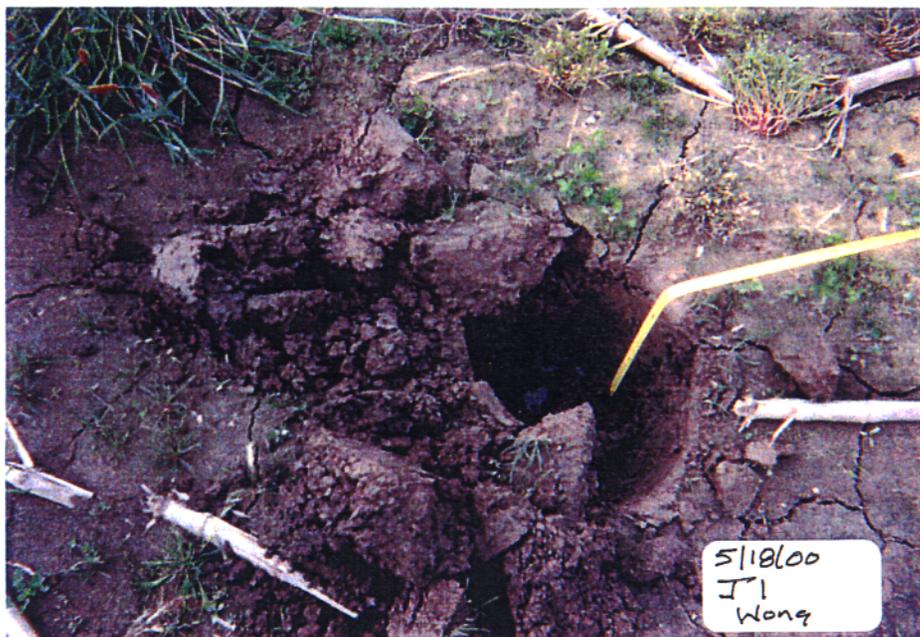
*J1 – Photograph at J1; Water at -9.0"/seepage at -8.5"; wetland and nonwetland plants (Creeping foxtail and Western pearlywort).*

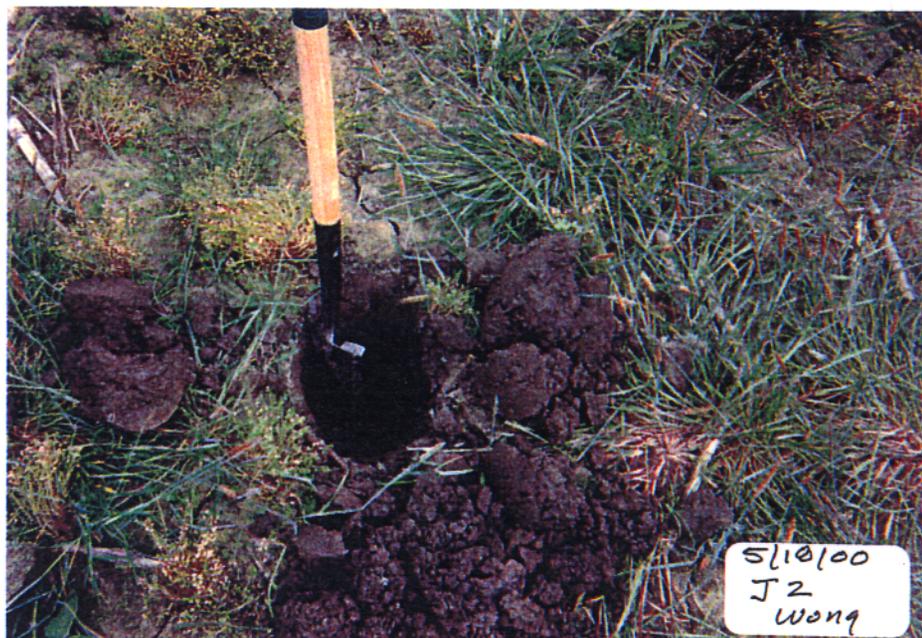
*J2 – Photograph at J2; no water or saturation to bottom of hole (-15"); wetland and nonwetland plants (Creeping foxtail and Western pearlywort). Other nonwetland or facultative plants are shepards purse, clover, carrot family.*

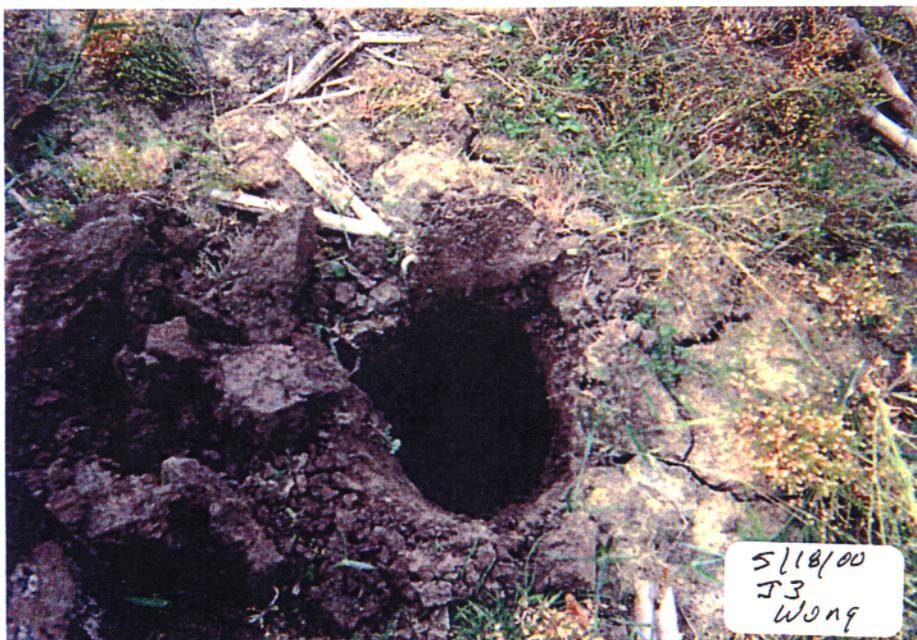
*J3 – Photograph at J3; seepage at -12.0"; wetland and nonwetland plants (Creeping foxtail and Western pearlywort)*

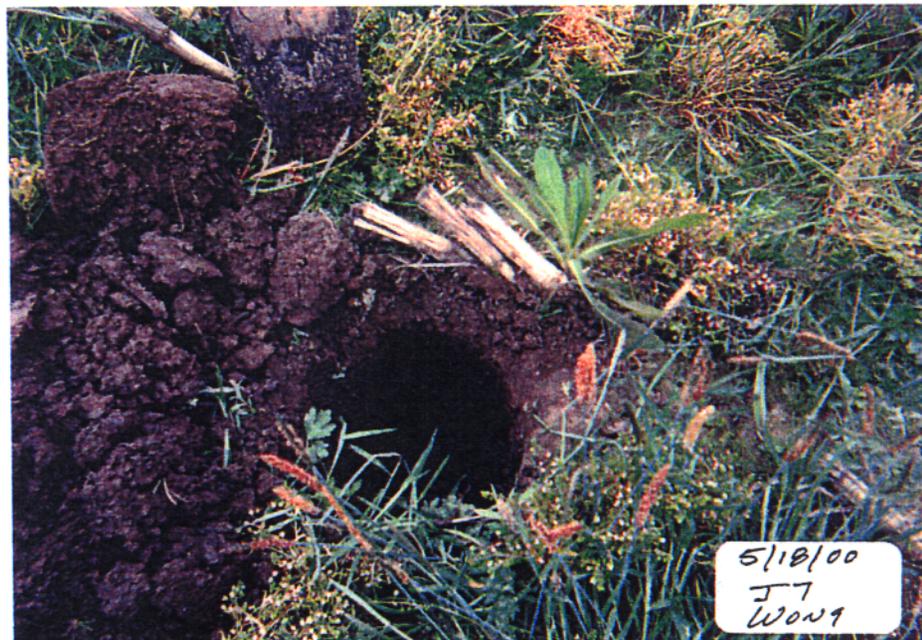
*J7 – Photograph at J7; seepage at -10.0"; saturation at -8.5"; located at edge of David Evans wetland boundary; wetland and nonwetland plants (Creeping foxtail, buttercup, Western pearlywort, thistle)*

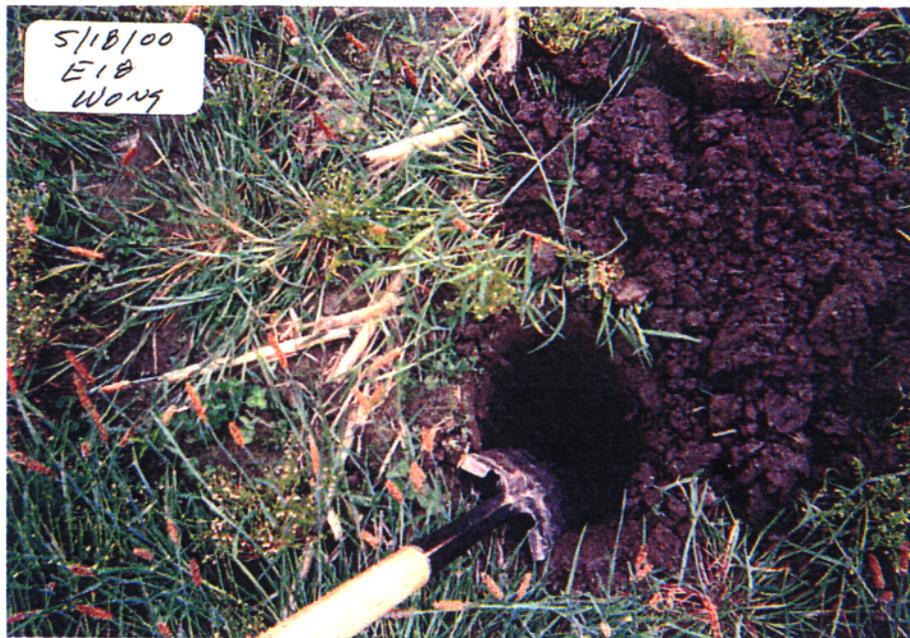
*E18 – Photograph at E18; seepage at -12.0"; wetland and nonwetland plants (Creeping foxtail and Western pearlywort)*

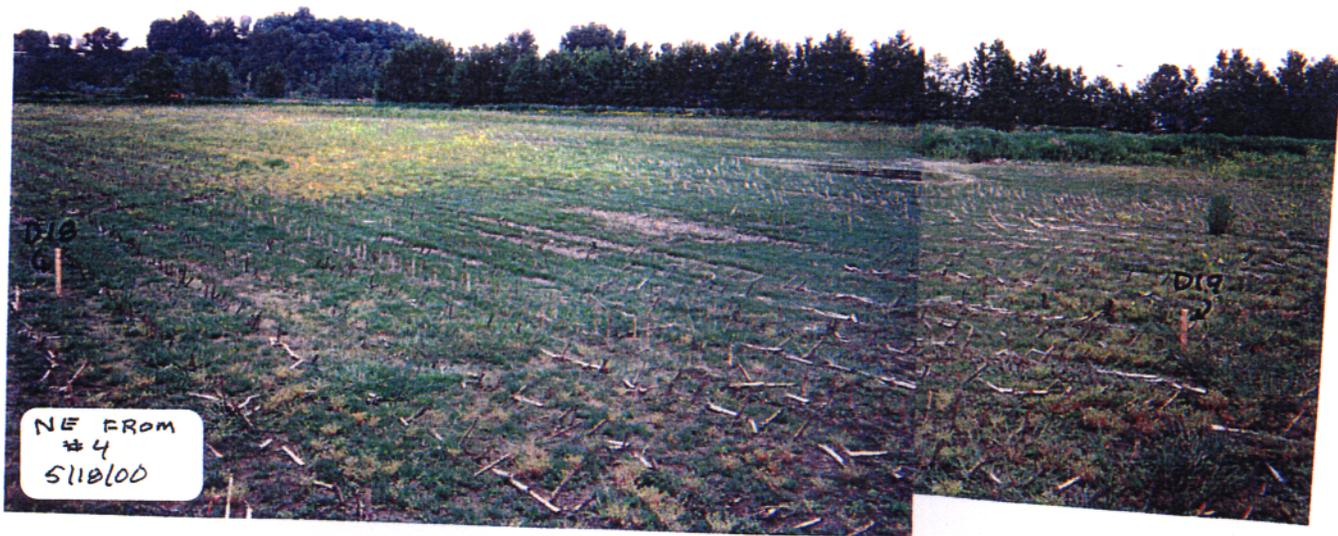
*Panorama – Photograph taken from sample #4, looking northeast into David Evans wetland; yellow tinge is a Brassica sp., likely field mustard or rape, a nonwetland species*
