Badger Mountain Solar Energy Project

ATTACHMENT H: GEOTECHNICAL ENGINEERING REPORTS

Attachment H-1: Stage I Report of Expected Geotechnical Conditions

Terracon Project No. GR205090 April 24, 2020

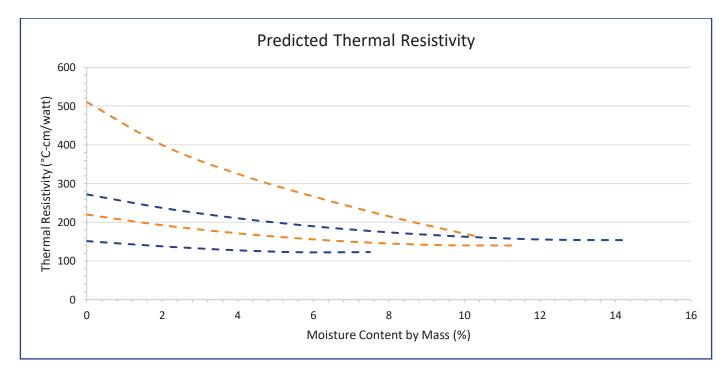
We collected information of the variables within Campbell's empirical equation from the USDA NRCS-NCGC SSURGO database and Geochemical and Mineralogical Data for Soils of the Conterminous United States – Data Series 801 published by the U.S. Department of the Interior and U.S. Geologic Survey. Site-specific USDA data was utilized, while data from Data Series 801 was utilized from the reports closest test sites that have the same or similar USDA soil units. To reflect the approximate depth burial depth of the power transmission cables we have utilized depth weighted values in our computation of thermal conductivity utilizing Campbell's empirical method. To compute the predicted range of thermal resistivity values expressed in the graph below, we have utilized a range of bulk densities (90 to 100 pounds per cubic foot) from the USDA data and the range of volumetric quartz content (0.03 to 0.13) from the Data Series 801.

The data expressed in ORANGE above is utilized to predict silty loam soils onsite, while the BLUE data is utilized to predict onsite sandy loam soils. Overall, due to anticipated low moisture contents and low specific gravities of the onsite loess soils we anticipate thermal resistivity values to be moderate to high with dry thermal resistivities values of greater than 300°C-cm/watt.

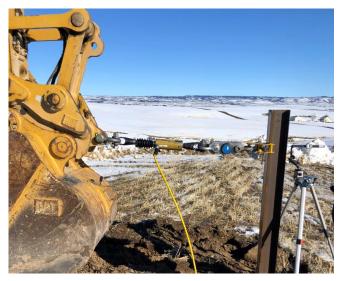
Figure 4-2: Lateral Testing Example

In general accordance with ASTM D3966, lateral tests were performed following axial testing. Lateral tests used a hydraulic tension jack, calibrated in-line load cell, and a reaction counterweight. The test apparatus was constructed so that the resultant load was applied horizontally on the pile's strong axis, near the target load application height of approximately 4.5 feet above grade, after the frost was removed. The resultant loads were applied in line with the central vertical axis of the pile. The support reactions were constructed to prevent instability and to limit undesired rotations or lateral displacements. The distance between the test pile and reaction point was at least five times the maximum diameter of the test pile. All apparatuses used for applying and measuring loads, including all struts and structural members, were of sufficient size, strength, and stiffness to safely prevent excessive deflection and instability up to 125% of the maximum applied test load.

The displacement reference frame was supported independent of the loading system, with supports firmly planted on the ground at a clear distance from the test pile. The reference frames were oriented perpendicular to the line of load application, placing the beam supports as far as feasible from the test pile and reaction force system. The reference beams were constructed to allow displacement measurements to be taken near ground level and near the load application height. Figure 4-2 displays an example lateral test configuration.

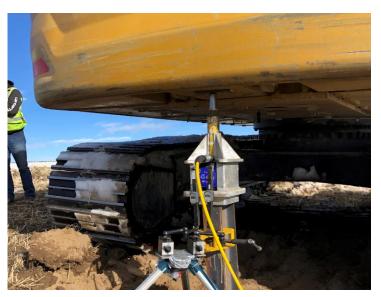
Figure 4-3: Axial Compressive Testing Example

In accordance with ASTM D1143, the compressive loading and measurement apparatus were constructed and positioned so that the resultant loads were applied vertically and in line with the central vertical axis of the pile so as to minimize eccentric loading and avoid a horizontal load component. A clear distance was provided between the test pile and the reaction points. The distance between the test pile and reaction point was at least five times the maximum diameter of the pile. All apparatuses used for applying and measuring loads, including all struts and structural members, were of sufficient size, strength, and stiffness to

safely prevent excessive deflection and instability up to 125% of the maximum anticipated test load. The displacement reference frame was set up independent of the loading system, with supports firmly planted on the ground as far as feasible away from the test pile. Displacement indictors rested on a platform fixed to the test pile. Figure 4-3 displays an example axial compressive test configuration.

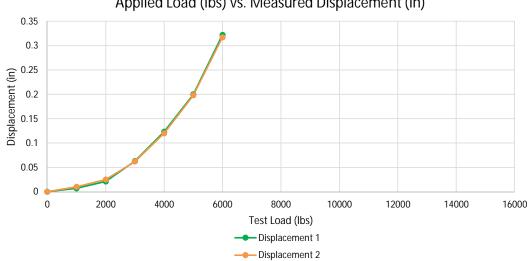
Applied Load (lbs) vs. Measured Displacement (in)

Disp @ 0) min (in)	Disp @ 1 min (in)	
Test Load (lbs)	Disp #1	Disp #2	Disp #1	Disp #2
0	0	0	0	0
1000	0.007	0.01	0.007	0.01
2000	0.02	0.021	0.021	0.025
3000	0.062	0.062	0.063	0.062
4000	0.121	0.119	0.123	0.12
5000	0.191	0.189	0.2	0.198
6000	0.309	0.31	0.322	0.317
7000				
8000				
9000				
10000				
11000				
12000				
13000				
14000				
15000

Project:	Badger Mountain	Pile ID:	PLT-AP18-8T
Test Date:	2/8/2021	Pile GPS Location:	47.43366 , -120.16502
Testing Phase:	Design	Pile Install Date:	2/4/2021
Test Weather:	Cloudy	Pile Drive Time:	23.0 seconds
Technician:	Shelby Kellogg	Pile Type:	W6x9
Load ID:	10555	Pile Length:	13.0 feet
Disp #1 ID:	17B0326	Pile Stick-up:	5.0 feet
Disp #2 ID:	WW-DISP-4E-1	Pile Embedment:	8.0 feet
CD* Load:	10,800	Load Height:	5.0 feet
Notes:	5 in frost removed	Load Test Type:	Tensile

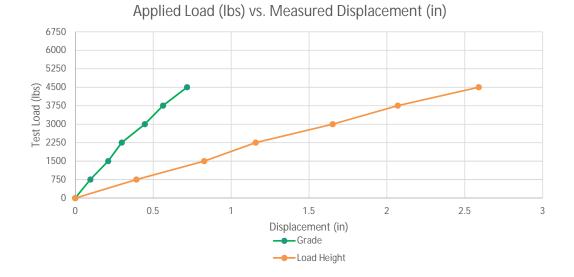
Disp @ (Disp @ 0 min (in)		1 min (in)
Test Load (lbs)	Grade	Load Height	Grade	Load Height
0	0	0	-	-
750	0.096	0.385	0.097	0.392
1500	0.199	0.787	0.199	0.787
0	0.01	0.018	-	-
1500	0.211	0.819	0.211	0.827
2250	0.292	1.154	0.298	1.158
3000	0.437	1.636	0.438	1.648
0	0.03	0.061	-	-
3000	0.442	1.642	0.446	1.652
3750	0.562	2.053	0.563	2.07
4500	0.689	2.554	0.717	2.59
5250	1.013	3.741		
6000				
0			-	-

Project:	Badger Mountain	Pile ID:	PLT-AP8-6L
Test Date:	2/6/2021	Pile GPS Location:	47.45512 , -120.19140
Testing Phase:	Design	Pile Install Date:	2/3/2021
Test Weather:	Clear	Pile Drive Time:	19.3 seconds
Technician:	Ben Pierce	Pile Type:	W6x9
Load ID:	10555	Pile Length:	11.0 feet
Disp #1 ID:	17B0326	Pile Stick-up:	5.0 feet
Disp #2 ID:	WW-DISP-4E-1	Pile Embedment:	6.0 <i>feet</i>
Failure Load*:	4,700	Load Height:	5.0 feet
Notes:	4 in displacement at 4700, 5 in frost removed	Load Test Type:	Lateral

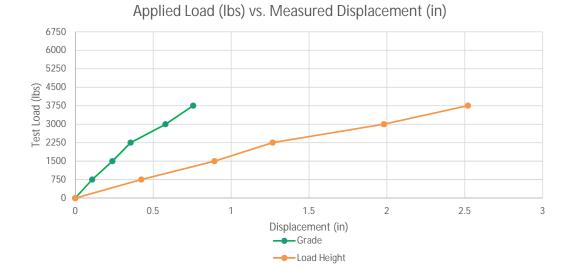
Project:	Badger Mountain	Pile ID:	PLT-B12-6 (R5.42)
Test Date:	2/6/2021	Pile GPS Location:	47.45457 , -120.18722
Testing Phase:	Design	Pile Install Date:	2/3/2021
Test Weather:	Clear	Pile Drive Time:	128.0 seconds
Technician:	Ben Pierce	Pile Type:	W6x9
Load ID:	10555	Pile Length:	11.0 feet
Disp #1 ID:	17B0326	Pile Stick-up:	5.6 feet
Disp #2 ID:	WW-DISP-4E-1	Pile Embedment:	5.4 feet
Failure Load*:	4,300	Load Height:	5.0 feet
Notes:	4 in displacement at 4300, 4 in frost removed	Load Test Type:	Lateral

Disp @ () min (in)	Disp @ 1 min (in)	
Test Load (lbs)	Grade	Load Height	Grade	Load Height
0	0	0	-	-
750	0.107	0.425	0.108	0.424
1500	0.21	0.7995	0.211	0.799
0	0.018	0.046	-	-
1500	0.238	0.902	0.238	0.893
2250	0.35	1.273	0.355	1.267
3000	0.509	1.791	0.525	1.846
0	0.047	0.126	-	-
3000	0.581	2.012	0.579	1.981
3750	0.735	2.418	0.756	2.52
4500				
5250				
6000				
0			-	-

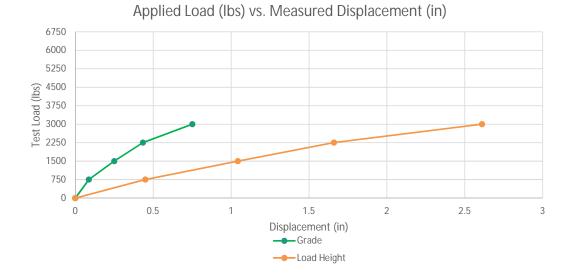
Project:	Badger Mountain	Pile ID:	PLT-B16-6 (R5.42)
Test Date:	2/6/2021	Pile GPS Location:	47.45132 , -120.19205
Testing Phase:	Design	Pile Install Date:	2/3/2021
Test Weather:	Clear	Pile Drive Time:	91.2 seconds
Technician:	Ben Pierce	Pile Type:	W6x9
Load ID:	10555	Pile Length:	11.0 feet
Disp #1 ID:	17B0326	Pile Stick-up:	5.6 feet
Disp #2 ID:	WW-DISP-4E-1	Pile Embedment:	5.4 feet
Failure Load*:	3,650	Load Height:	5.0 feet
Notes:	4 in displacement at 3650, 5 in frost removed	Load Test Type:	Lateral

Disp @ (Disp @ 0 min (in)		Disp @ 1 min (in)	
Test Load (lbs)	Grade	Load Height	Grade	Load Height	
0	0	0	-	-	
750	0.085	0.424	0.087	0.449	
1500	0.227	0.954	0.238	0.999	
0	0.033	0.182	-	-	
1500	0.25	1.037	0.25	1.043	
2250	0.418	1.602	0.434	1.66	
3000	0.667	2.336	0.69	2.405	
0	0.233	0.673	-	-	
3000	0.744	2.551	0.751	2.61	
3750					
4500					
5250					
6000					
0			-	-
