National Transportation Safety Board

Railroad Accident Brief

CSXT Petroleum Crude Oil Train Derailment and Hazardous Materials Release

Accident No.:	DCA14FR008
Location:	Lynchburg, Virginia
Date:	April 30, 2014
Time:	1:54 p.m. eastern daylight time
Train:	CSXT Train K08227
Railroad:	CSX Transportation (CSXT)
Property Damage:	$1,224,000
Injuries:	0
Fatalities:	0
Type of Accident:	Derailment with hazardous materials and fire

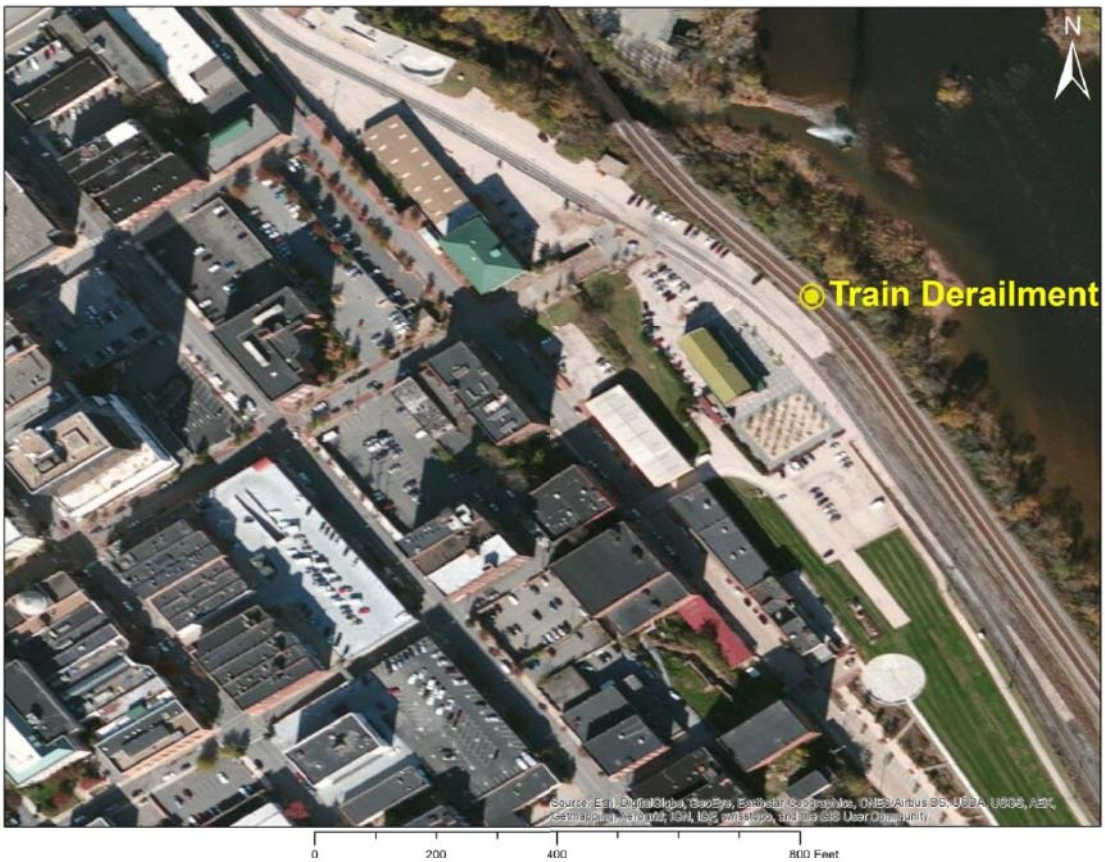
Figure 2. Derailment site in Lynchburg, Virginia.

The derailment resulted in a large fire along the James River. The Lynchburg Fire Department ordered the evacuation of about six blocks along the riverfront and south of the derailment area, affecting about 350 residents and 20 businesses. (See figure 2.)
