**RAILWAY INVESTIGATION REPORT
R13D0054**

RUNAWAY AND MAIN-TRACK DERAILMENT

**MONTREAL, MAINE & ATLANTIC RAILWAY
FREIGHT TRAIN MMA-002
MILE 0.23, SHERBROOKE SUBDIVISION
LAC-MÉGANTIC, QUEBEC
06 JULY 2013**

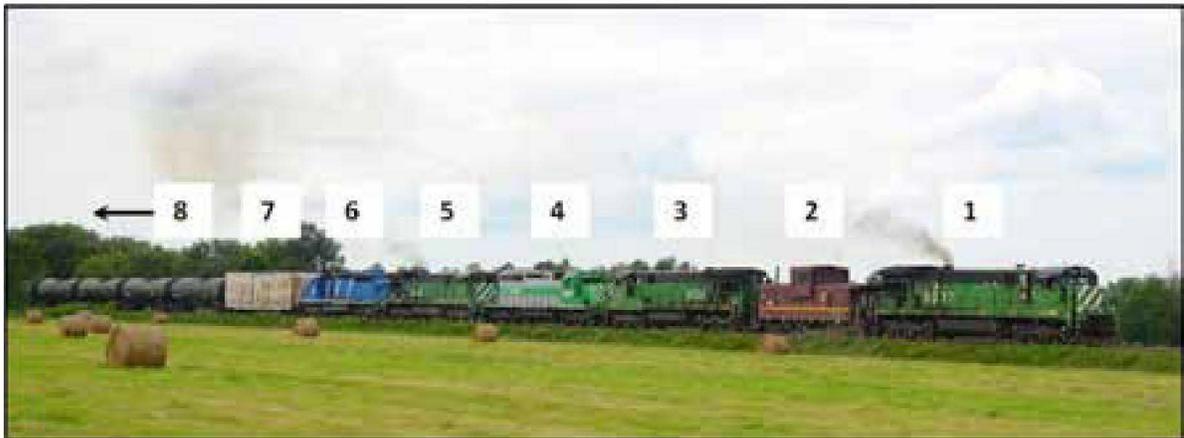
1. lead locomotive MMA 5017, General Electric Company (GE) C30-7;
2. special-purpose caboose (VB car) VB 1;
3. locomotive MMA 5026, GE C30-7;
4. locomotive CITX 3053, General Motors (GM) SD-40;
5. locomotive MMA 5023, GE C30-7;
6. locomotive CEFX 3166, GM SD-40;
7. buffer car CIBX 172032; and
8. 72 tank cars.

Photo 2. MMA-002 at Brookport on 05 July 2013 (photo: Richard Deuso, with TSB annotations)

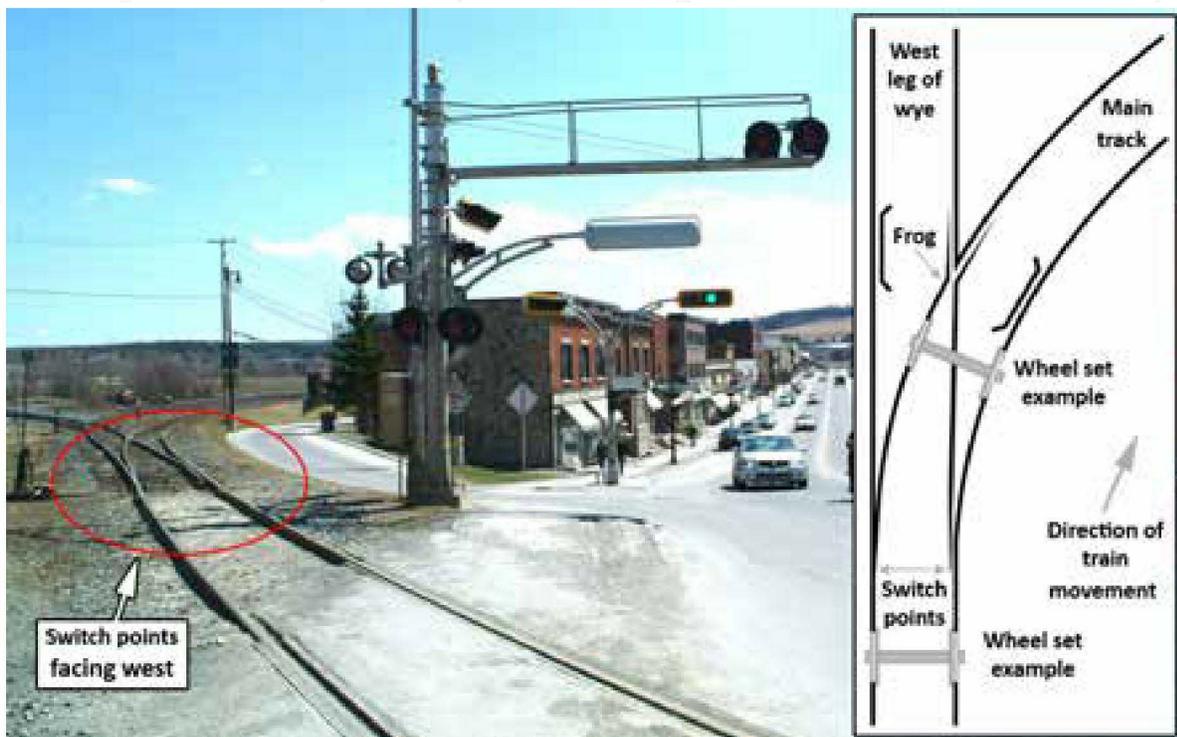
The MMA Megantic Station was located in a commercial district of Lac-Mégantic, where the Sherbrooke and Moosehead Subdivisions met. Frontenac Street, a main thoroughfare, ran through the centre of the town. The main track intersected with Frontenac Street just west of the Megantic West turnout and was maintained for a maximum speed of 15 mph. The turnout was located at Mile 0.23, with the switch points facing west (Photo 4).

Photo 4. Frontenac Street public grade crossing, looking eastward. The circled area denotes the location of the switch points and the frog for the Megantic West turnout (photo: Pierre Blondin, with TSB annotations).

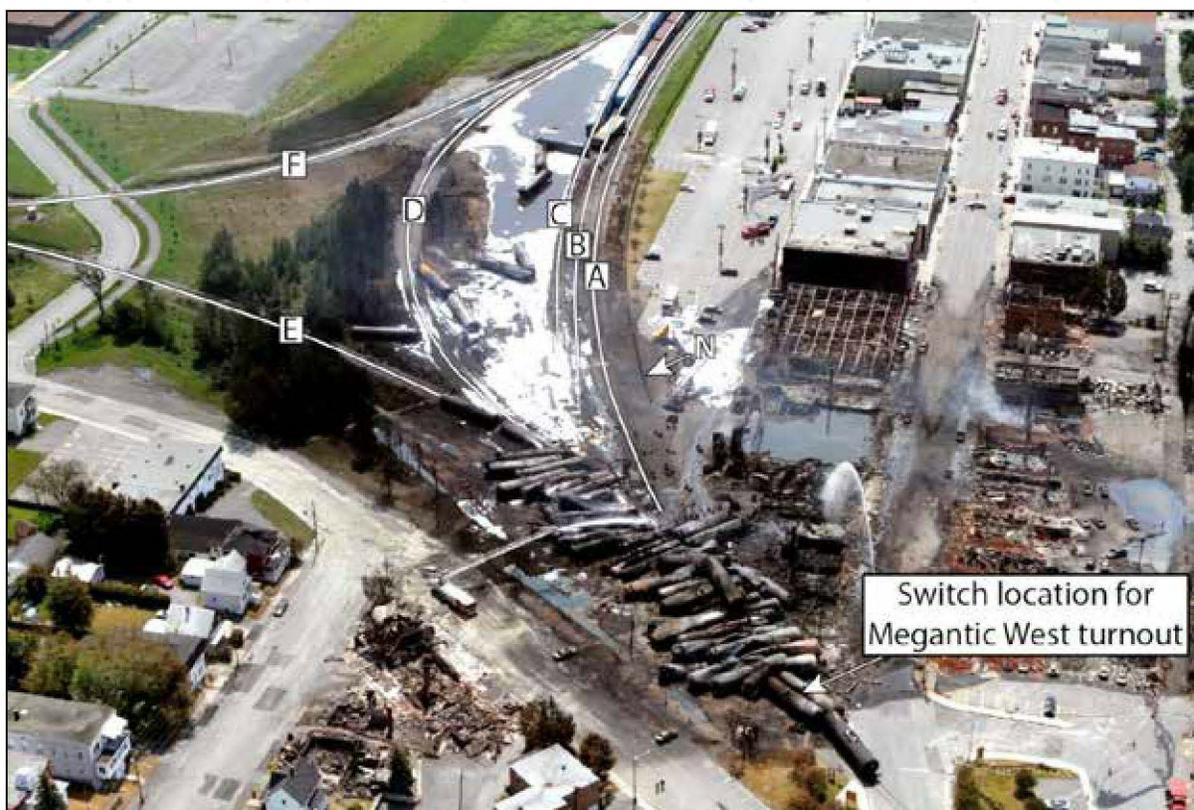
The derailed equipment covered the main track, 3 adjacent yard tracks, and the west leg of the wye, which is a triangular arrangement of tracks that can be used for turning rail equipment (Photo 5).¹¹ At the time of the accident, there were box cars parked in yard tracks 1 and 2.

Photo 5. Eastward view of the location of the tracks in relation to the first derailed cars: main track (A), yard track 1 (B), yard track 2 (C), yard track 3 (D), and the west and east legs of the wye tracks (E and F)

- The damage to the main track started approximately 20 feet east of Frontenac Street.
- The main-track turnout, approximately 400 feet of main track, and an additional 2000 feet of yard and wye tracks, including 3 turnouts, were destroyed.
- Approximately 500 feet from the crossing, the main track was shifted about 4 feet to the north.
- Yard tracks 1 and 2 were demolished from the west-end turnout for about 600 and 500 feet, respectively.
- Rails were curled and twisted, unsettled from tie plates, and moved randomly. Due to the severity of the fire, most track components were badly damaged.
- The Frontenac Street southeast public-crossing cantilever mast and the control box were shattered. Road traffic lights, electrical wires, lighting posts, and other appliances were also damaged.

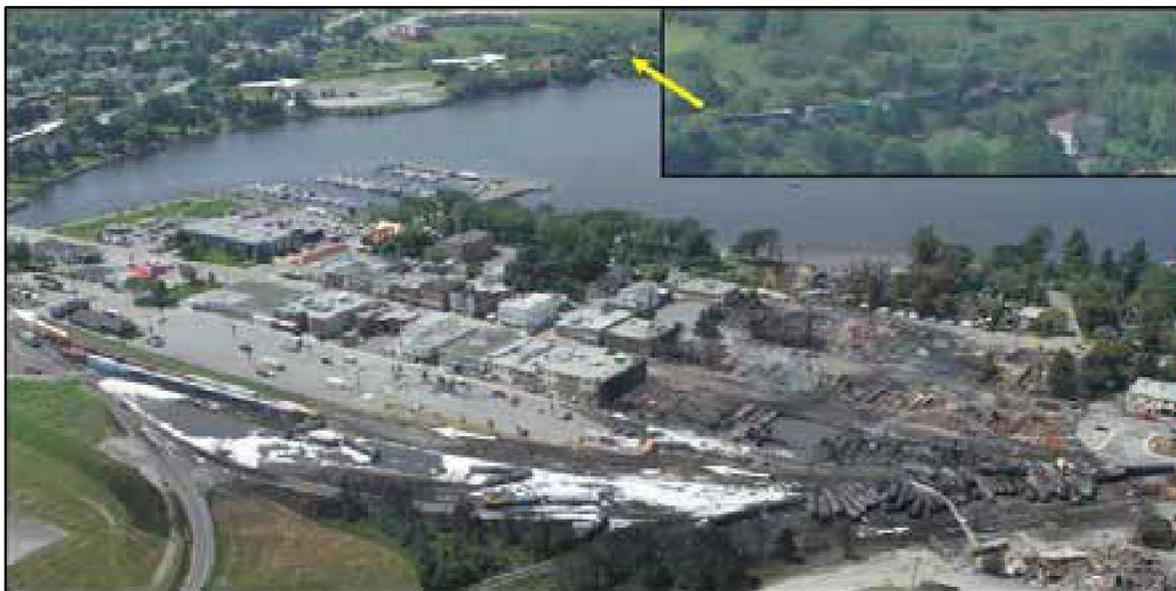
The locomotive consist came to rest approximately 4400 feet east of the Lac-Mégantic derailment site, at Mile 116.41 of the Moosehead Subdivision (Photo 6).

Photo 6. Location of the locomotive consist (Mile 116.41 of the Moosehead Subdivision) in relation to the derailment site. The white arrows denote the route of the locomotive consist, which followed the main track.

- There was no damage to the track between the derailment site and the location of the locomotives.
- There was a black oily residue, similar to the residue observed at Nantes, on the ground adjacent to the lead locomotive (MMA 5017), as well as about 600 feet east of where the locomotives came to rest.

- Hand brakes were applied on all 5 locomotives and the VB car.
- There was severe wear on some of the brake shoes and various degrees of blueing¹² on most of the wheels.

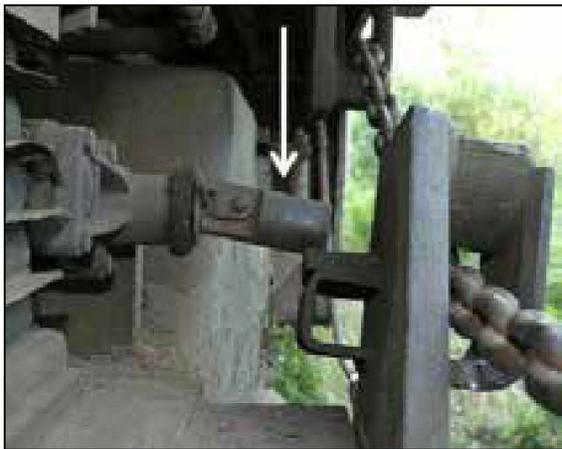
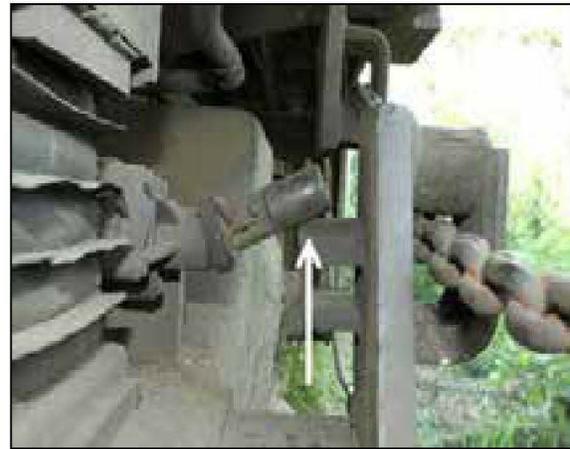
Photo 10. QRB valve used to exhaust brake cylinder air during hand brake application

Photo 11. As the hand brake is tightened, the upward movement is intended to activate the release mechanism on the QRB valve.

The QRB valve on the second locomotive (MMA 5026) did not trip to exhaust brake cylinder air when tested. An examination of the valve showed wear and damage to the QRB valve's lifter and inside surface of the retaining disc. In addition, the examination showed that non-standard repairs had been applied to the valve's release mechanism in an attempt to keep the valve working.

If the QRB valve does not trip, the hand brakes will not provide any braking effort. To ensure that the hand brakes remain operational on these locomotives, MMA issued *Summary Operating Bulletin 2-276*, which stated in part:

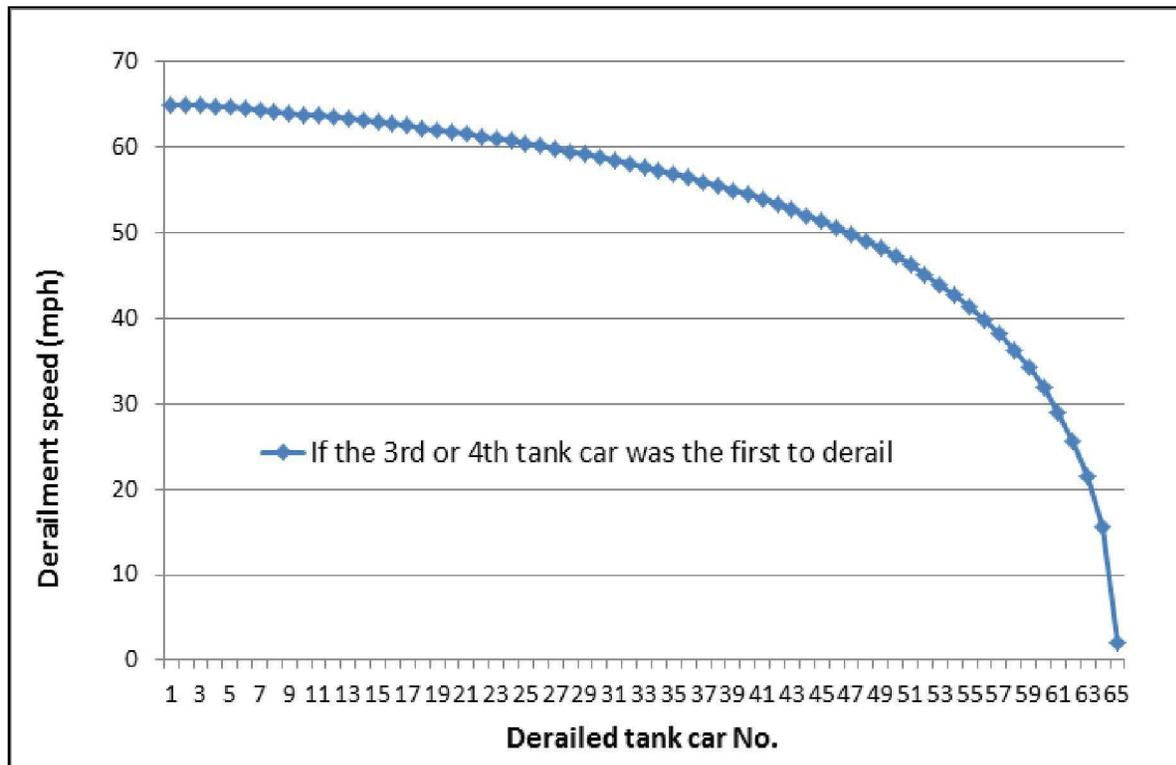
Figure 5. Estimated speed at which each car derailed if the third or fourth car was the first to derail³²

At the time of the derailment, the train was near the Megantic West turnout. The train was analyzed to assess the in-train forces as it transitioned from the downhill grade of 1.26% to the relatively flat terrain of 0.2% at Megantic. A vehicle dynamics simulation of a Class 111 tank car negotiating the curve at Megantic Station was also conducted (see Engineering Laboratory Report LP188/2013 for complete details). It was determined that a combination of the centrifugal force and the dynamic forces generated by the track geometry conditions at a speed of 65 mph was sufficient to cause the derailment. With extremely high lateral forces on the high rail, gauge widening could occur. Furthermore, with complete unloading on the low rail, wheel lift could occur. Either of these conditions or a combination could cause track damage and a derailment.

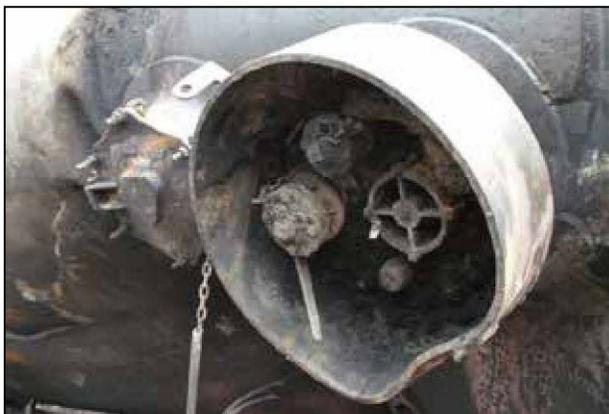
The top fittings of 32 of the 63 tank cars were housed in a $\frac{3}{4}$ -inch-thick steel circular protective housing designed to provide top discontinuity protection in accordance with applicable AAR requirements⁴⁰ (Photo 21).

Photo 21. Protective housing providing top discontinuity protection for tank car fittings (removed cover)

- The top fittings were breached on 4 of the 27 cars (15%) that were equipped with top discontinuity protection housings and that sustained impact damage.
- The top fittings were breached on 16 of the 26 cars (62%) that were equipped with a hinged housing and that sustained impact damage.

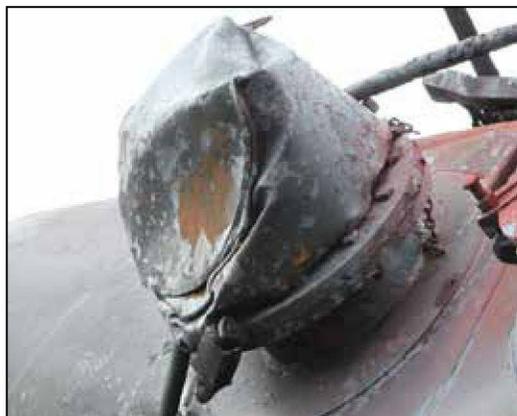
The top fittings of the remaining 31 tank cars were located in a hinged housing that did not have to meet any of the top discontinuity protection requirements (Photo 22).

Photo 22. Hinged housing for tank car fittings

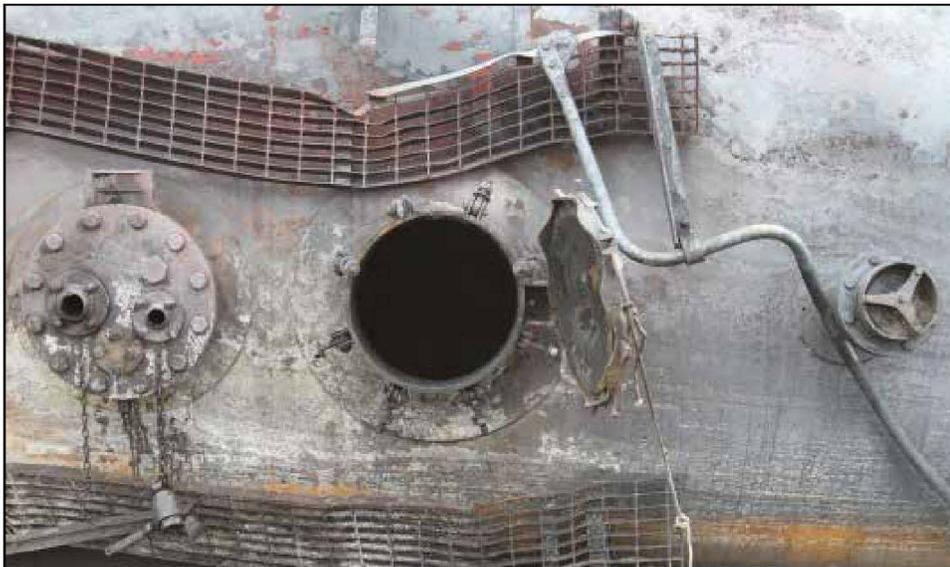
- The manway gaskets on most of the derailed tank cars were damaged by extended exposure to the post-derailment fire.
- The manway cover of 2 cars had separated as a result of impact damage.
- The manway cover hinges, bolts, or lugs of 22 tank cars exhibited impact damage that may have compromised their seals.

Photo 23. Manway cover and opening

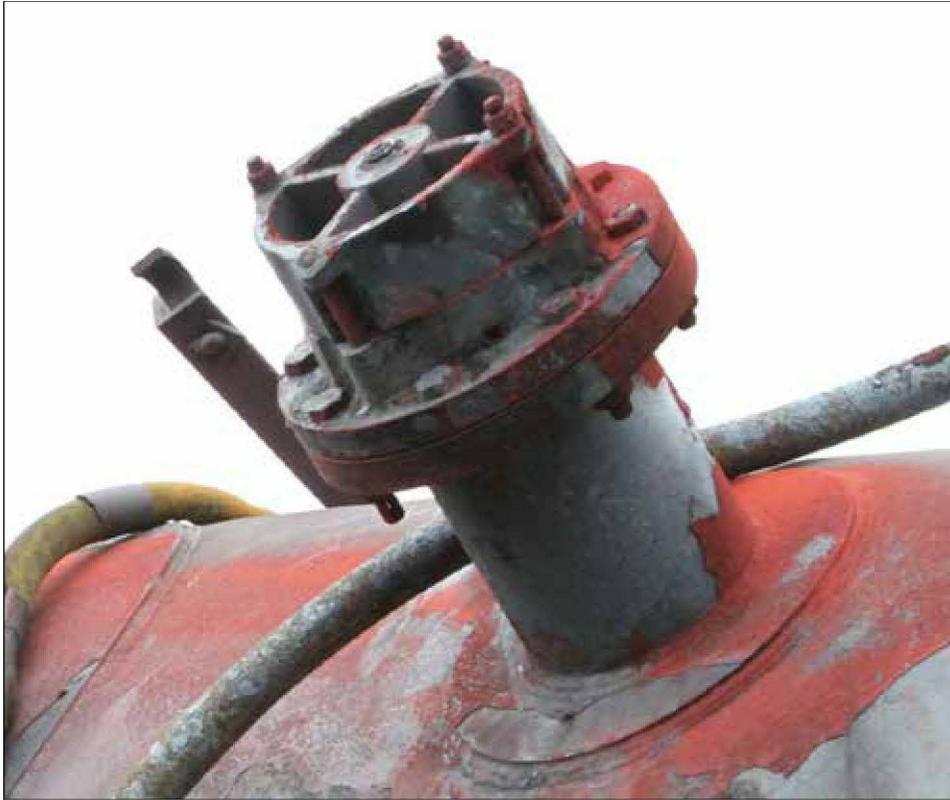
- Most of the cars with damaged PRDs came to rest on their sides or upside down, putting the PRD in contact with the liquid space inside the tank; product flowed from the damaged PRD and fed the pool fire.
- On 32 cars, the PRD was fastened to the top unloading nozzle assembly within the top discontinuity protection housing. The PRD of 3 of these 32 cars, or 9%, were breached.
- On the 31 other cars, the PRD was fastened to a safety valve nozzle attached to the top of the tank (Photo 24). The PRDs of 9 of these, or 29%, were breached.

Photo 24. Pressure relief device

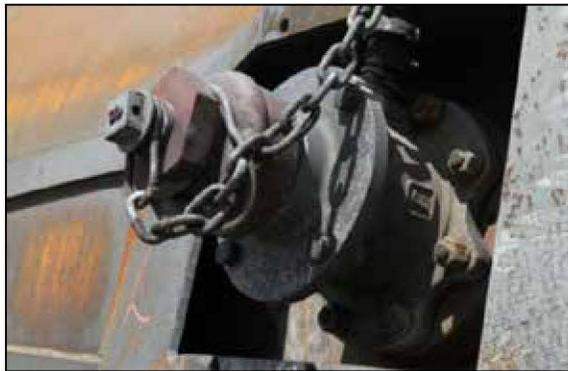
- There were 36 tank cars with sheared-off BOV nozzles (Photo 26).
- Seven of these tank cars had damaged or missing BOV handles, resulting in the ball valve being open or partially open, which led to a release of product.
- Six tank cars were equipped with internal plug-type BOVs. None of these BOVs were breached.
- The BOV handle assemblies of 43 tank cars were deformed, impact-damaged, or missing.

Photo 25. Bottom outlet valve

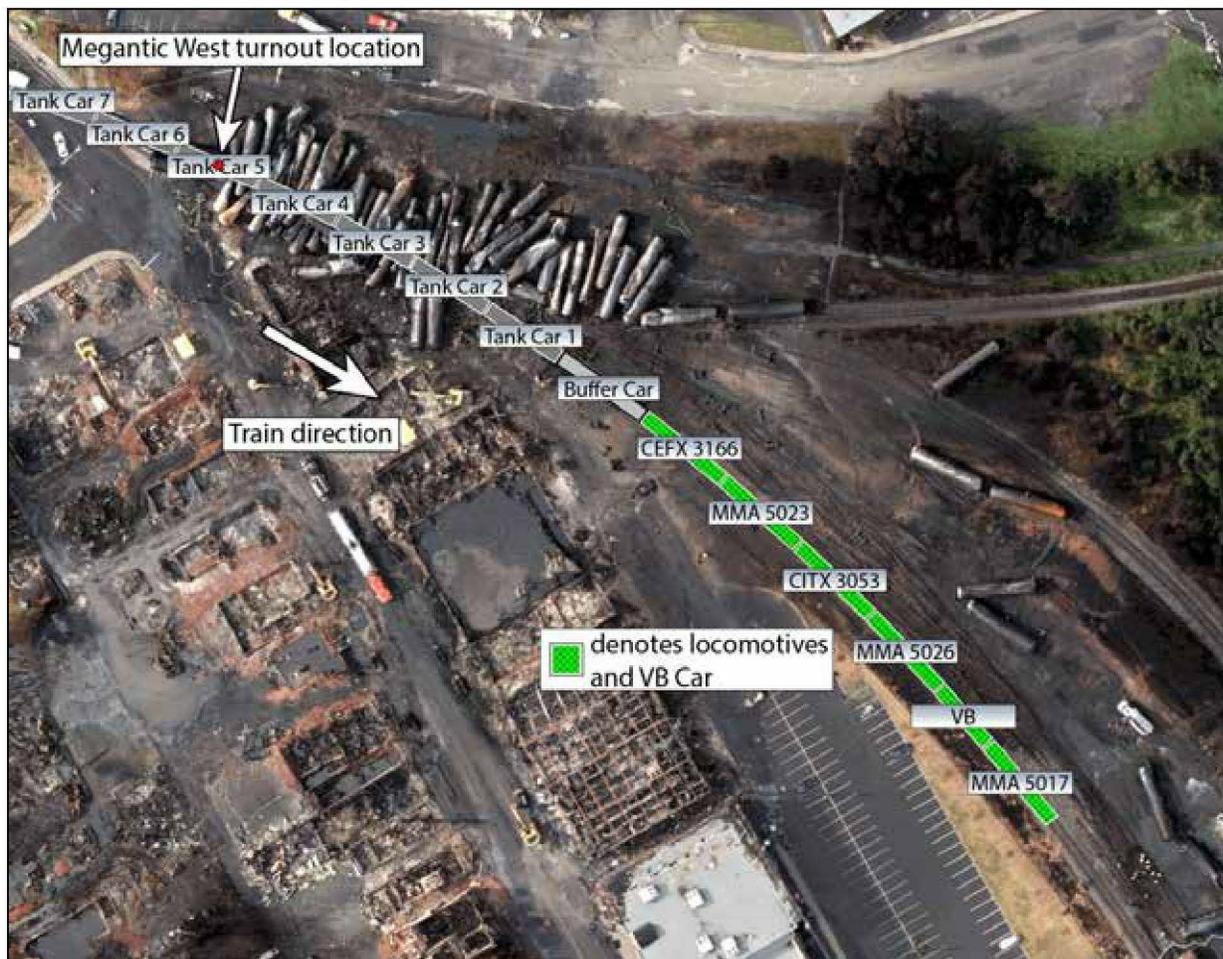
The general trajectory of the derailed equipment also confirmed that the point of derailment (POD) was at or near the Megantic West turnout. To determine which cars were most likely the first to derail, the TSB analyzed LER information to establish the locations of the cars when the brake pipe pressure dropped to zero, as this indicated the moment of separation caused by the derailed equipment. Results show that tank cars 4 through 6 were closest to the POD at that time (Photo 29).

Photo 29. Location of the train when the brake pipe pressure dropped to 0 psi (sources: AeroPhoto and locomotive event recorder data)

An examination of the damage and of the final resting locations of the first derailed cars, starting from the front of the train, allowed the investigation to conclude that the derailment most likely occurred ahead of the sixth tank car.
