*VANCOUVER ENERGY DISTRIBUTION
TERMINAL*

WRITTEN EXPERT TESTIMONY OF
MICHAEL S. HILDEBRAND

**TESTIMONY
ON THE CAPABILITY OF THE CITY OF SPOKANE,
WASHINGTON TO RESPOND TO A HIGH HAZARD
FLAMMABLE TRAIN DERAILMENT INVOLVING
BAKKEN CRUDE OIL.**

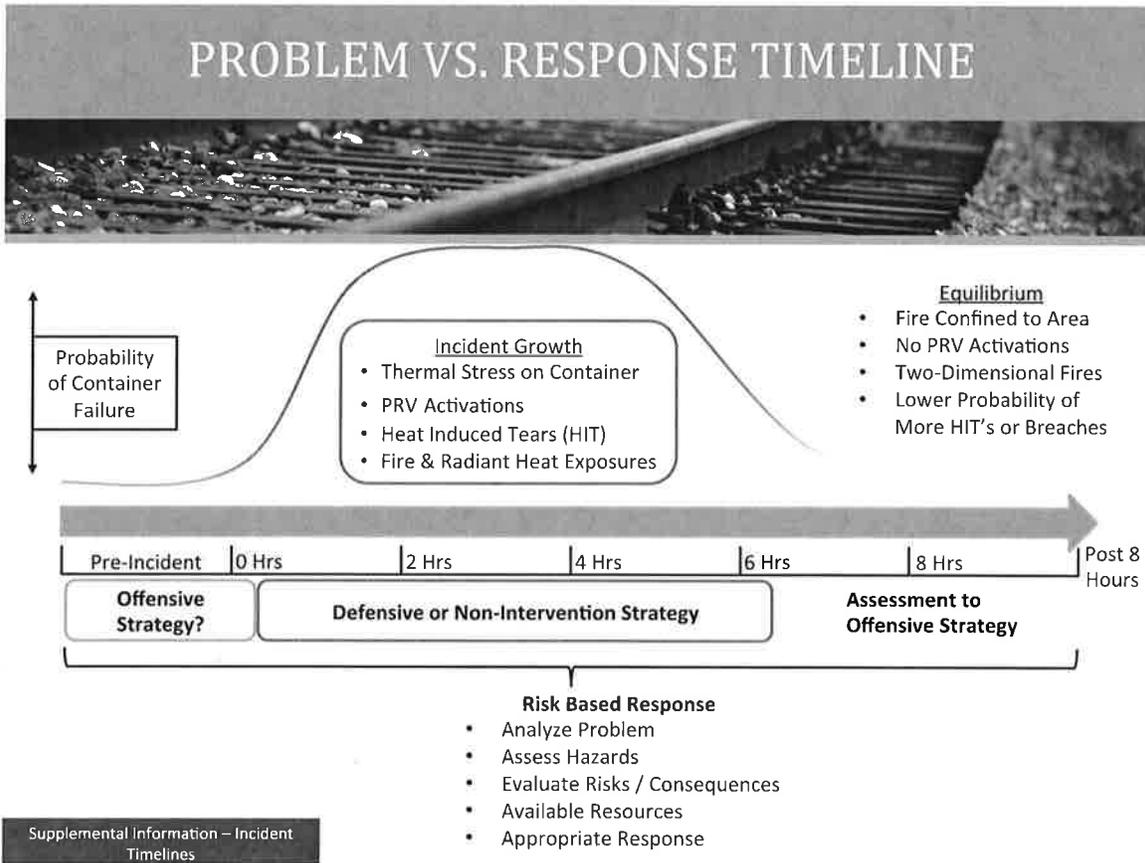
Phase-1: The initial derailment and fire. (1 hour into the incident). If derailed tank cars are initially breached through mechanical or valve failure and an ignition occurs, the breached cars burn and the fire will impinge adjacent exposures. These exposures may include unbreached tank cars which can result in additional tank car failures and an increase in the size of the fire. In this phase of the incident there may be a window of opportunity for the fire department to intervene and use an offensive strategy to attempt to attack and extinguish the fire. An adequate supply of water and foam concentrate must be available to execute an offensive strategy. Based on actual HHFT derailment experience, to date, no HHFT fires have been controlled or extinguished by a fire department using offensive strategy in the early Phase-1 of the incident.

Phase-2: Incident Growth. (2 to 8 hours into the incident). In this phase of the incident, the fire grows larger and becomes very hot and intense. Incident growth will generally follow a process of: (a) thermal stress from the initial fire upon the tank cars; (b) activation of tank car pressure relief devices; (c) continued thermal stress on adjoining tank cars from a combination of both pool fires and pressure-fed fires from activated Pressure Relief Devices; (d) increasing probability of container failures through heat induced tears; and (e) subsequent fire and radiant heat exposures on surrounding exposures when explosive release events occur. In this middle phase of the incident, the fires are extremely hot and three-dimensional making them difficult and unsafe to approach. Running or unconfined spill fires and releases may occur. Spills may flow into storm drains and other underground structures creating secondary spills and fires. In addition, the use of large water streams for cooling may also spread the fire to unintentional areas. The window of opportunity for extinguishment closes and the fire department has to switch to either a defensive or non-intervention strategy. The curve on the graphic shown on page-7 represents the probability of additional container failures, which leads to a cascading and growth response scenario.

Phase-3: Equilibrium. (8 to 12+ hours.) Fires will continue to burn off the available flammable liquid fuel until such time that it achieves a level of “equilibrium” and is no longer growing in size or scope. An analysis of historical incidents shows that equilibrium at a major incident may not occur for approximately 8-12 hours. There is a lower probability of additional heat induced tears or tank car breaches once equilibrium is achieved.

“Equilibrium” benchmarks would include the fire being confined to a specific area and no longer increasing in size or scope, no Pressure Relief Device activations, the fire dynamic being two-dimensional.
