DEADLY CROSSING

NEGLECTED BRIDGES & EXPLODING OIL TRAINS

A report by Waterkeeper Alliance,
Riverkeeper & ForestEthics
November 2015

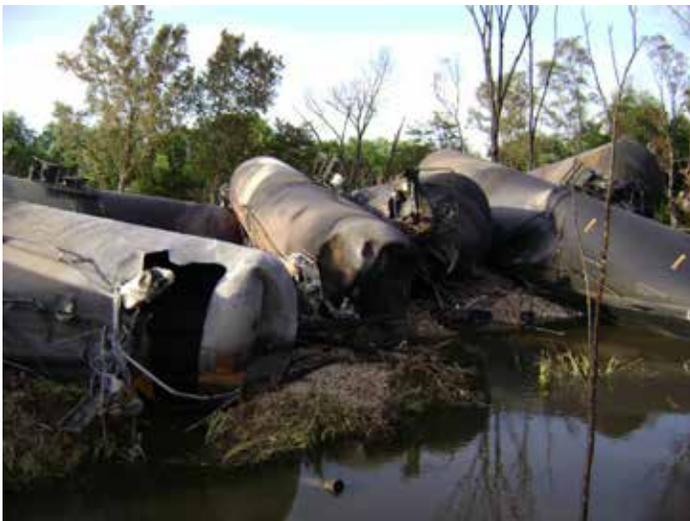
The May 2015 train derailment in Cherry Valley, IL, spilled about 324,000 gallons of ethanol, about 75 percent of the product carried in the 15 DOT-111 tank cars, from shell breaches, damaged top fittings, or damaged bottom outlet valves. Photo: NTSB

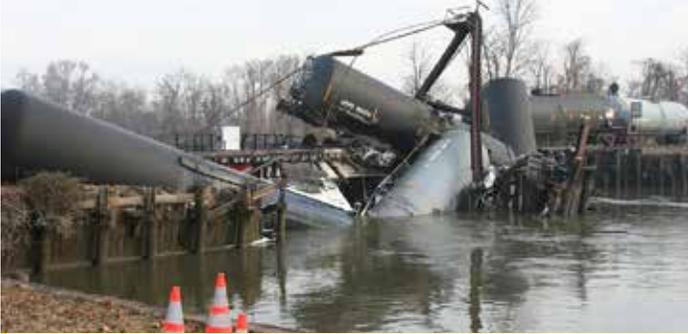
In November 2012 a bridge near Paulsboro, NJ, collapsed sending four DOT-111 tank cars of vinyl chloride into Mantua Creek. Photo: NOAA

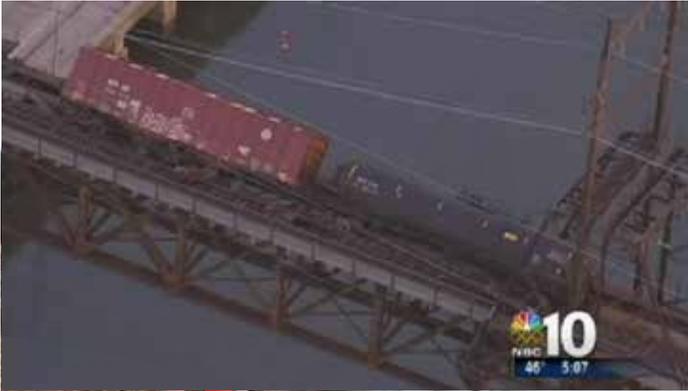
A catastrophe was narrowly avoided in Philadelphia when six tank cars derailed on a rail bridge in January 2014

- In January 2014, seven train cars (six of them containing crude oil) derailed and dangled from a bridge over the Schuylkill River in Philadelphia. Faulty bridge maintenance was identified as the probable cause.⁹⁹
- A 2012 railroad bridge collapse and subsequent release of hazardous materials in Paulsboro, NJ was blamed by the NTSB on the lack of a comprehensive safety management program. “Such a program,” according to the safety board, “would have identified multiple bridge malfunctions, which had been increasing in frequency, and mitigated the risks associated with the continued operation of the bridge.” Hal Hart, the then-vice chairman of the NTSB, concluded that “[i]nadequate bridge inspection procedures – compounded by the lack of a safety management system – were the problem.”¹⁰⁰

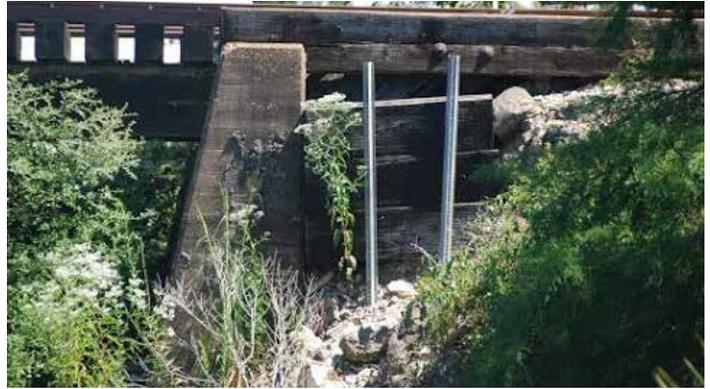
▲ Rail bridges crossing Chickasaw Creek and Bayou Sara in close proximity to residential areas receive a large amount of rail traffic and show signs of deteriorating, including rusting and slumping.

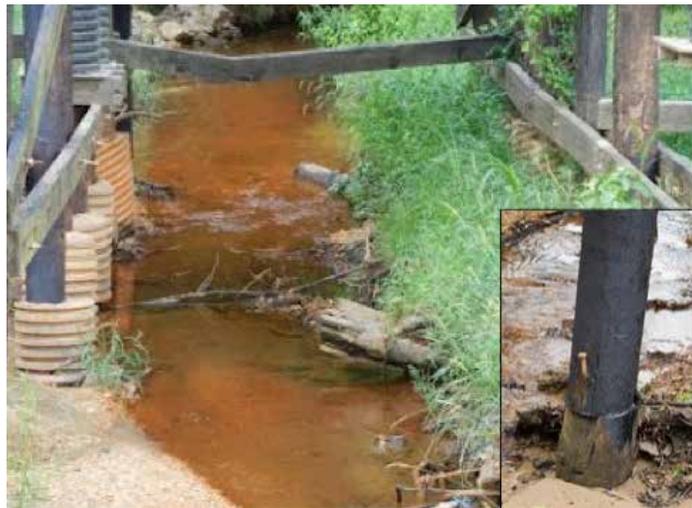
A wooden rail bridge crosses Black Creek and passes by a recreational facility that hosts hundreds of people. This bridge has wooden beams that are cracked, rotten, and detached from the support beams.

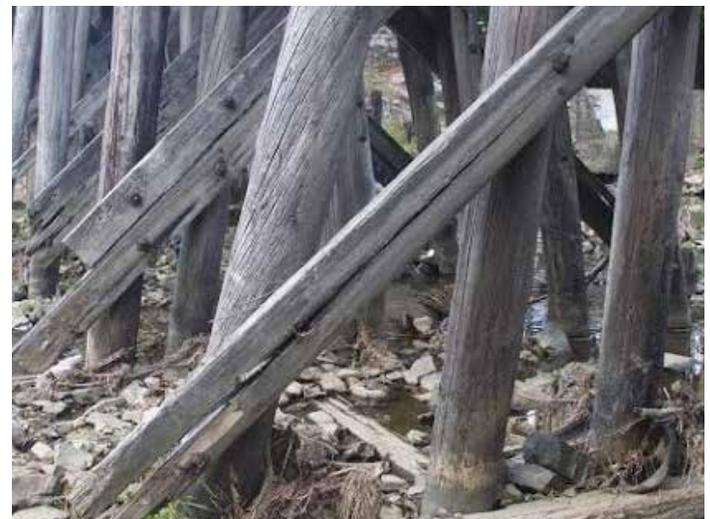
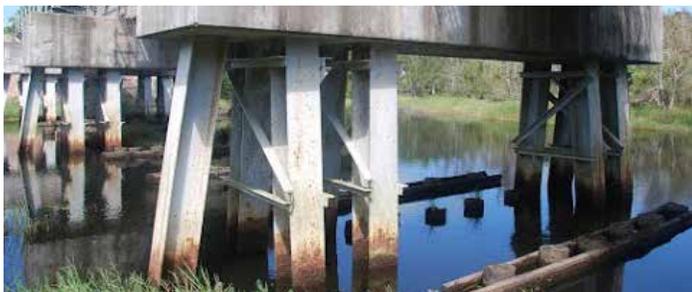
Bridge crossing the Lake Merritt Channel, a tributary of the San Francisco Bay, has cracked concrete pilings with exposed steel rebar. A derailment on this bridge would carry oil directly into the heart of Oakland and the Bay. A petroleum pipeline also runs along this bridge.

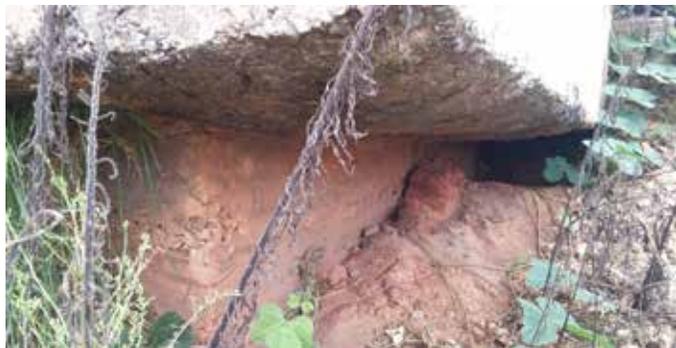
▲ A large trestle bridge crossing the Alcovy River has significant undercutting on its foundation and the bolts connecting the trestle to the foundation are warped and loose.

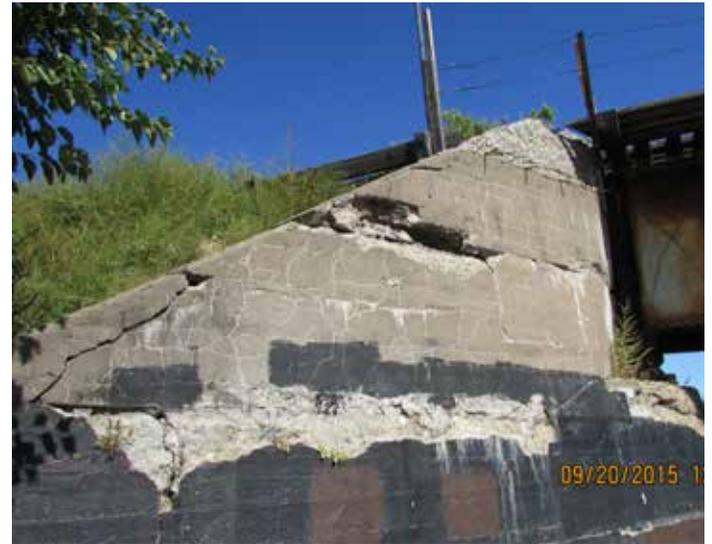
A bridge that crosses Sand Creek, a tributary of Lake Pend Oreille and the associated Pend Oreille River, has a foundation that appears slumped and cracked. The Sand Creek Bridge bisects two marinas and is adjacent to the most popular and frequented swim beach on the lake.

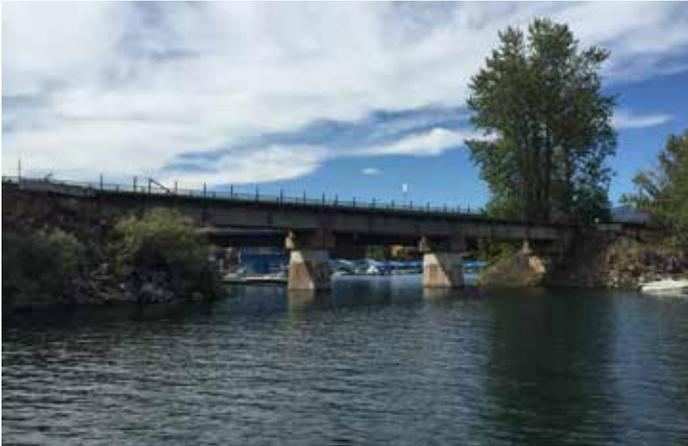
On the Portneuf River a bridge appears to have a slab missing from its concrete that separated and collapsed. Another bridge in the Snake River Watershed that appears to be undergoing repairs has wood rotting and missing from tracks. This bridge is close to a number of popular public walkways used by residents to enjoy the riverfront.

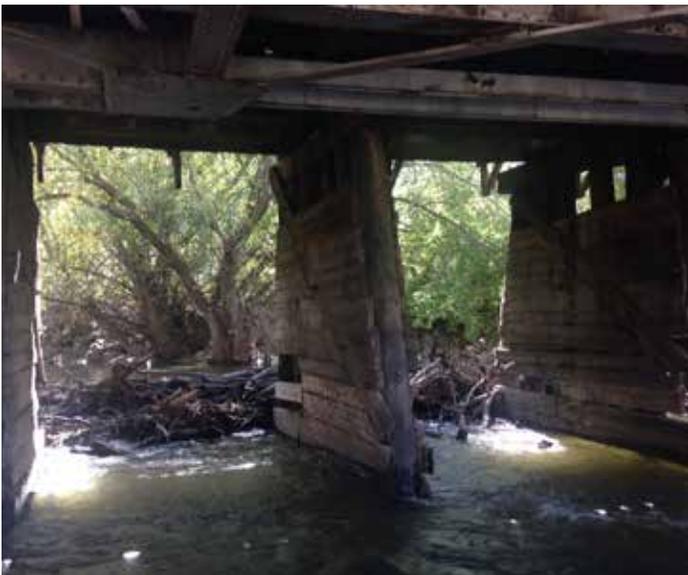
On the Passaic River, Point-No-Point Bridge is near an energy facility building and an Amtrak transit line. The swing bridge shows signs of crumbling bricks and cracks at its base. The surrounding area consists of delicate New Jersey Meadowlands, home to hundreds of species of wildlife and connects the densely populated cities of Newark and Kearny, both of which experience environmental justice issues.

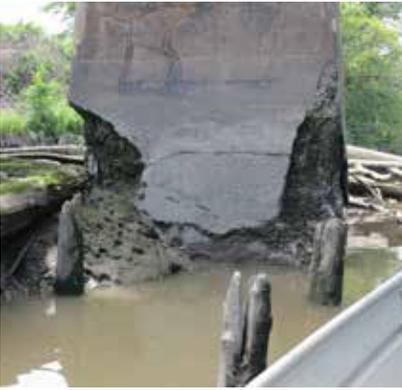
◀ On another tributary of the Hudson River a bridge spanning the Normans Kill in Albany shows extensive cracking and major deterioration of concrete, including large chunks of missing concrete

on the bases of the bridge footings. Cracks and missing concrete is also observable on structures supporting the rail bed. A derailment on this bridge could threaten Port of Albany commerce.

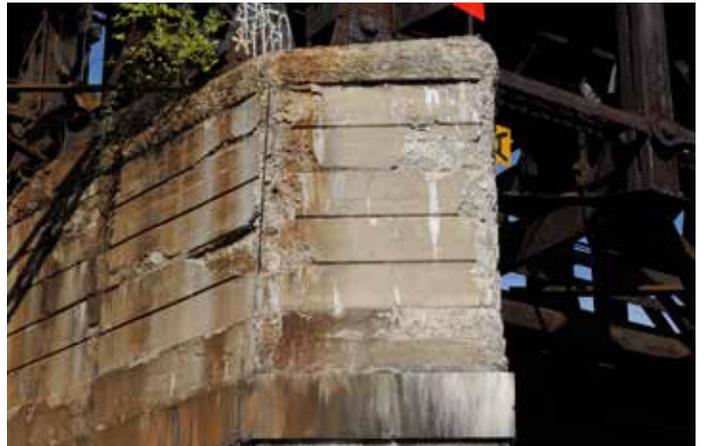
A rail bridge crossing a street in a residential neighborhood in the Youghiogheny watershed has crumbling concrete exposing the steel frame and loose or missing bolts. Most of the population of the town of Garrett, PA, would be in the evacuation zone in the case of an oil train derailment.

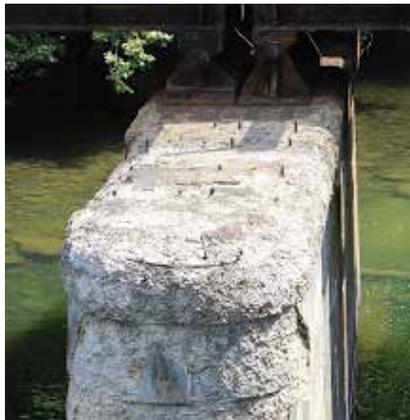
◀ Located near a very popular recreation area and downtown Confluence, PA, is a rail bridge crossing Laurel Hill Creek. The main support on this bridge has crumbling concrete, exposing steel rebar.

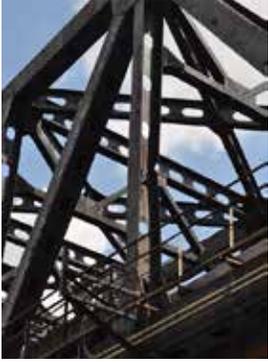
◀ A bridge crossing the Youghiogheny River was the site of a train derailment in 2014, where 10 rail cars, including one carrying light petroleum, derailed, causing three cars to be suspended above the water. This bridge has a bent steel beam, but it is unclear if this beam is the result of the derailment.

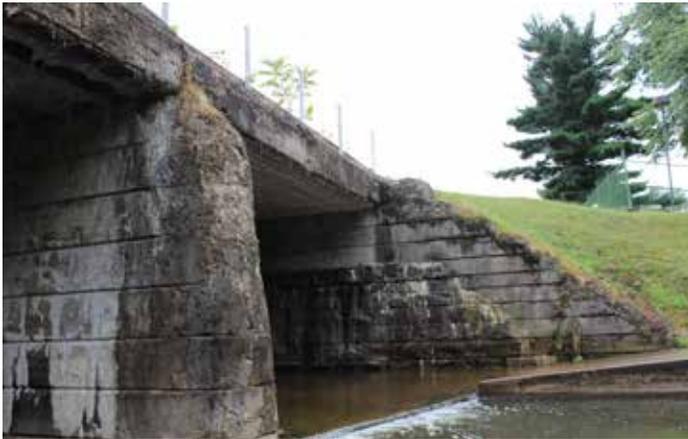
A narrow rail bridge located immediately upstream of the Richmond City drinking water intake facility that provides water to approximately half a million people has significant cracking and steel braces on the foundation that appear to be a makeshift repair.

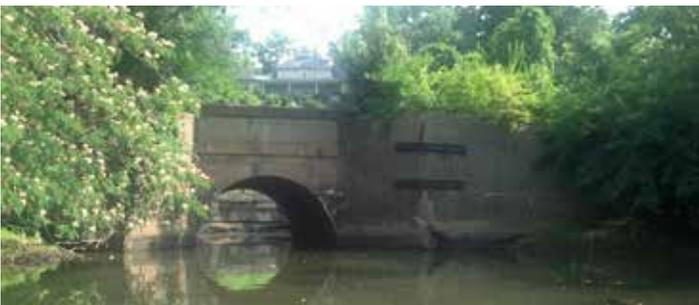
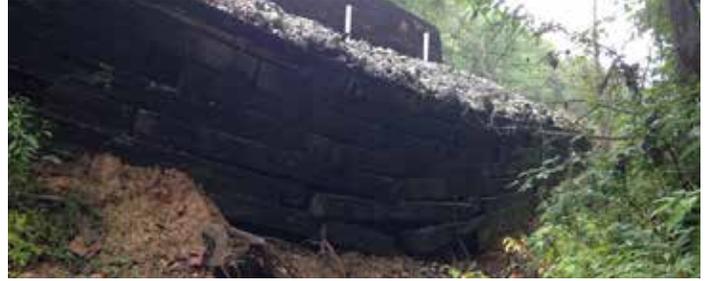
▲ On Rockfish Run, a nearly 200 year-old culvert converted to a rail bridge has a wooden structure intended to contain loose rocks that make up part of the foundation. Four to six unit trains cross these bridges weekly. Timbers are bulging and coming apart, releasing the rocks.

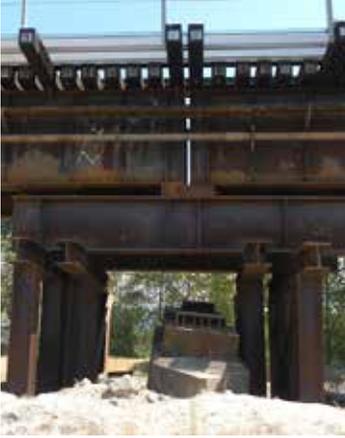
◀ A bridge crossing the Skagit River has sunken, cracked, and eroded piers and significant rust on beams. This bridge is upstream from a water treatment plant that serves about 56,000. A derailment here could threaten the structural stability of levees, causing flooding in nearby cities.

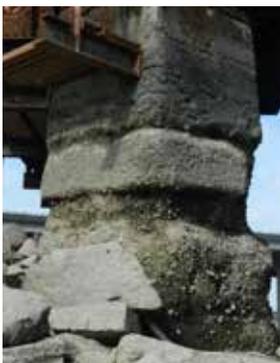
◀ The Ebey Slough rail bridge, in Marysville, WA, is adjacent to the Tulalip Reservation, a city park and about 355 feet from Interstate 5, the main North/South highway on the West Coast. Two of the three concrete footings appear to have been undermined by tidal currents. All three footings exhibit cracks in the concrete and considerable
