Memo

To: Amy Moon, EFSEC; Ami Hafkemeyer, EFSEC
From: Dave Kobus, Scout Clean Energy
Cc: Tim McMahan, Stoel Rives; Pat Landess, Scout Clean Energy; Linnea Fossum, Tetra Tech; Troy Rahmig, Tetra Tech
Date: August 9, 2023
Subject: Horse Heaven Wind Farm Anticipated Project Modifications for Final Application for Site Certification

EXECUTIVE SUMMARY

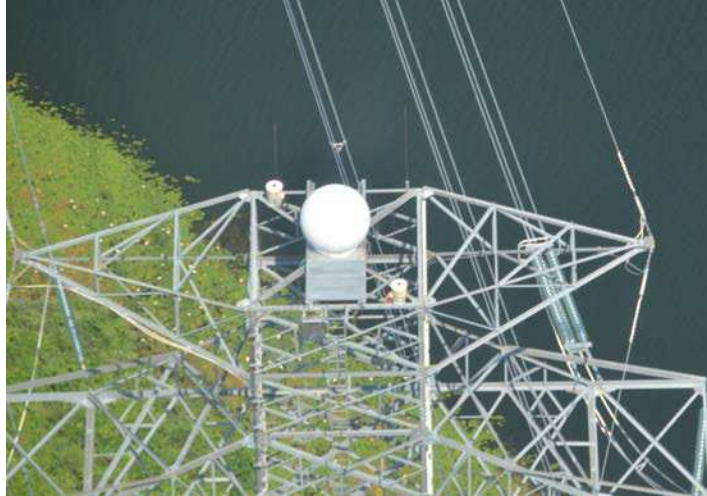
Figure 4. DeTect X-Band ADLS Radar With Radome Enclosure

The HARRIER ADLS can use 360-degree, 200-watt solid state S- or X-band Doppler radar sensor(s), which are referred to as HARRIER Surveillance Radars (HSRs) [4]. The HSR assessed by the FAA for this technical note was the X-band version. The HSR is designed to detect noncooperative aircraft in environments with large amounts of radar clutter, such as wind turbine blades at wind farms [4]. Figure 4 shows an example of the X-band version of the HSR with the radome enclosure installed on top of a transmission tower.

DeTect states that the HSR has a detection range of up to 28 statute miles. The HSR can be set to detect aircraft based on user-defined perimeters (DeTect recommends setting a detection range of up to 10 miles). The system is powered by 110/220 volts of alternating current, 60/30 amperage service with uninterruptable power supply back-up and power conditioning (30 minutes) [4]. DeTect also offers an optional diesel generator to assist ensuring continuous operation.

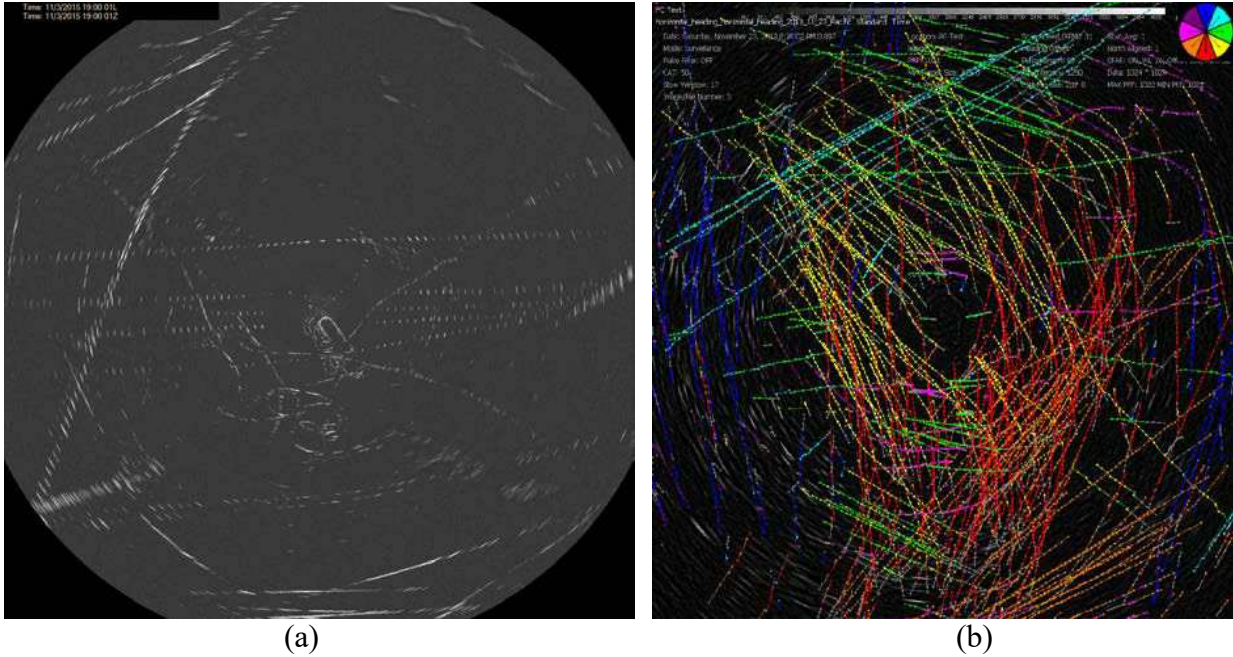
Figure 5. Unprocessed Radar Image (a) and Radar Image Processed by HARRIER Server (b) [5]

Figure 5(a) shows a 1-hour, time-lapsed image plot of raw aircraft radar tracks, while figure 5(b) shows radar tracks after being processed by the Merlin software [5]. This software also receives input from the obstruction lighting system regarding the status of these lights. All aircraft track data is recorded to the SQL database, which can be accessed by other monitoring systems, such as CMMS interface [6]. This database also provides a forensic tool in the event of system failure [6].

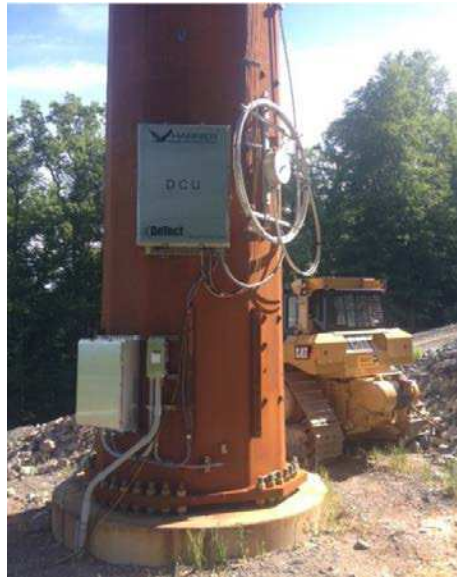
Figure 15. The DCU Installed on Transmission Tower [6]

Figure 15 shows an example of the DCU equipment located at the base of both transmission towers where HSRs were installed. These controlled the power and revolution radar rate and sent the radar-generated signals to the radar server for processing.

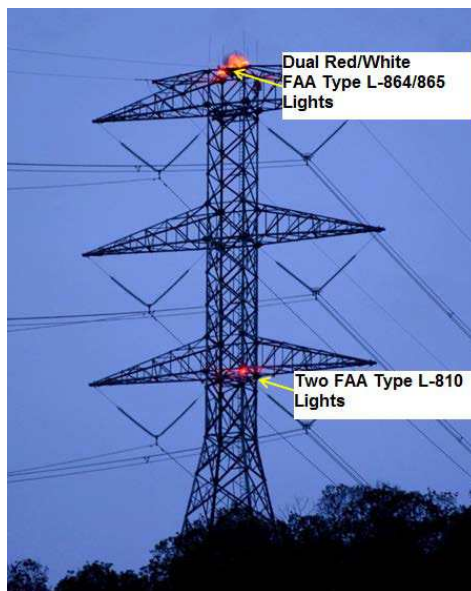
Figure 16. The FAA Type L-864/L-865 Obstruction Lights Controlled by the HARRIER ADLS [3]

The HARRIER ADLS assessed near 12N controlled obstruction lights on designated transmission towers. As shown in figure 16, these obstruction lights included FAA type L-864/865 medium-intensity red/white lights installed on the tops of the towers, and FAA type L-810 red lights installed on the sides of the towers.

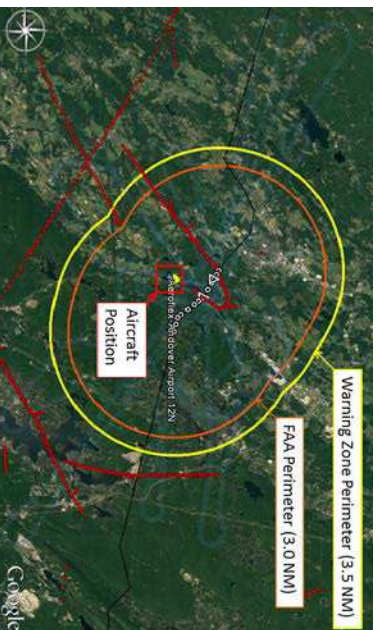
Figure 24. Aircraft Takes Off Inside Warning Zone and Flies Directly Over Transmission Lines (Events 1-4)

- Event 1:**
- Aircraft begins its takeoff from inside the warning zone.
 - Aircraft is not detected.
 - Lights are on prior to takeoff.

- Event 2:**
- Aircraft takes off and is detected by radar.
 - Aircraft is registered within warning zone.
 - Lights remain on.

- Event 3:**
- Aircraft flies directly over the transmission lines and radar.
 - Aircraft continues to be tracked by radar.
 - Lights remain on.

- Event 4:**
- Aircraft exits the warning zone perimeter heading southwest.
 - Lights remain on until the ADLS countdown reaches zero.
