STATE OF WASHINGTON  
**DEPARTMENT OF ECOLOGY**

June 27, 2022

RE: High Top and Ostrea Projects Shorelands, Wetland and Waters of the State Review

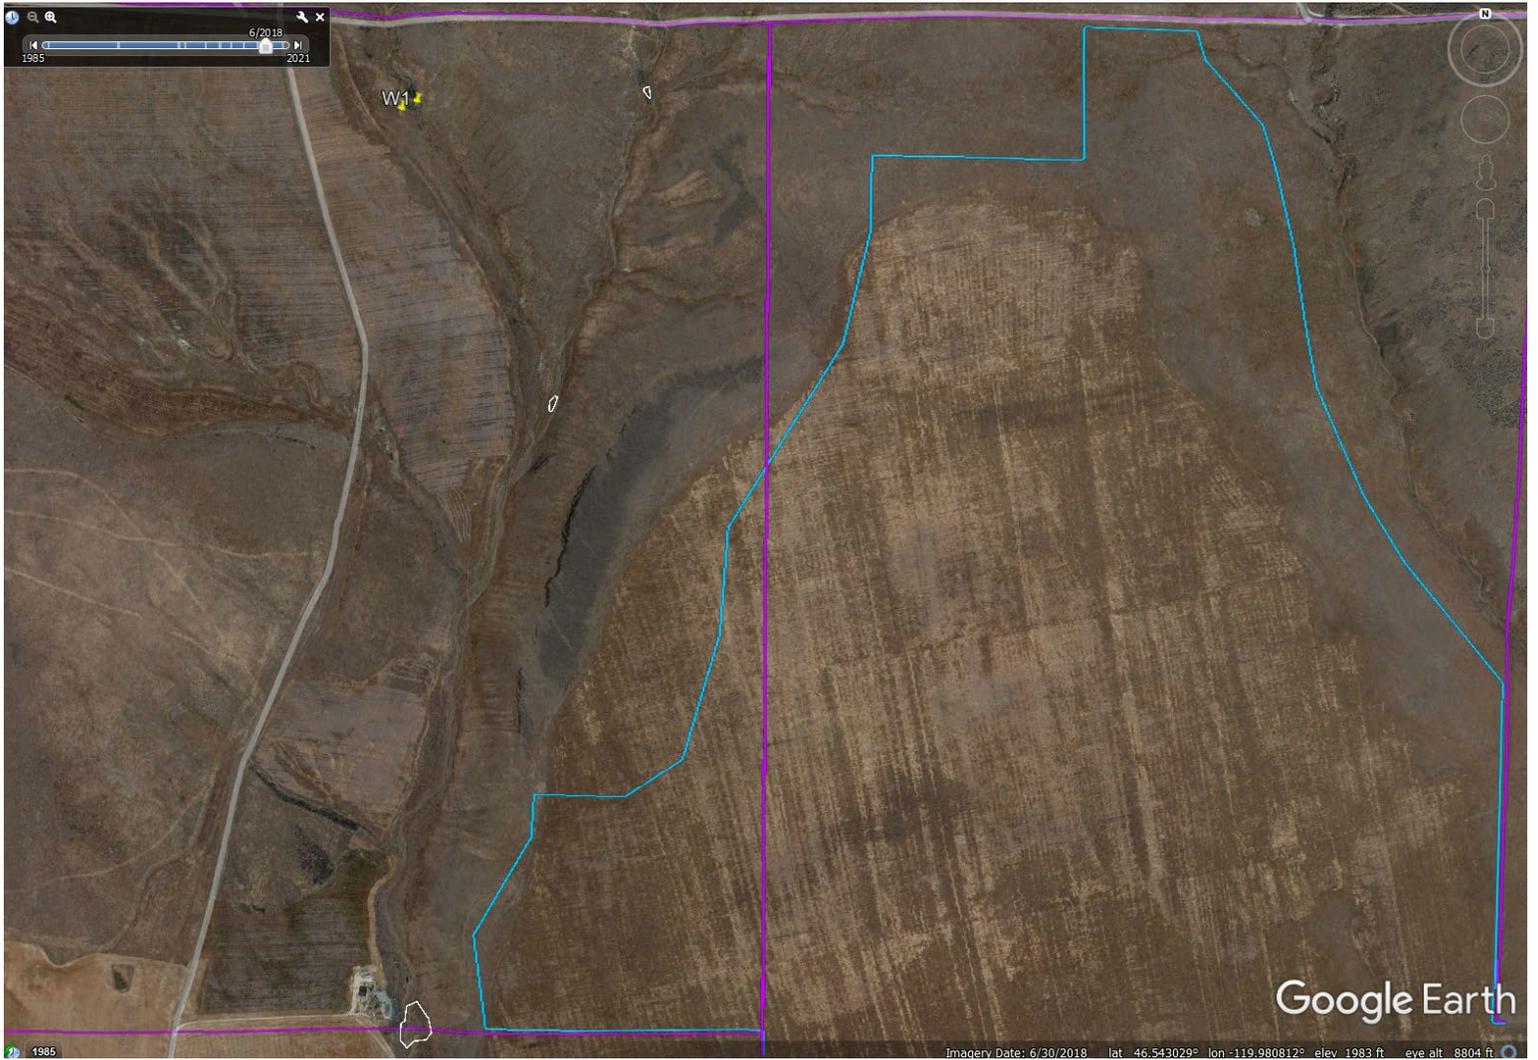
Image 1. High Top areas of interest

Several areas of interest were identified on aerial imagery that Ecology would like the opportunity to field verify via a site visit in late April or early May (Image 1 and 2). The wetland investigations were conducted in months outside the growing season and during drier times of the year (December and July for High Top; and July and May for Ostrea, respectively). It is not uncommon for ephemeral streams to have riverine wetlands associated with them. These wetlands are typically only observable during the wettest part of the growing season when the streams are flowing. The timing of the investigation could make the determination of seasonal, riverine wetlands difficult. For example, the datasheet for sampling point 01, mentions bedrock was located within 3 inches of the soil surface which meets Hydrologic indicator, D3, Shallow aquitard. The selection of two secondary indicators of hydrology, suggests wetland hydrology is present. Also, the time of the year could impact the occurrence of hydrophytic vegetation. The restricted soil profile and potential ponding could result in a lack of hydric soil characteristics. Ecology recommends that EFSEC request an additional site visit to verify the lack of seasonal wetlands throughout the project site. The use of Regional Supplement to the Corps of Engineers Wetland Delineation Manual: Arid West Region (Version 2.0), Chapter 5, Difficult Wetland Situations in the Arid West, may be required.

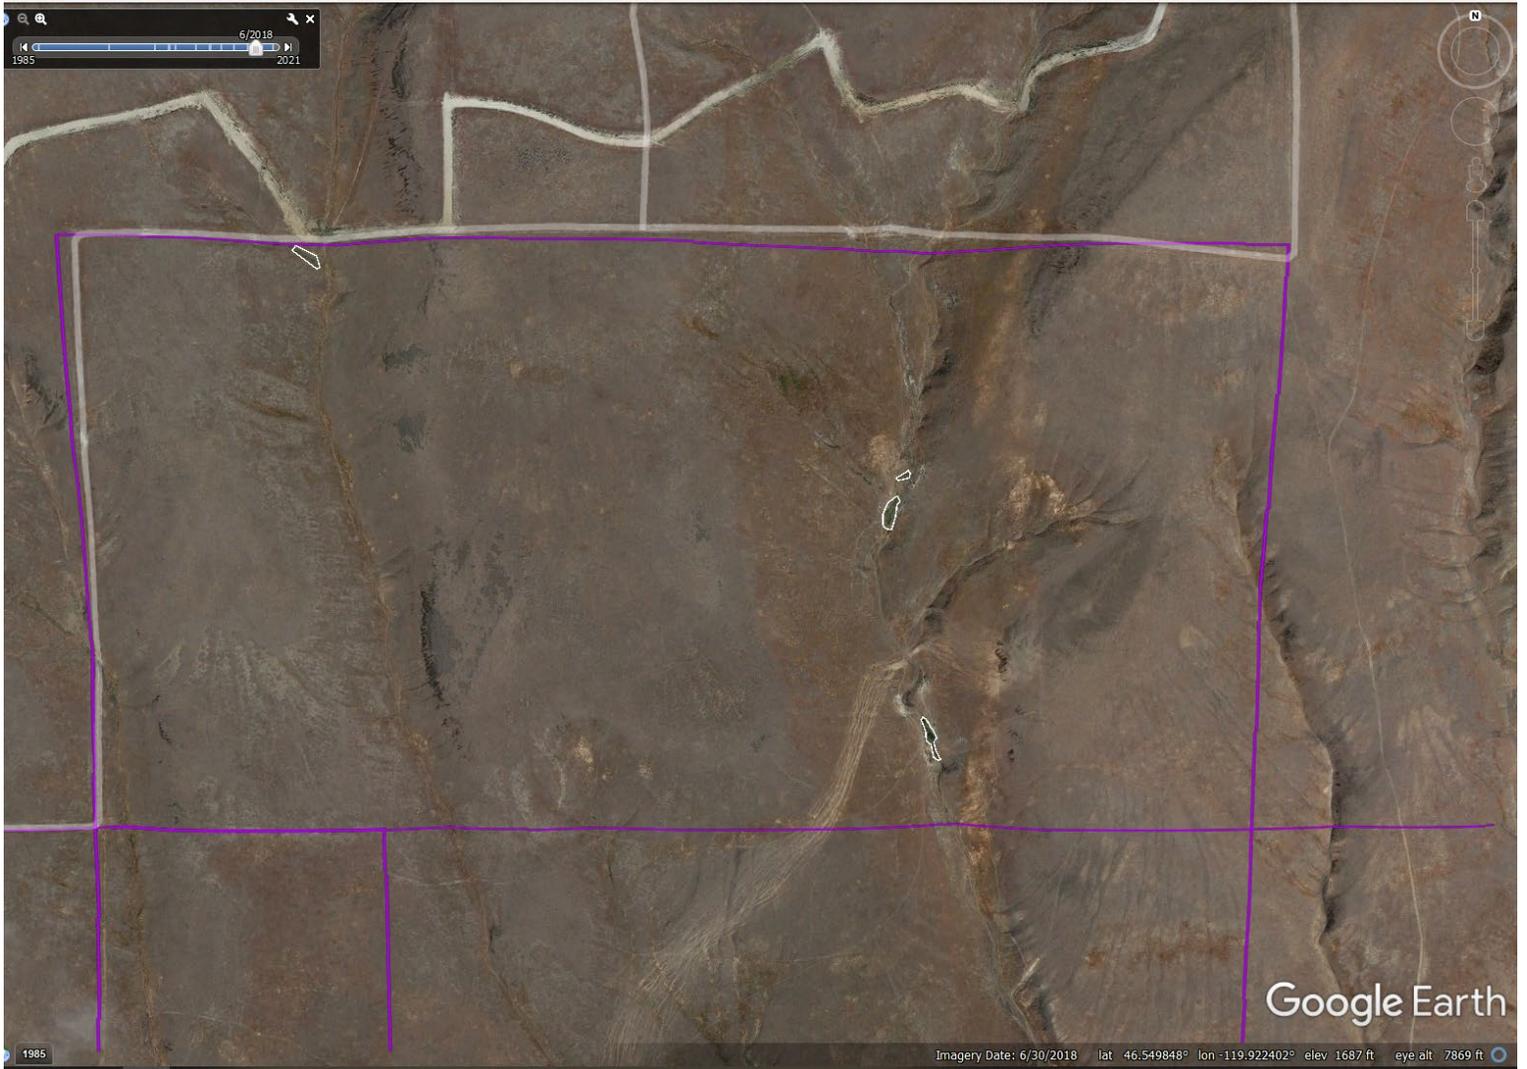
Image 2. Ostrea areas of interest
